Building & Termite / Pest Report

Inspection Date: 16 Feb 2025

Property Address: Sample Street Bundoora 0101

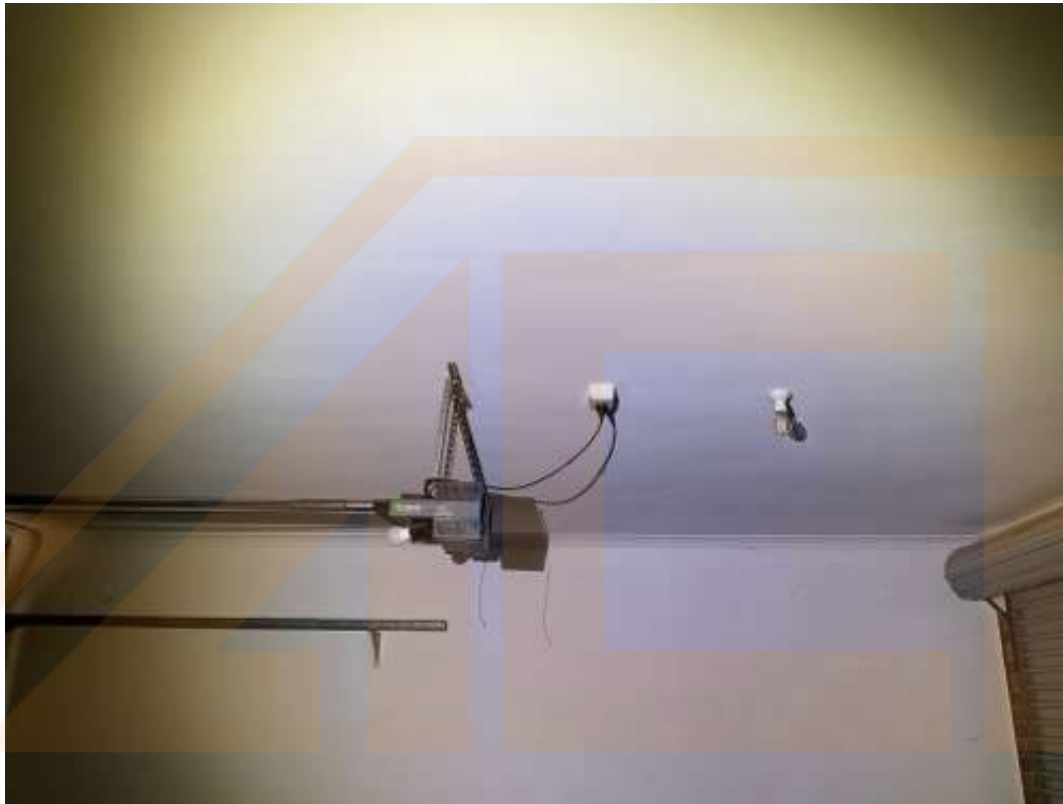
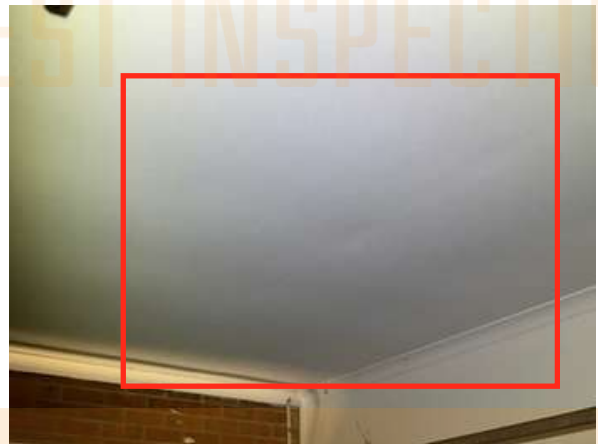
Serious Safety Hazard 1.01

When the plaster is severely compromised and bowed, we make this statement a safety hazard as the risk is much higher. However, at this stage the plaster does not appear to be too compromised, but please do not underestimate how quickly this situation can worsen.

The most common causes of plaster failure include sub-standard workmanship, physical damage, and moisture damage. Moisture, in particular, can cause the plaster to swell and shrink as the humidity changes. Minor sagging may only require re-gluing of ceiling sheets, which can be done by relevant tradespeople such as plasterers and painters. However, if excessive moisture has caused the roofing structure to swell and sag, it is crucial to identify and address the source of the water leak before undertaking any remedial works.

In this particular case, there is no insulation in the garage roof space protecting moisture attacking the plaster, so this certainly contributes to the problem.

Moisture exposure without insulation protection can damage the plaster. However, this may only be a contributing factor alongside other defects in the home, such as leaking roofs or defective workmanship, insufficient glue, and insufficient fixings.

In conclusion, the plaster defects in various areas of this property require immediate attention.

Drummy plaster generally requires chemical re-adhesion or screwing back to the frame, followed by patching and painting. However, in some cases, the plaster may be permanently deformed and need to be replaced entirely.

To prevent drummy plaster and plaster damage, it is essential to maintain a moisture-free and humidity-controlled environment. We recommend engaging a qualified plasterer and/or builder to carry out any necessary remedial works.

We suggest the client takes prompt action to address the issue, engaging qualified professionals to assess and rectify the plaster as necessary.

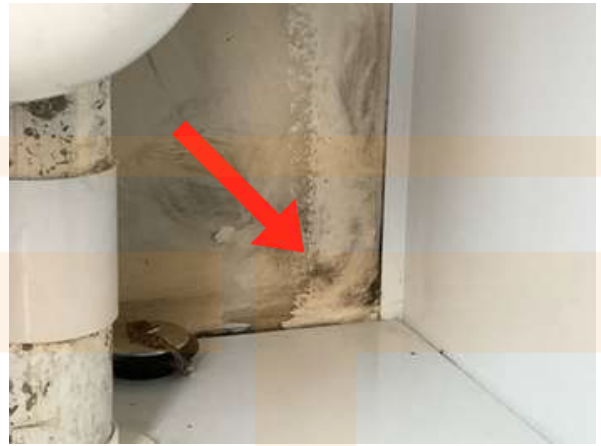
Serious Safety Hazard 1.02

Evidence of mould growth was observed. It is important to note that the presence of mould may indicate potential environmental, biological, or health issues.

To address any concerns regarding air quality spores or related issues, it is advisable to seek a specialist inspection from a suitably qualified environmental health inspector or a mould remediation company, especially if the mould is extensive.

In order to prevent further mould formation and development, it is recommended that the client ensures the general environment is free from moisture and humidity. However, in cases where the mould infestation is particularly severe, it is advised to engage the services of a professional cleaning contractor for thorough cleaning or remediation works. It is crucial to not only eliminate the visible mould but also determine the underlying cause of its growth. Simply getting rid of the mould without addressing the source may lead to its recurrence.

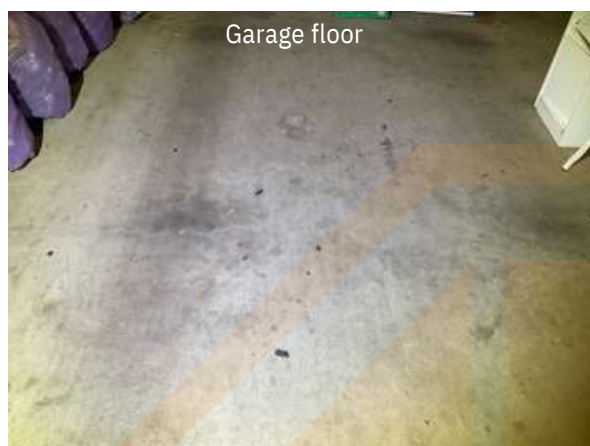
Minor Defect 2.01

Concrete - Cracking (under 5mm)

During the inspection of the property, it was observed that the concrete to area's has minor cracking. It is important to note that minor cracking, typically under 5 mm, is considered normal for concrete surfaces, such as paving, garage surfaces, driveways, or similar. However, if the cracks open and exceed 5 mm and/or if the concrete show signs of lifting or sinking, it may indicate more significant issues such as poor installation related to insufficient steel mesh or other factors.

To ensure the long-term stability of the concrete, I highly recommend having a professional assessment conducted in approximately 12 to 18 months. This assessment should be carried out by a skilled individual building Consultant, Engineer in severe cases, Concretor, Builder or similar skilled person with the understanding of concrete, who can determine if any further opening, movement or lifting of the concrete occurs.

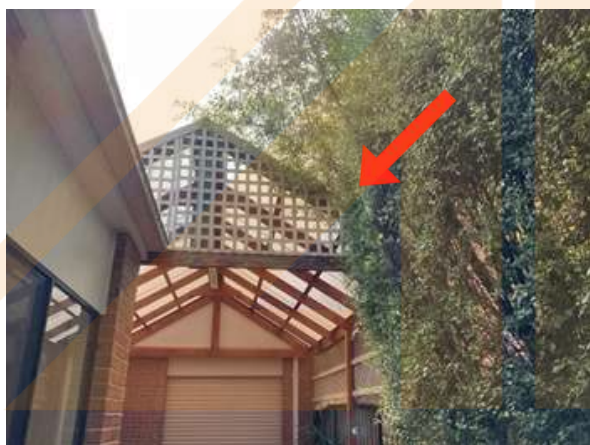
Minor Defect 2.02

Gutters are a critical part of the building's management of storm water and rain. It is therefore important that they be kept clear to prevent secondary damage to associated building elements, including exterior and interior walls, ceiling linings and any adjoining building elements. Where gutters are blocked, pooling of rainwater is likely to occur, fast-tracking rust and corrosion of the roof plumbing elements.

It is highly advised that all overhanging tree branches be removed as soon as possible to prevent any further damage. Repair and/or replacement of sections of damaged guttering may also be required where the extent of the damage necessitates.

Such works should be performed by the homeowner; however, appointment of a landscape contractor or an arborist may be required. Consultation with a licensed roof plumber is required where guttering has been damaged.

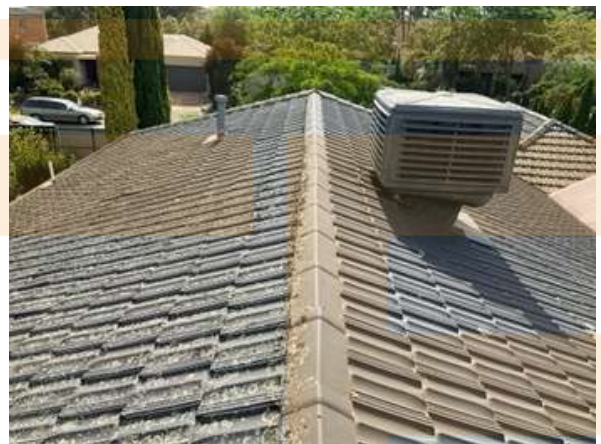
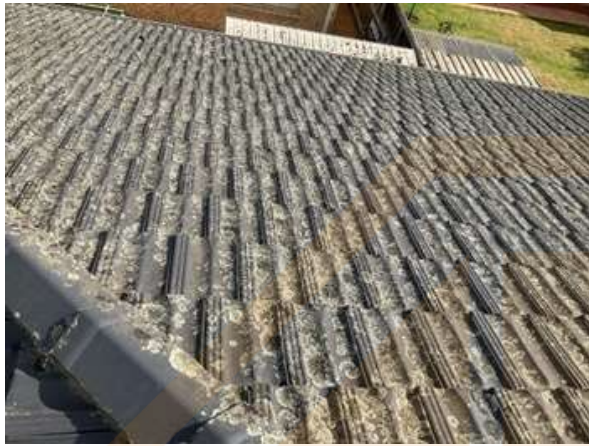
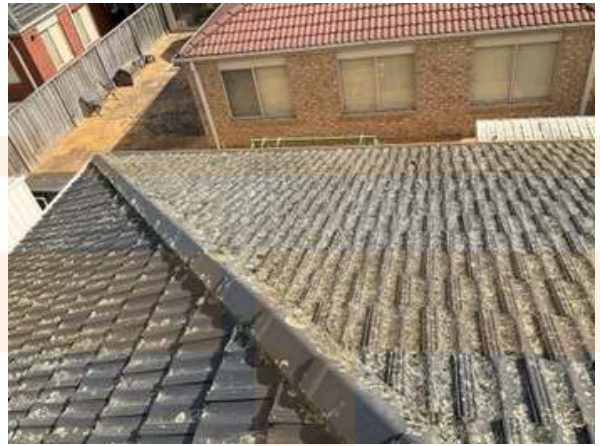
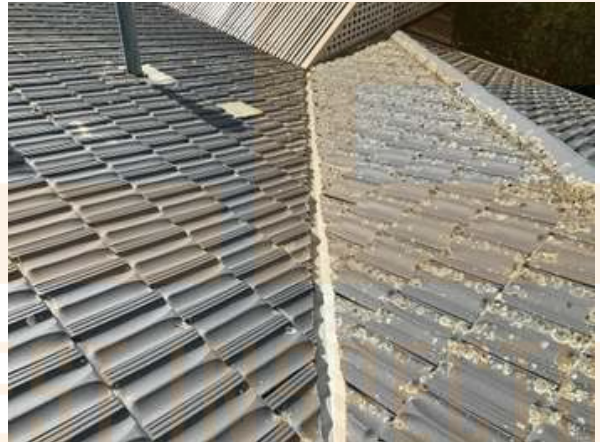
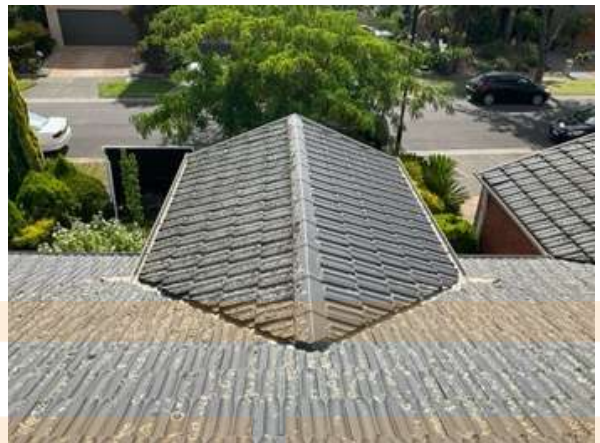
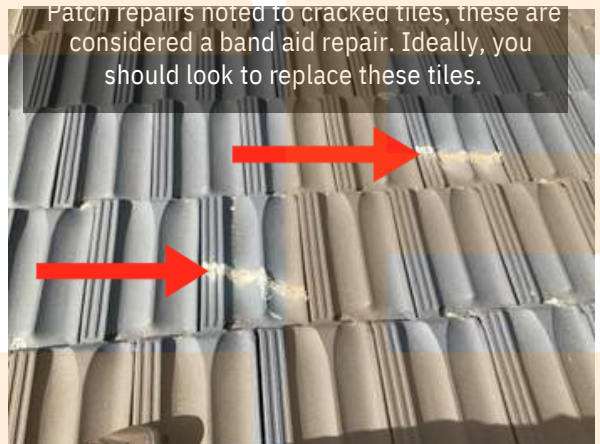
Minor Defect 2.03

Roofing - Exterior Roof Capping - Mortar Deteriorated The exterior roofing is showing signs of moss

Upon inspection of the exterior roof, it was noted that sections of the CEMENT TILE MORTAR has weathered and aged, showing varying levels of deterioration as the CEMENT TILE MORTAR has become loose, cracked and/or missing in the Valleys, Hips and/or Ridges.

Where left unmanaged, deteriorating roof tiles and cement tile mortar is likely to lead to water ingress through the roofing which creates a number of secondary defects, including minor and/or major water leaks and weather exposure to internal roofing structures.

The majority of the exterior ROOF TILES and the CEMENT TILE MORTAR are considered to be in :- WEATHERED, BUT REASONABLY GOOD CONDITION

Taking action to repair the roof will eliminate water ingress through the damaged areas and will increase the longevity of the exterior roofing structure.

Consultation with a roofing contractor should be considered :- OF IMPORTANCE

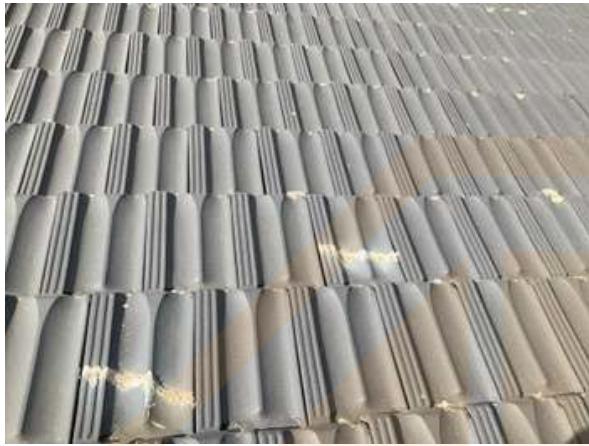
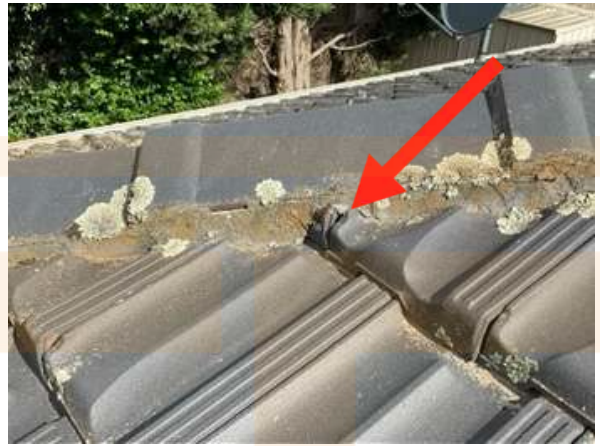
Patch repairs noted to cracked tiles, these are considered a band aid repair. Ideally, you should look to replace these tiles.

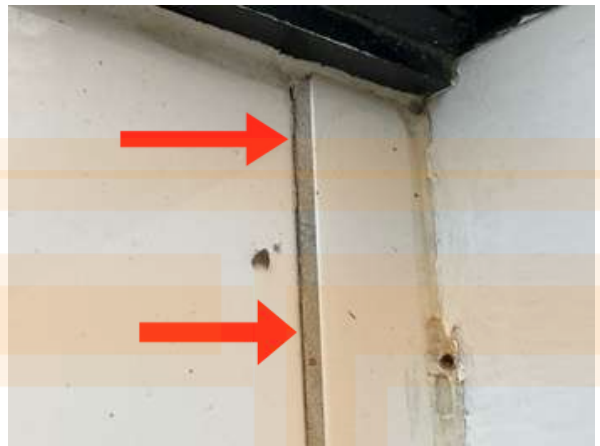
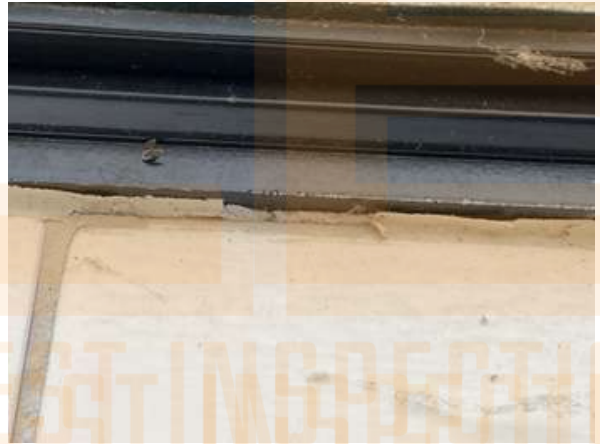
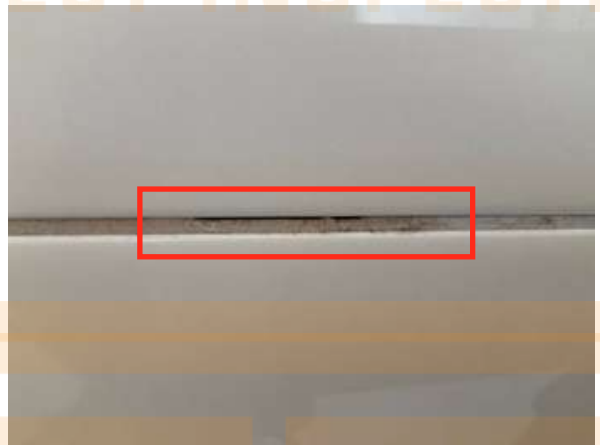
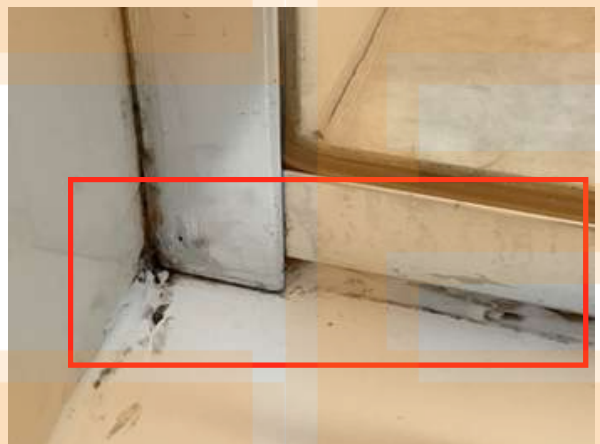
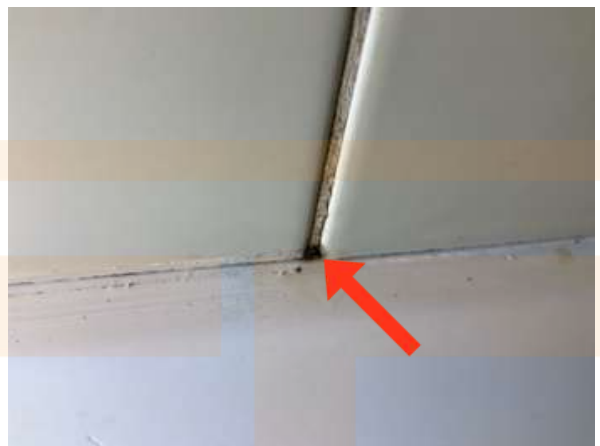
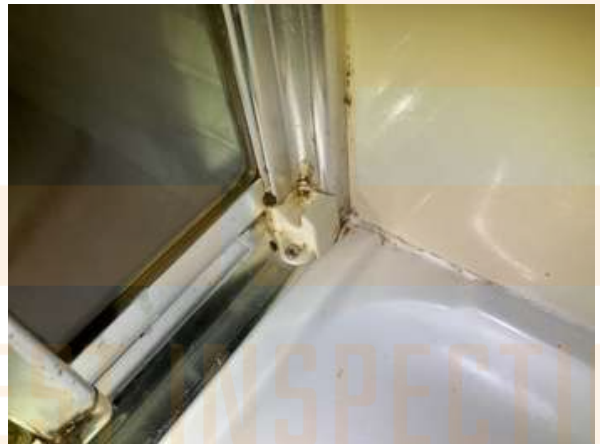
Minor Defect 2.05

Sealant & Tile Grout Damages Tile Grout & Sealant Damages The sealant & tile grout is damaged and worn in area's, which poses a potential risk of water ingress and potential building damages. It is crucial that repairs are performed promptly.

To address this, it is necessary to take out the old sealant & tile grout in its entirety and replace sealant & tile grout that can accommodate expected expansion and contraction while maintaining a watertight seal to protect all associated building materials. This will ensure the joints remain watertight and protective of all associated building materials.

If there are loose or cracked tiles, which may also involve damaged waterproofing, these should be repaired first.

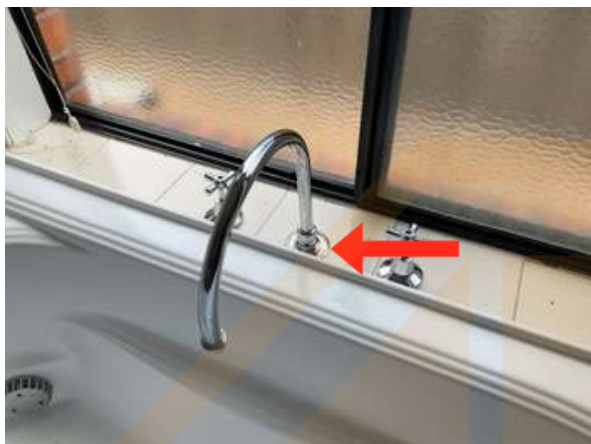
Minor Defect 2.10

The tap in this area has not been installed correctly, or has deteriorated with age, and is consequently loose. This tap being loose creates potential for water leaks and subsequent water damage to the surrounding area.

Where taps are loose, a qualified plumber should be appointed to re-fix the plumbing fitting to prevent further secondary damages that may not be seen, creating water damage unseen.

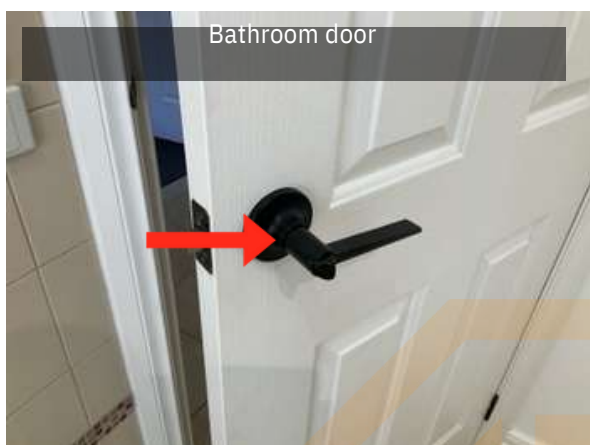
Minor Defect 2.12

At the time of the inspection the door handle in this area was found to be loose or not operating smoothly as the door handle should function.

Replacement or repair of the door handle is advised to improve the operational state of the associated door, also to ensure that a door does not remain locked, and unable to be opened. A qualified carpenter or general handyman should be appointed to replace or repair the door handle.

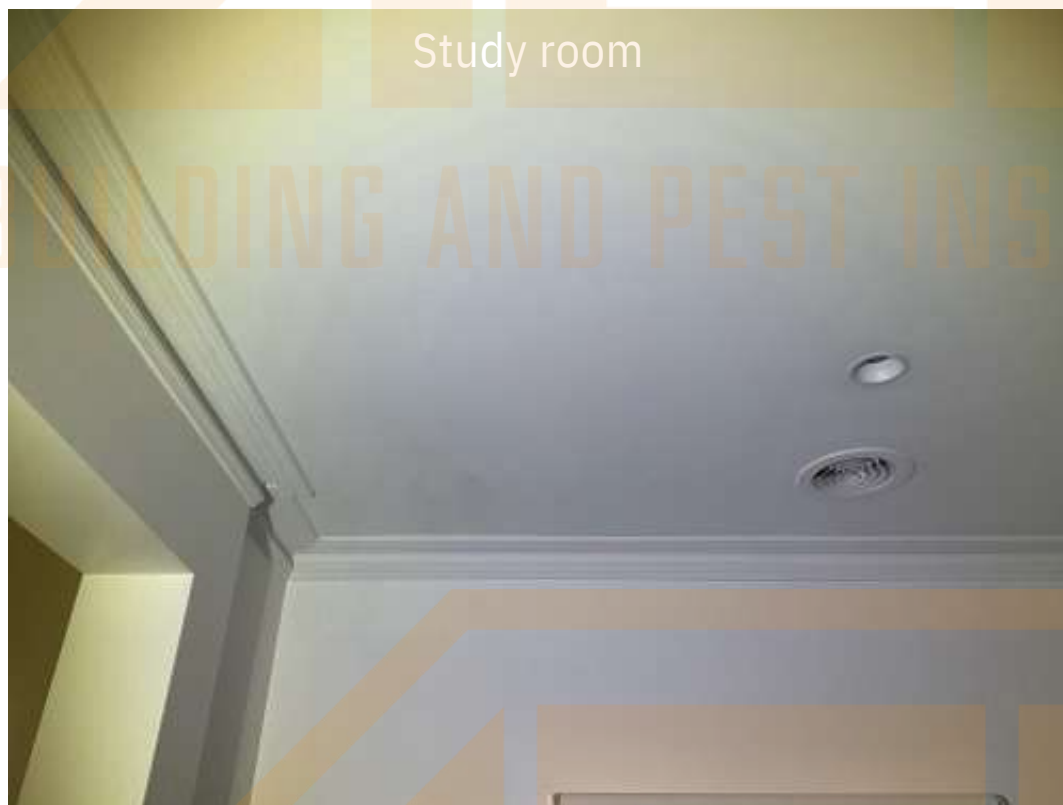
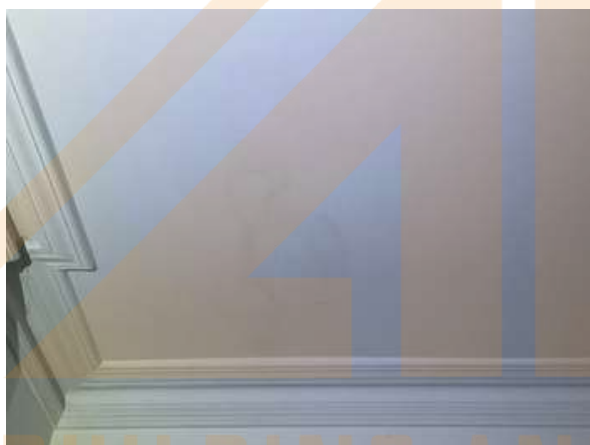
Minor Defect 2.15

property, it was observed that there is water damage to the ceiling lining in study room. This is usually an indication of excessive moisture present in the roof void, or coming from a leak in the roof covering, however at the time of the inspection there were no high moisture readings noted.

You will need to monitor this when there is heavy rainfall. If the problem still persists then It is recommended to appoint a roofing plumber or if the water problem is internally the appropriate trades person as soon as possible to identify the leak and carry out necessary rectification works to restrict further water damage. Once the leak is repaired, it is advisable to consult with relevant tradespeople such as plasterers and painters. Depending on the extent of the damage, rectification works may involve replacing the ceiling lining or minor repainting. In cases where water staining is old and inactive, affected building materials may be repaired or replaced at the discretion of the client.

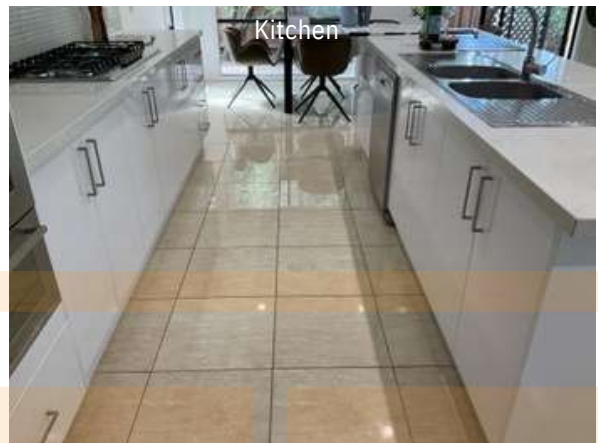
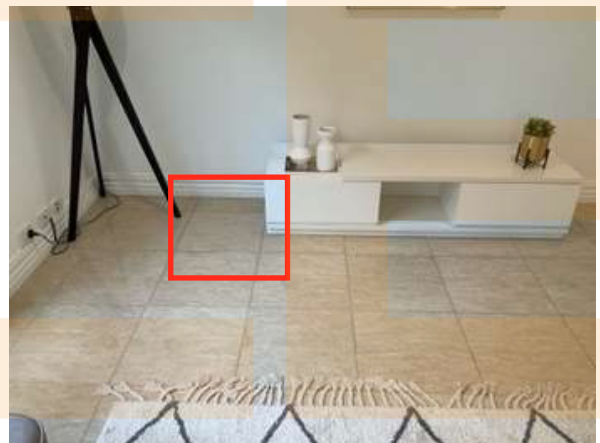
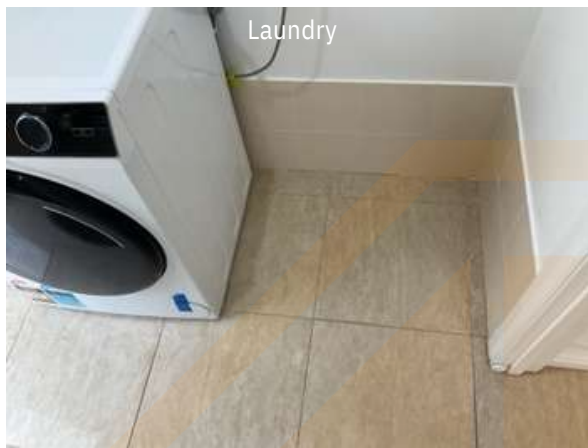
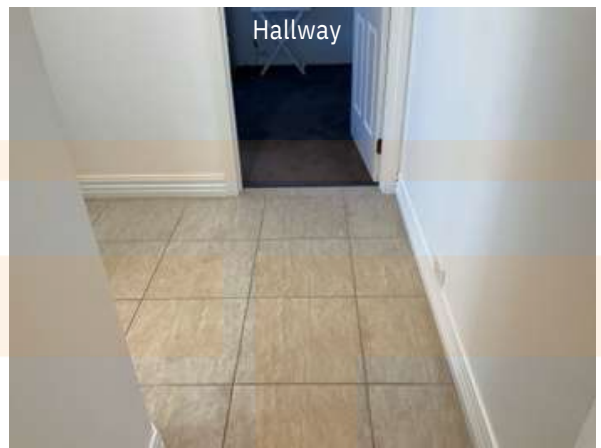
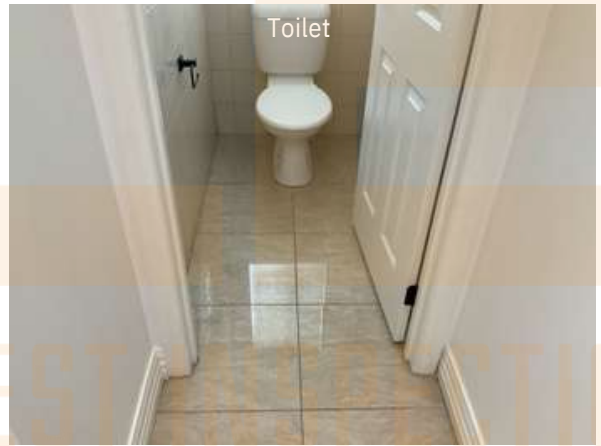
Minor Defect 2.16

Any exposure to moisture can cause tiled areas to become drummy and/or cracked over a prolonged period of time.

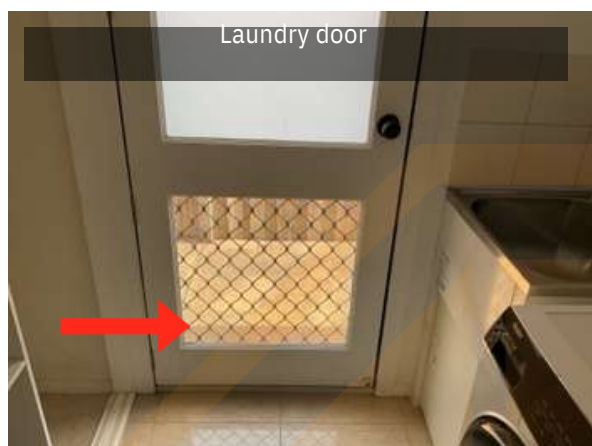
Safety door glass

The inspection of the internal areas revealed a safety concern regarding the laundry door. The glass pane in the lower section of the door is located below 600 mm from the floor, and it does not appear to be safety glass. This presents a potential risk of injury in case of accidental impact, as non-safety glass may shatter more easily. To mitigate this risk, it is recommended that the existing glass be replaced with safety glass, which complies with the relevant safety standards. This would enhance the safety for occupants, particularly in environments with children or pets.

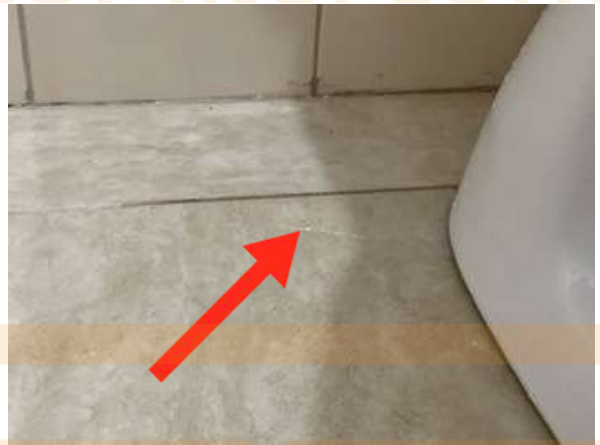
Finding: Toilet leak

In the separate toilet, there is a noticeable leak originating from the pipe connection when the toilet is flushed. This leak may lead to water pooling on the floor, posing a risk of water damage to the flooring and potential mold growth if left unaddressed. To rectify this issue, it is recommended to have a licensed plumber inspect the toilet's plumbing connections and replace or repair any faulty seals or components. Ensuring a tight seal and proper functionality will help prevent future leaks and maintain the integrity of the flooring.

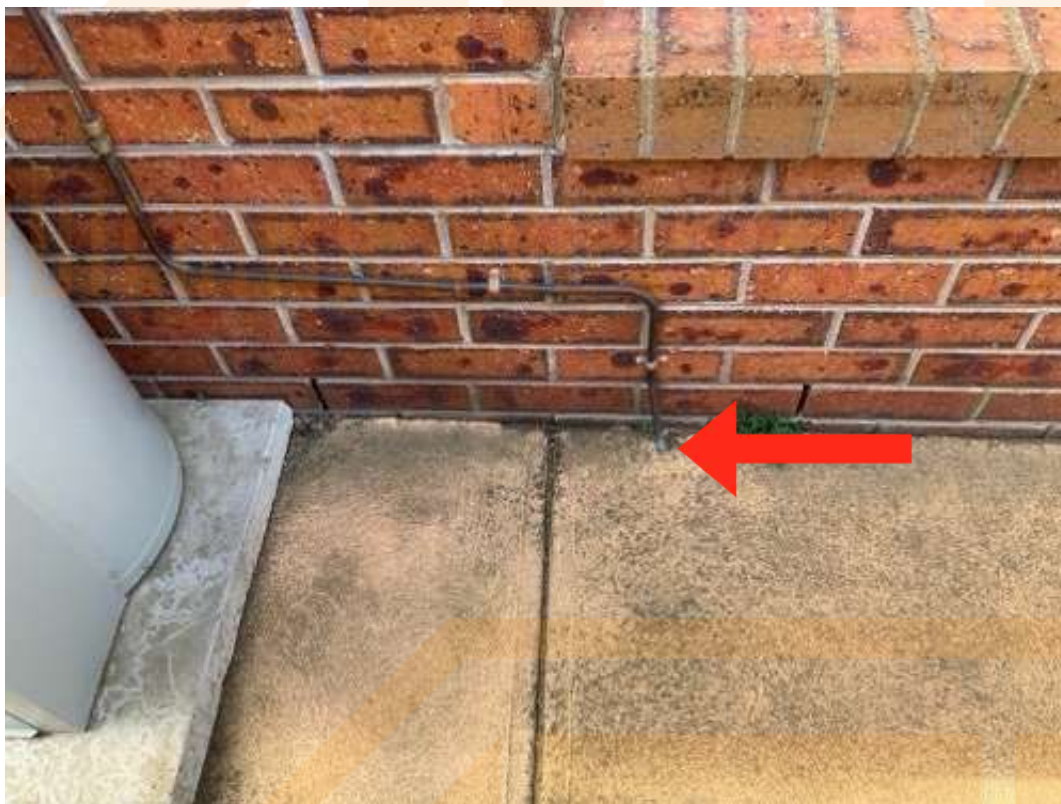
These damp conditions can lead to secondary defects such as rot, rust or corrosion of associated building elements, the formation of fungal decay, or even the creation of potential slip hazards. When coupled with poor site drainage, pooling of water may also attract termite activity to this area.

It is highly recommended that a licensed plumber be appointed to connect the HWS overflow in order to prevent such an environment from being created. These minor works should be carried out as soon as possible.
