# Building & Termite / Pest Report

**Inspection Date: 16 Feb 2025**

**Property Address: Sample Street Craigiburn**

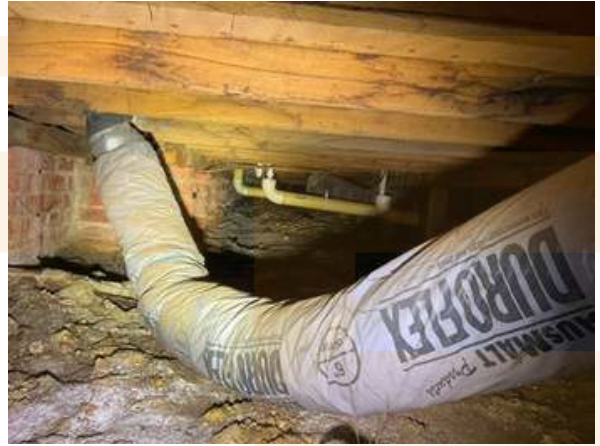
### Serious Safety Hazard 1.01

During the inspection of the subfloor area, it was observed that there is a significant presence of mould growth. It is important to note that mould can thrive in the soil or dirt of a subfloor, and its growth is primarily caused by excessive moisture and dampness. Upon further examination, it was found that the ventilation to the subfloor perimeter is ineffective, resulting in limited airflow and inadequate ventilation.

Additionally, there may be obstructions or low clearance within the subfloor space, leading to restricted air flow. A well-ventilated subfloor is crucial in maintaining dry conditions and preventing secondary damage like wood rot and pest activity. Moreover, it plays a vital role in preventing the development of mould and mildew, which can pose respiratory safety hazards for occupants.

The current ventilation design is not suitable for this particular subfloor, and it is recommended to consider implementing mechanical ventilation, such as powered fans, to improve subfloor airflow.

To address this major defect, it is essential to determine the underlying cause of the mould growth rather than merely removing the mould itself. Failure to address the root cause may result in the recurrence of mould. The causes or sources of the mould must be urgently addressed, and remedial works should be conducted promptly to prevent the development of potentially harmful subfloor conditions and further damage to the subfloor area.

For severe cases of mould, it is recommended to engage the services of a professional cleaning contractor. It is important to note that mould remediation should only proceed once the causes have been identified and repaired.

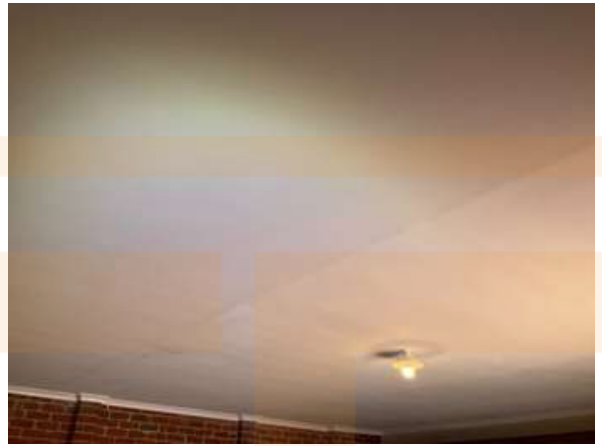
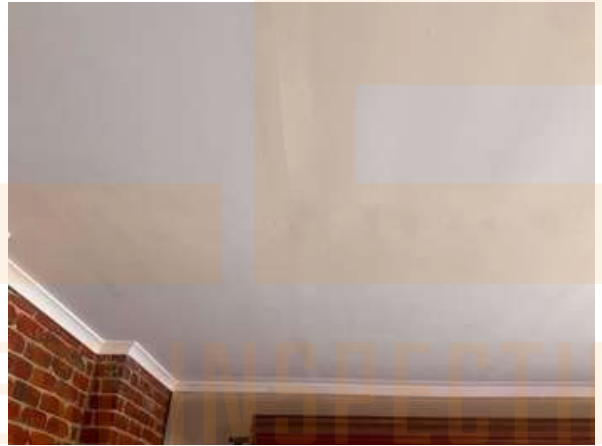
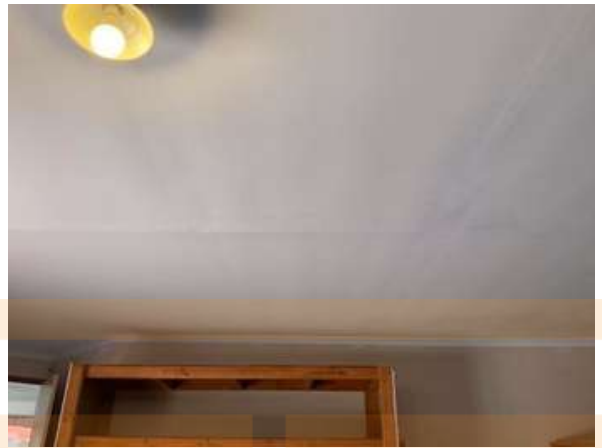
## Serious Safety Hazard 1.02

When the plaster is severely compromised and bowed, we make this statement a safety hazard as the risk is much higher. However, at this stage the plaster does not appear to be too compromised, but please do not underestimate how quickly this situation can worsen.

During our inspection, we have identified a significant defect in the plaster of this property. The plaster in question has suffered severe compromise, resulting in a loss of structural integrity. Additionally, it has sagged and stretched, making repair highly unlikely. In some areas, the plaster sheeting has become drummy, meaning it has detached from its original fixing. This not only poses a safety risk, as plaster ceilings can unexpectedly drop, but also indicates a need for repair or replacement.

In this particular case, there is no insulation in the garage roof space protecting moisture attacking the plaster, so this certainly contributes to the problem.

Drummy plaster generally requires chemical re-adhesion or screwing back to the frame, followed by patching and painting. However, in some cases, the plaster may be permanently deformed and need to be replaced entirely.

To prevent drummy plaster and plaster damage, it is essential to maintain a moisture-free and humidity-controlled environment. We recommend engaging a qualified plasterer and/or builder to carry out any necessary remedial works.

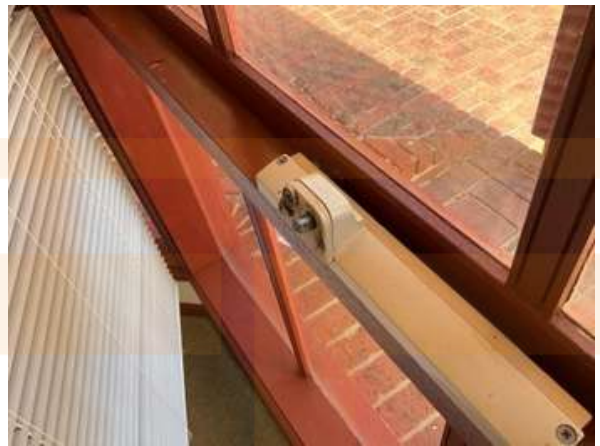
## Serious Safety Hazard 1.04

Window Accessories Missing/Broken

During the inspection of the property, it was observed that the windows in the internal area are not functioning entirely as intended. Various components such as handles, locks, ropes, and window frames were found to be broken, damaged, or missing, which significantly affects the functionality of the windows. This poses a safety risk as windows that do not function or lock properly can compromise the security of the property.

In order to ensure a comprehensive assessment, it is recommended that all windows in the property be tested for their performance. This will help identify any additional defects or concerns that may need attention. Taking these remedial actions will contribute to the overall improvement of the windows' functionality and ensure a safer environment within the property.

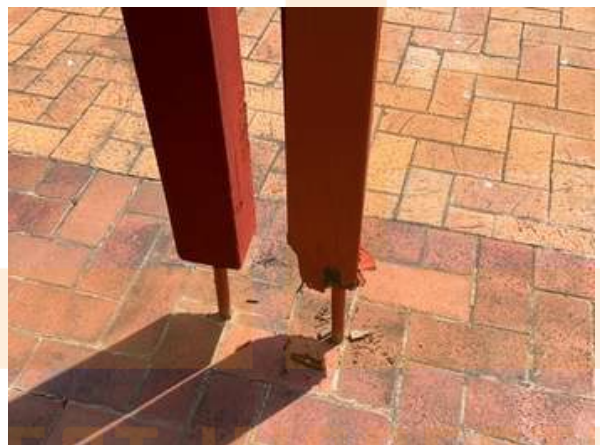
### Major Defect 2.01

It is crucial to address this issue promptly as it poses a safety hazard to anyone in the vicinity.

Additionally, it is essential to clean up the area to eliminate constant moisture.

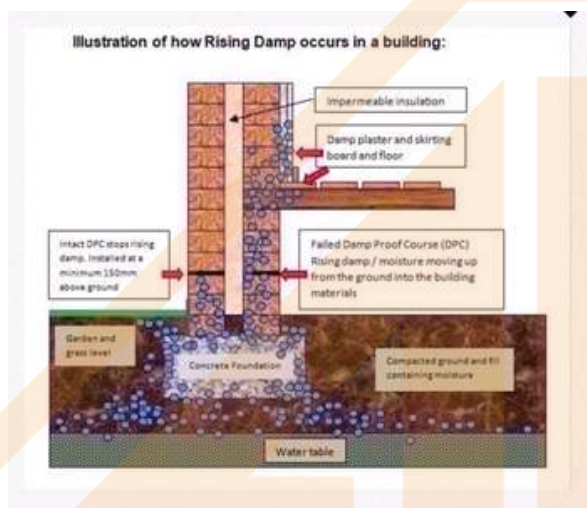
In summary, the rising damp issue in the garage of the Australian residential property requires immediate attention. By addressing the underlying cause and implementing the recommended remedial actions, the potential health risks and further damage to the building can be mitigated.

To rectify this major defect, it is recommended to engage the services of a qualified plumber, builder, and/or structural engineer, and possibly a geotechnical engineer, to conduct further investigations. These professionals will be able to provide a comprehensive analysis and suggest appropriate remedial actions, such as installing a new damp proof course, improving drainage systems, and repairing any damaged building elements. It is important to note that without these invasive investigations, a complete analysis of the defect cannot be determined.

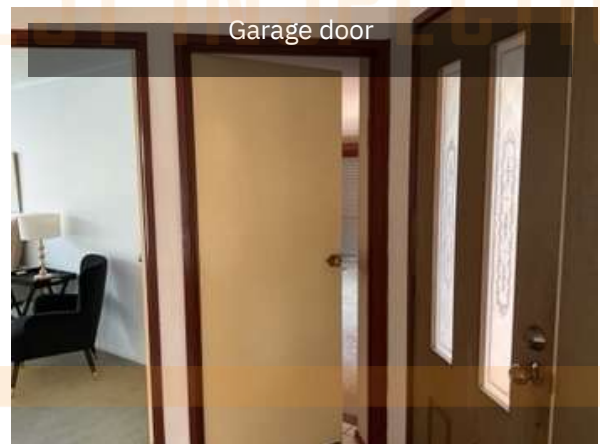
## Minor Defect 3.02

It is crucial to determine whether the door requires typical minor adjustments due to wear and tear or if there are more significant concerns causing the binding/jamming.

Please note any planing, shaving, sanding or cutting to doors requires appropriate painting upon completion for the long-term protection of the door.

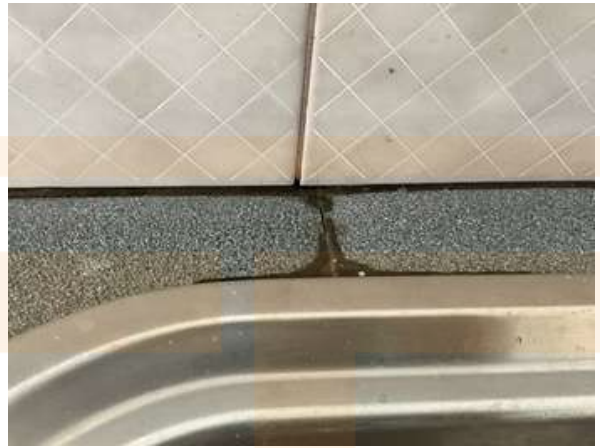
### Minor Defect 3.06

**Location:** Sealant & Other Damages  
**Finding:** Sealant – Worn / Damages

It is imperative that the necessary repairs and maintenance are carried out as soon as possible to prevent any potential building damages and to ensure the long-term durability and safety of the property.

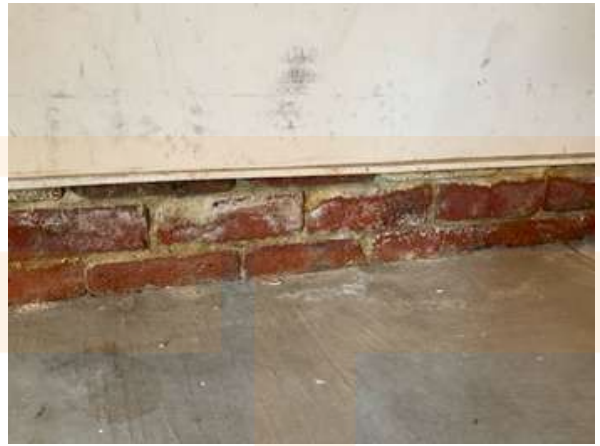
### Minor Defect 3.09

On another matter, it is common for efflorescence to occur to the concrete and brick walls, adjacent to the neighbouring property, which generally states that the neighbouring properties water run-off is falling directly towards the garage, which can create other concerns with water into the foundations

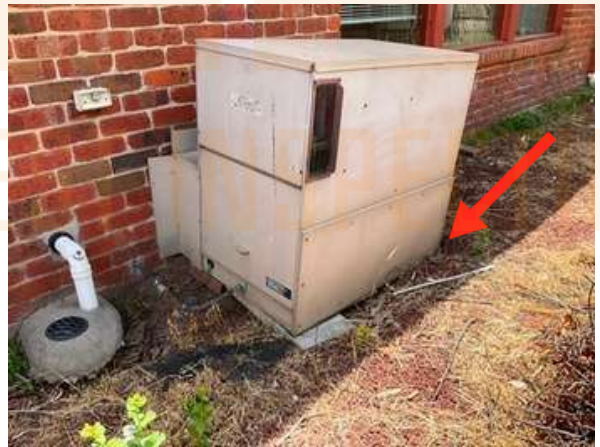
During the inspection of the property, it was observed that the Boiler service is positioned directly on the ground without any concrete base or support. This lack of proper support can lead to potential issues with the plumbing connections, including water and gas. The movement of the Boiler service due to its unstable positioning can compromise these connections, posing a risk to the overall functionality of the unit. Furthermore, the absence of a concrete base exposes the hot water service to accelerated deterioration, which can further impact its performance and lifespan.

To address this defect, it is recommended that a qualified professional be engaged to install a concrete base or suitable support for the Boiler service. This will ensure stability and prevent any movement that may jeopardize the plumbing connections. Additionally, the installation of a concrete base will help protect the unit from premature deterioration, allowing for its optimal functioning and longevity.

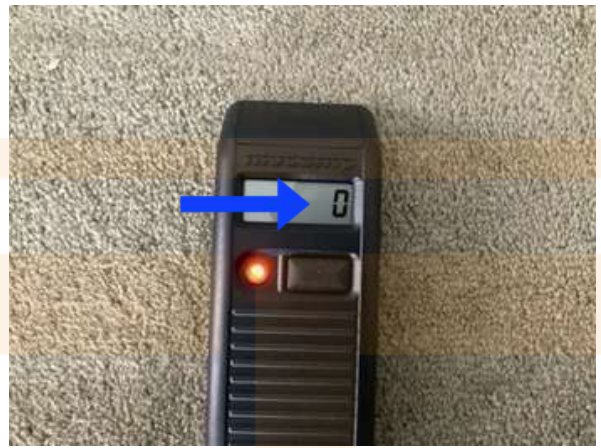
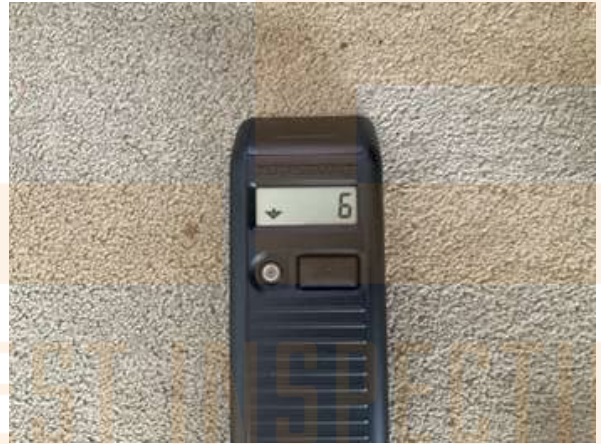
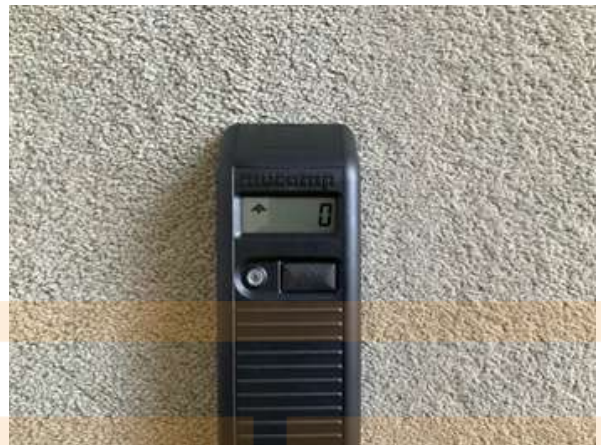
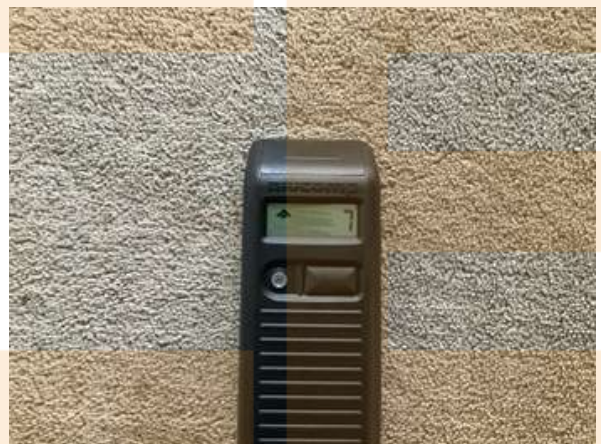
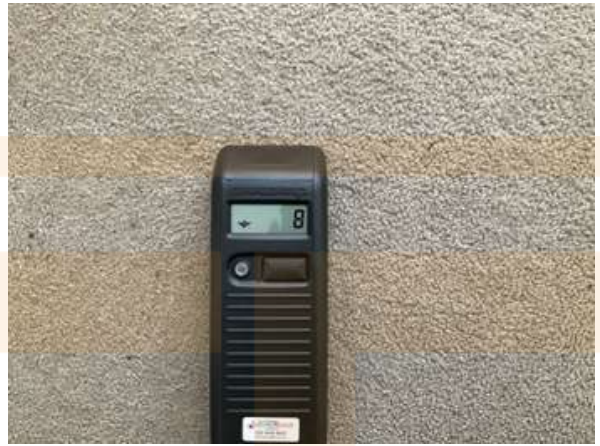
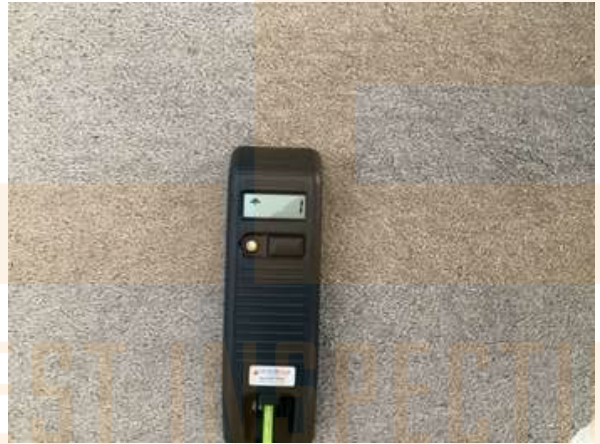
### Minor Defect 3.14

◆ RESULT - Taking into consideration, the properties type and age, it appears that the FLOOR LEVELS HAVE ACCEPTABLE VARIATIONS IN HEIGHT.

Where flooring remains relatively unchanged for an extended period of time (i.e. several months or seasons ) it is likely that the flooring is relatively stable, however unexpected movement to the foundations of a property can occur at any time, for reasons such as extensive tree roots, water pooling to the foundations, general age and/or other type conditions.

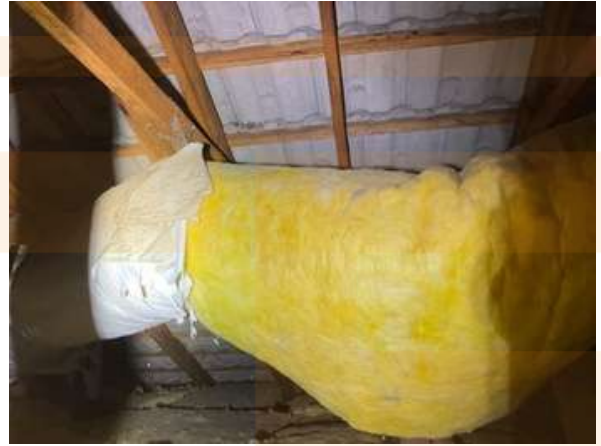
The damage sustained by the ducts detracts from the energy efficiency of the property. The airflow within the property is likely to be restricted, particularly in areas where ducting shows signs of major damage.

A heating/cooling specialist should be appointed to provide further advice on remedial work options and to perform any works deemed necessary.

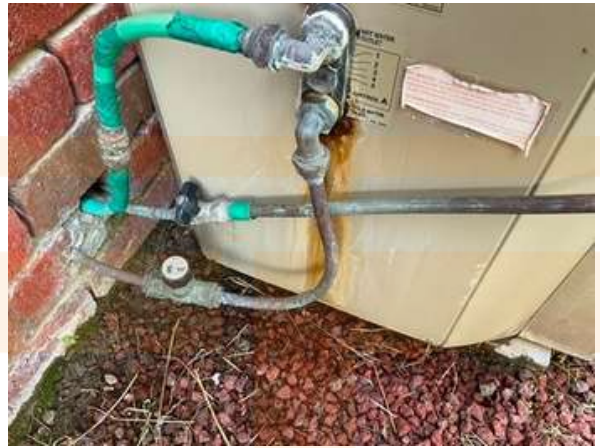
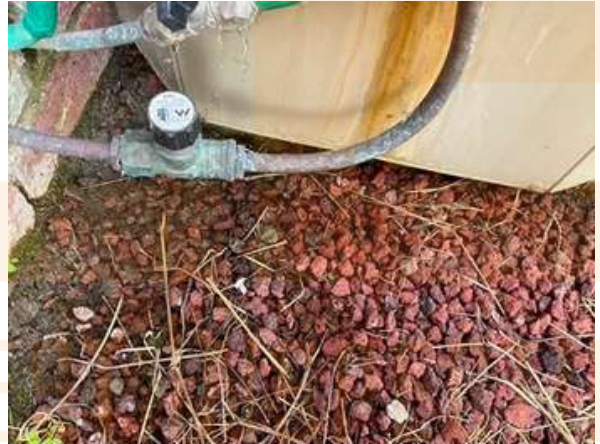
**Finding:** Water storage heater

During the inspection, I observed an active leak in the water storage tank, which appears to have been an ongoing issue as the surrounding wall area was noticeably saturated. Additionally, there was evidence of ponding near these regions, and the brickwork exhibited high moisture readings. This leak poses an immediate concern and should be addressed urgently to prevent further damage to the walls. I recommend engaging a licensed plumber to assess the situation and carry out the necessary repairs to the water storage tank and any affected areas. Prompt action is essential to mitigate the risk of structural damage to the property.

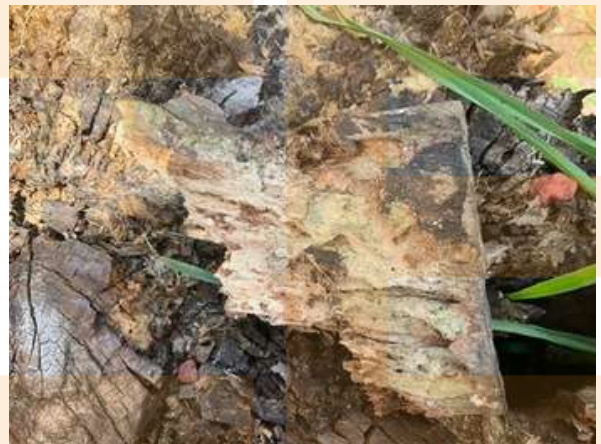
Whilst we have identified and added photos in areas detected with termite damage, please understand that the possibility of other areas within the property having potential termite damage is high.
