Building & Termite / Pest Report

Inspection Date: 3 Feb 2025

Property Address: Sample Street Altona 1234

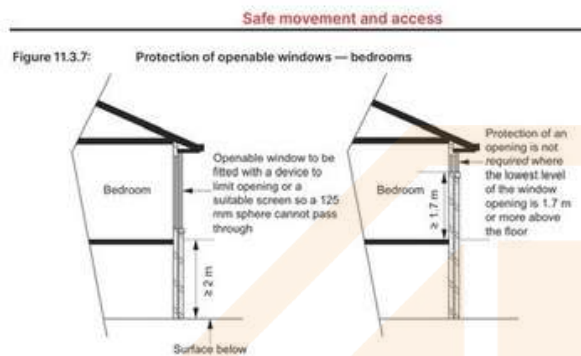
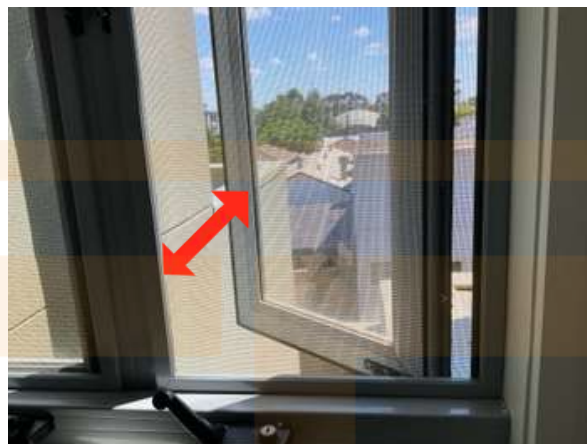
Serious Safety Hazard 1.01

Windows - Internal Areas Window Openings - Unsafe There are windows that do not have restricted openings to areas considered high risk.

I highly recommend for the safety of children and pets you engage a window technician to install window limiting devices to the high risk windows in order to restrict the openings to 125 mm as per the current building codes and standards.

Generally window mechanisms will need to be replaced with winding type windows and limiting devices installed to sliding type windows.

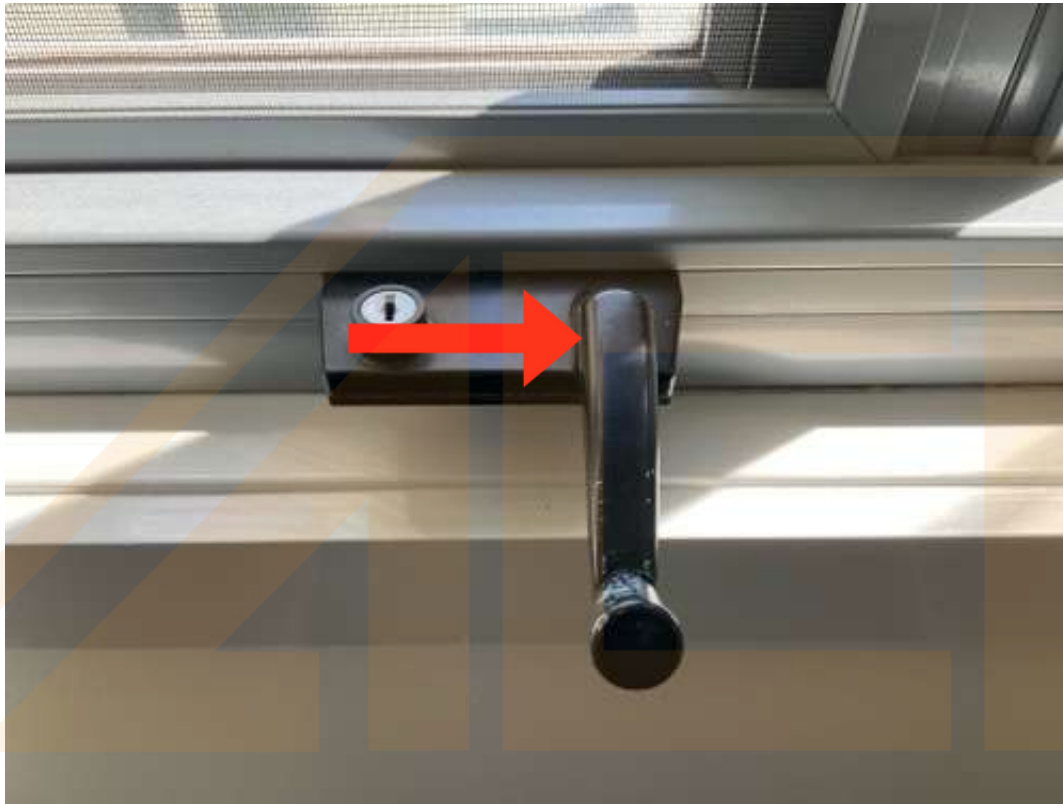
Serious Safety Hazard 1.02

Window Accessories Missing/Broken

During the inspection of the property, it was observed that the windows in the bedroom two are not functioning entirely as intended. Various components such as handles, locks, were found to be broken or damaged which significantly affects the functionality of the windows. This poses a safety risk as windows that do not function or lock properly can compromise the security of the property.

To address this issue, it is recommended that the broken or damaged components be replaced as soon as possible. It is advisable to engage the services of a general handy person, carpenter, window manufacturer, or service technician who can effectively perform the necessary repairs or replacements. This will not only improve the operational state of the affected windows but also enhance the safety of the internal area.

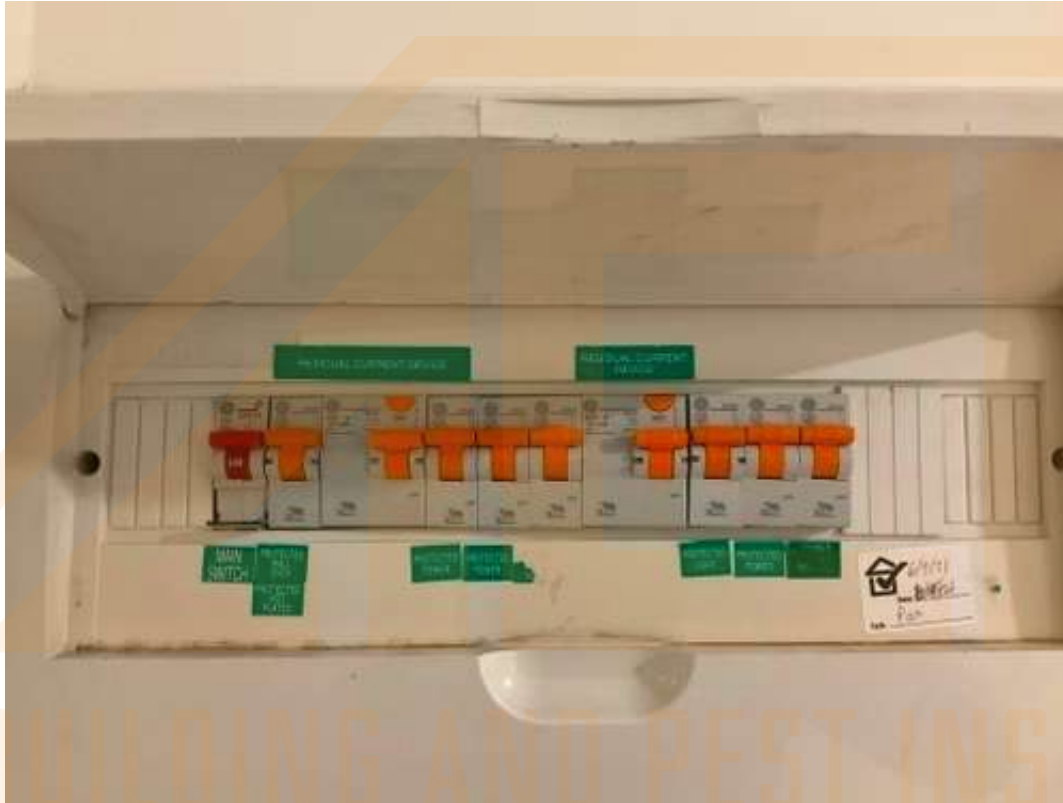
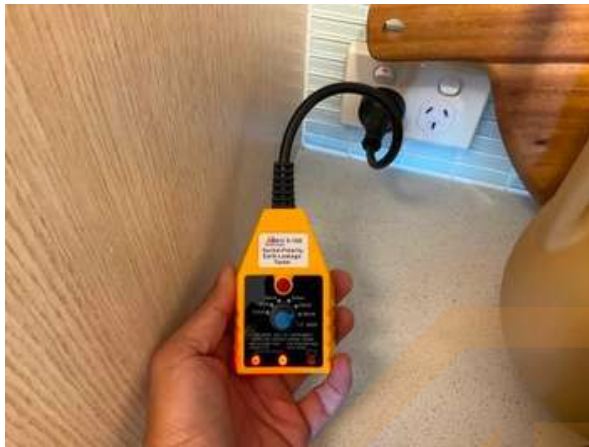
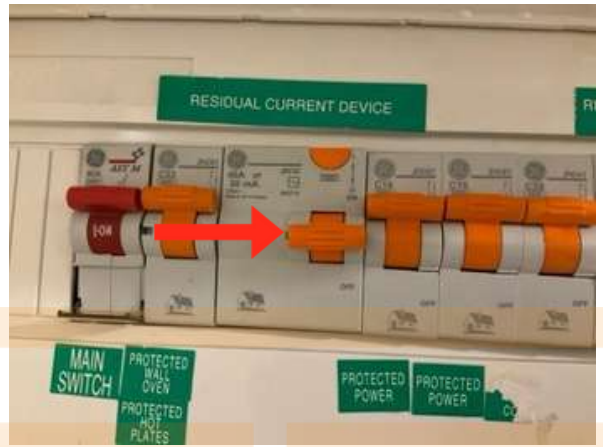
Serious Safety Hazard 1.03

Safety Switch FAILED TO TURN BACK ON

After we performed safety switch testing with our instrumentation, the safety switch FAILED TO TURN BACK ON .

Safety Switch test to trip the safety switch at less then 30 milli amps was performed and the initial tests to the safety switch DID trip at 30 milli amps, however after testing the safety switch I tried numerous times to reset the safety switch and it would not turn back on. Once this happens it is highly recommended that the safety switch be replaced as a matter of urgency by a qualified electrician as it is not operating as it was intended to by the manufacturer.

A faulty safety switch, can place a person in a very dangerous situation in the event of a faulty appliance or faulty wiring and may cause electrocution or fire.

As a matter of urgency, we highly recommend that you engage in a qualified electrician to provide further electrical investigations in order to determine if the safety switch/switches require replacement and/or if there is any faulty wiring.

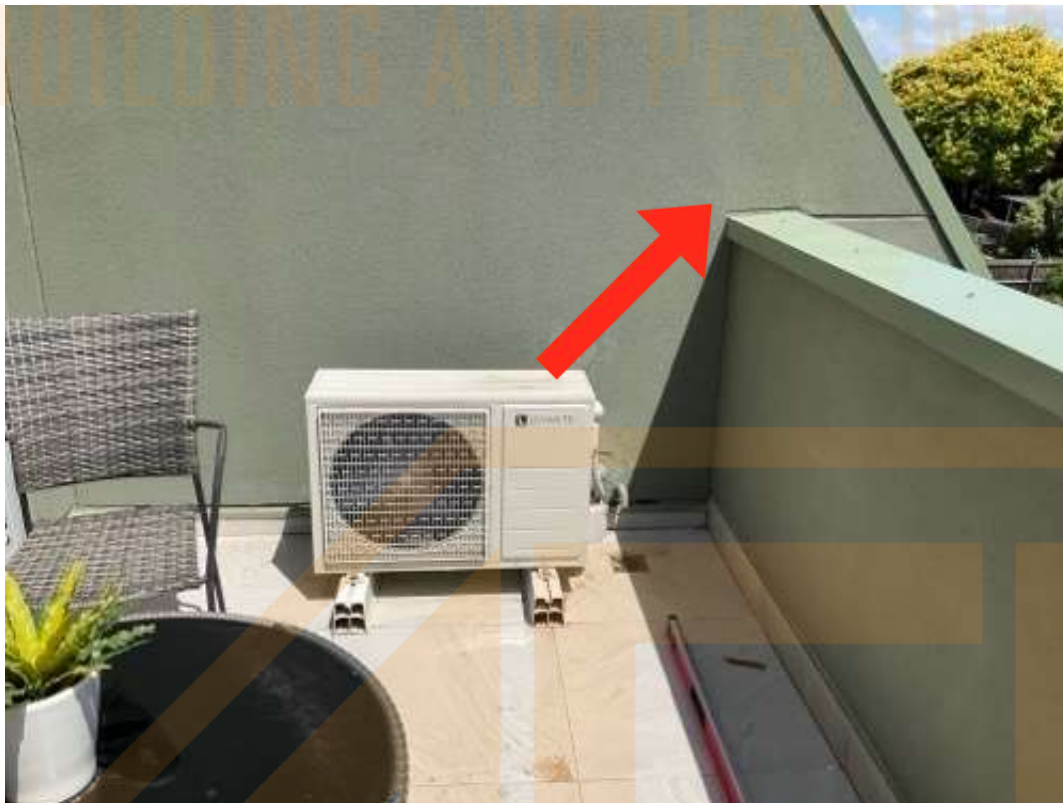
Serious Safety Hazard 1.04

Finding: Airconditioning Unit Location (Safety Hazard)

I wanted to bring to your attention a concern I have regarding the placement of the air conditioning unit in relation to the barrier/balustrade on the balcony. From my professional opinion as an inspector, it is evident that the current positioning of the unit poses a potential safety hazard. The air conditioning unit serves as a stepping point towards the top of the balcony barrier/balustrade, which could be dangerous for children or pets.

I strongly recommend further investigation into this matter and prompt remedial action. This could involve relocating the air conditioning unit to a safer area, away from the barrier/balustrade, or installing additional protective measures such as a barrier or guard to prevent unauthorized access.

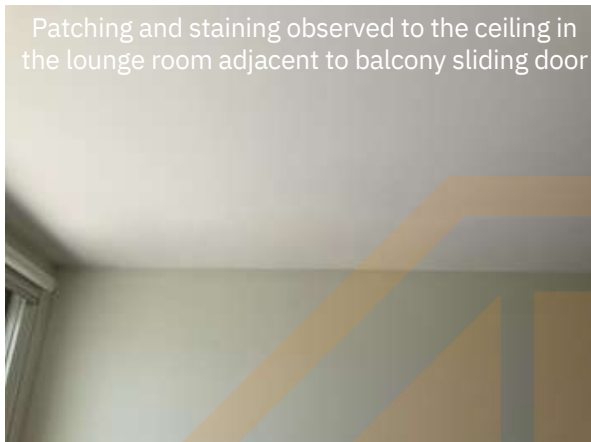
Major Defect 2.01

Plaster Ceiling - Water Damage / Water Staining

The ceilings underneath the balcony were found to be stained and patched up, indicating damage caused by water ingress through the tiles on the balcony above, among other possible sources. It is unclear how severe the timber damage is between the ceiling and the balcony area, but it is evident that water has been penetrating the balcony for a period of time. The damages may be more severe than they appear, and a visual inspection may not provide an accurate perception

Patching and staining observed to the ceiling in the lounge room adjacent to balcony sliding door

A comprehensive assessment of the damages will require invasive works, such as dismantling the under area of the balcony and/or removing the tiled area associated with the waterproofing and substrate. This is necessary to determine the structural integrity of the timbers and other building materials, as hidden damages may not be visible during a visual inspection.

All tiles on the balcony and the substrate will need to be removed and redone, including the waterproofing, to properly evaluate the extent of the damage. It is essential that all workmanship is performed by qualified individuals to ensure the warranty for the work. (If this has been complete then proof of work should be obtained along with warranty)

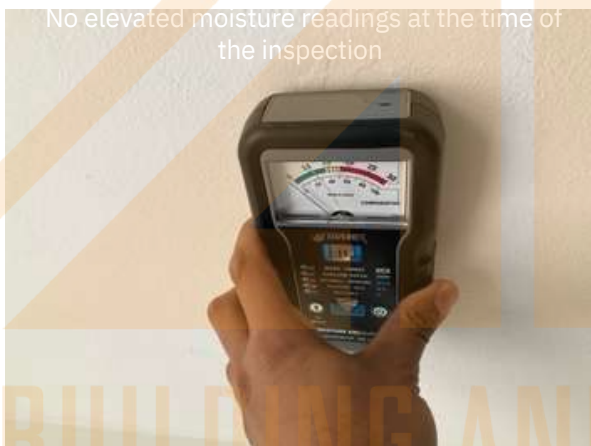
No elevated moisture readings at the time of the inspection

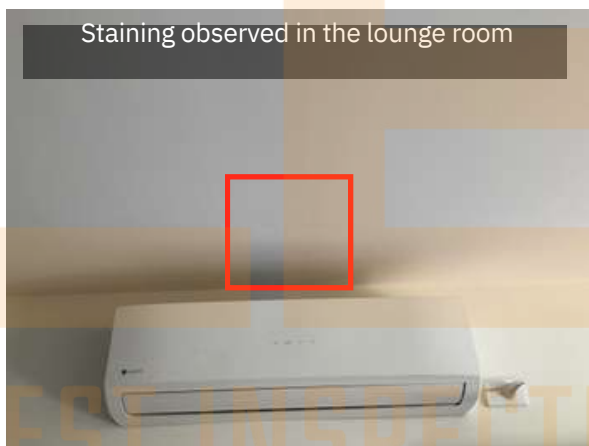
Staining observed in the lounge room

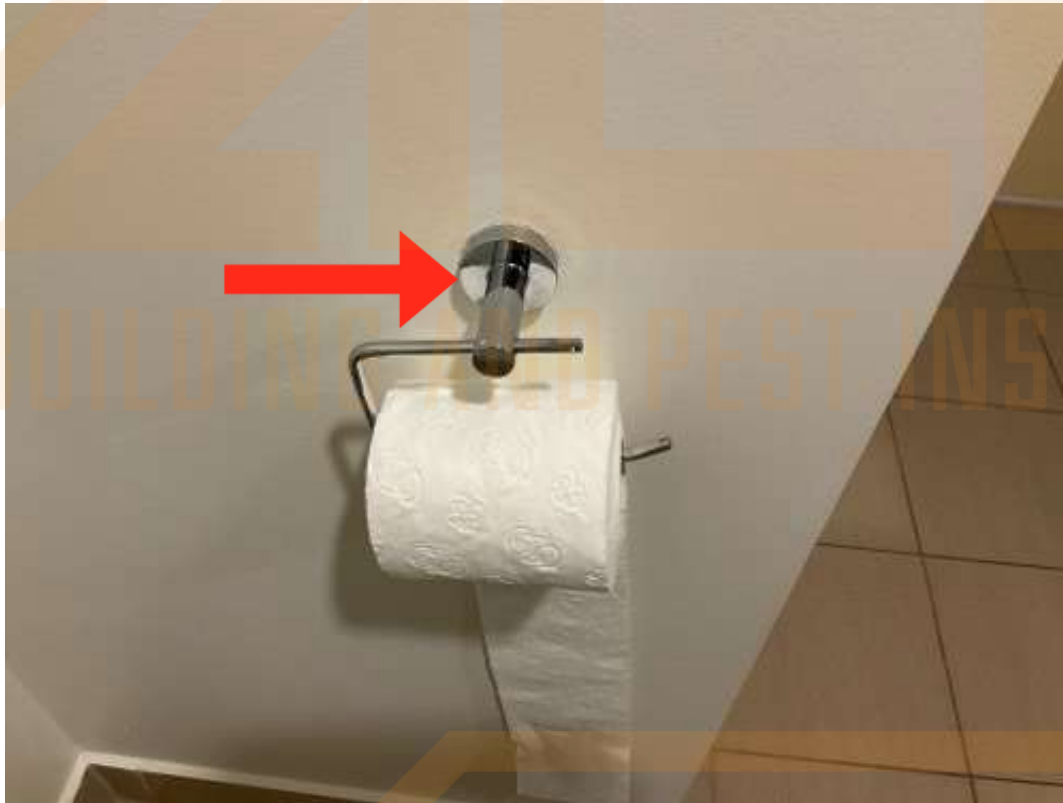
Minor Defect 3.01

Toilet roll holder - Loose

The toilet roll holder was found to be loose at the time of inspection. While not a major operational defect, function can deteriorate if the problem is left unmanaged.

It is advised that the homeowner performs remedial works to re-attach the toilet roll holder to its original fixing.

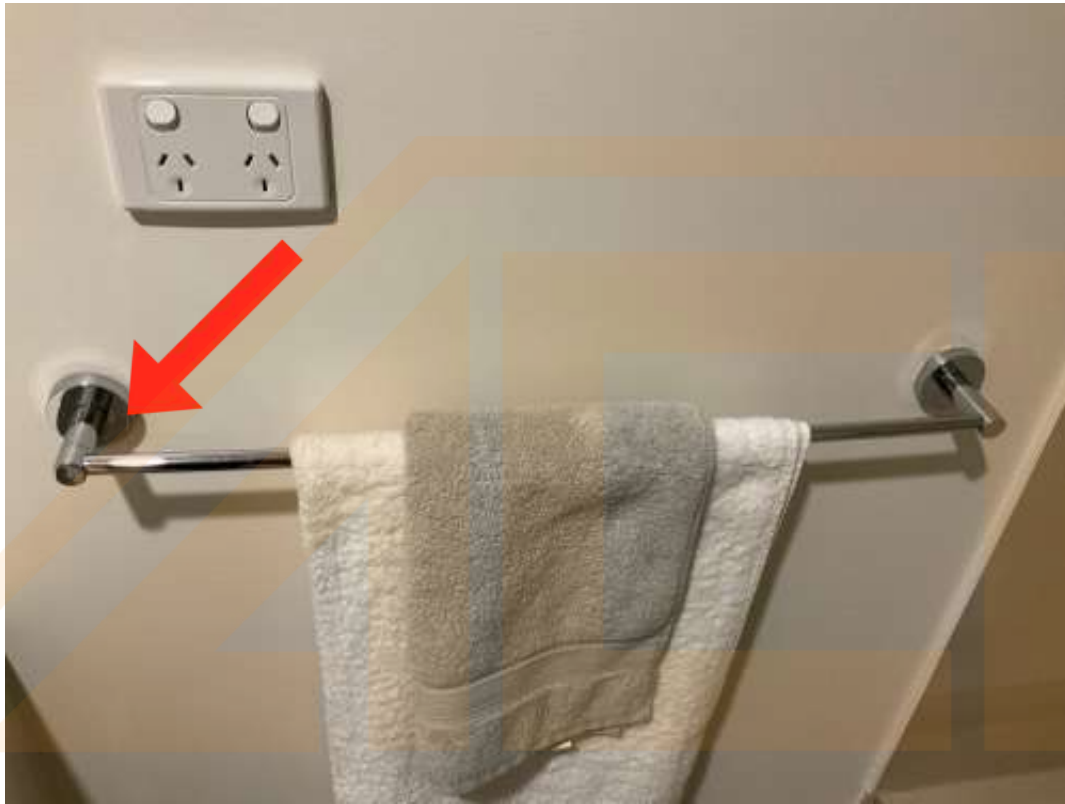
Minor Defect 3.02

Towel Rail - Loose

The Towel Rail was found to be loose at the time of inspection. While not a major operational defect, function can deteriorate and cause further damage to the plaster/tiles if the problem is left unmanaged.

It is advised that the homeowner performs remedial works to re-attach the towel rail to its original fixing.

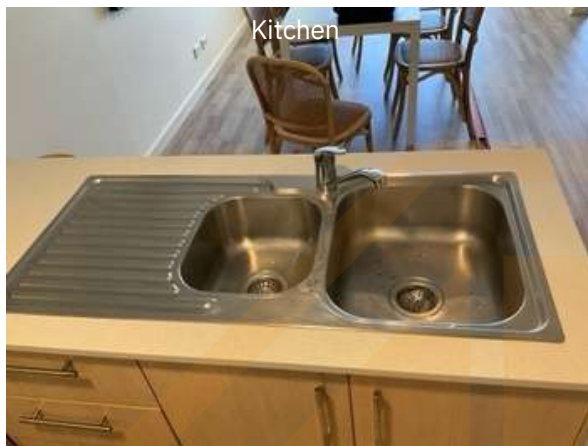
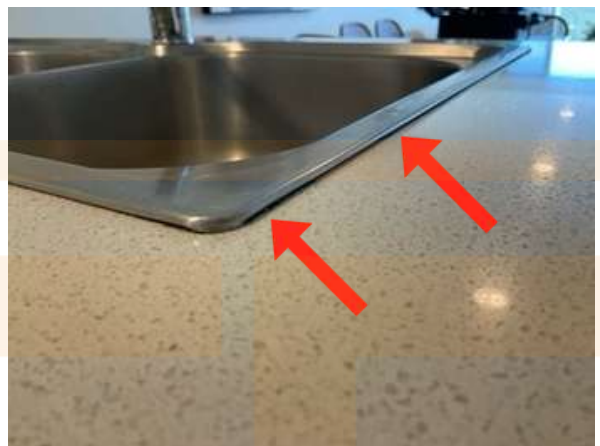
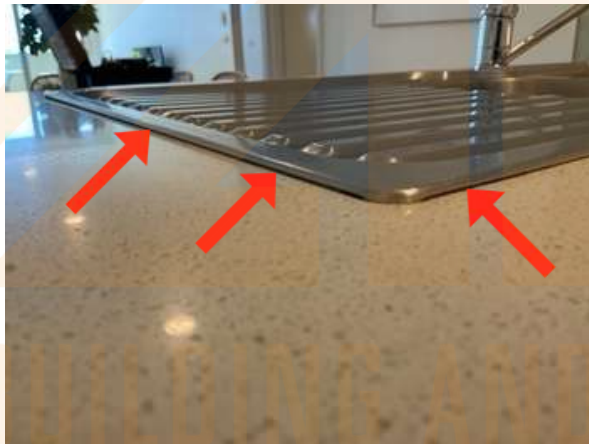
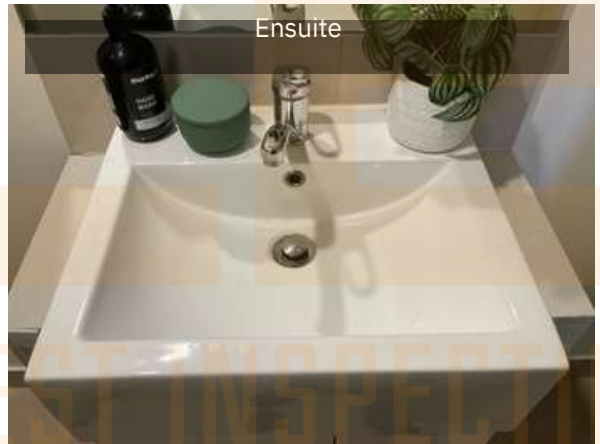
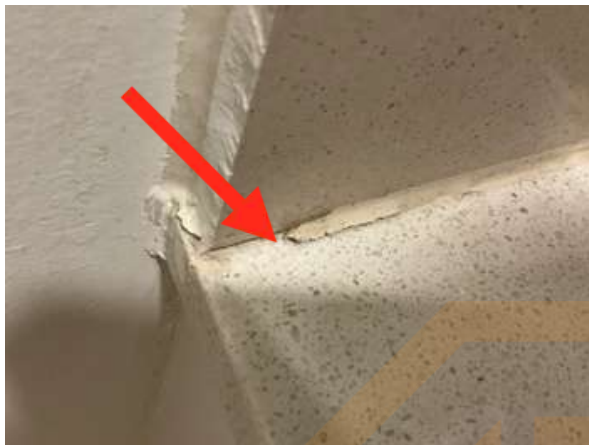
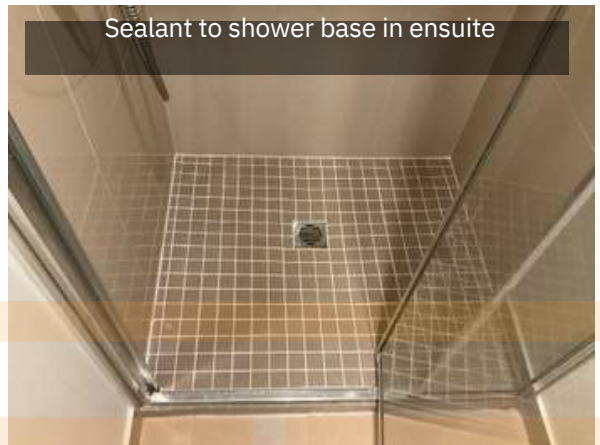
Minor Defect 3.03

Sealant & Tile Grout Damages Tile Grout & Sealant Damages. The sealant & tile grout is damaged and worn in area's, which poses a potential risk of water ingress and potential building damages. It is crucial that repairs are performed promptly.

To address this, it is necessary to take out the old sealant & tile grout in its entirety and replace sealant & tile grout that can accommodate expected expansion and contraction while maintaining a watertight seal to protect all associated building materials. This will ensure the joints remain watertight and protective of all associated building materials.

It is recommended to engage a sealant specialist tiling contractor and/or registered builder to assess the damage caused by water in the affected areas, if any and can clean the area, remove old sealant and tile mortar, and then re-seal and re-mortar the affected areas promptly.

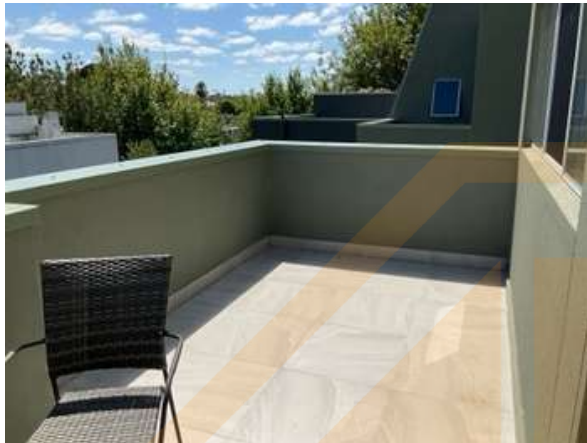
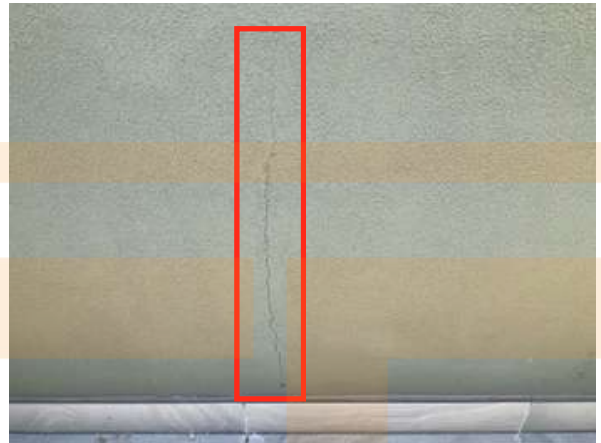
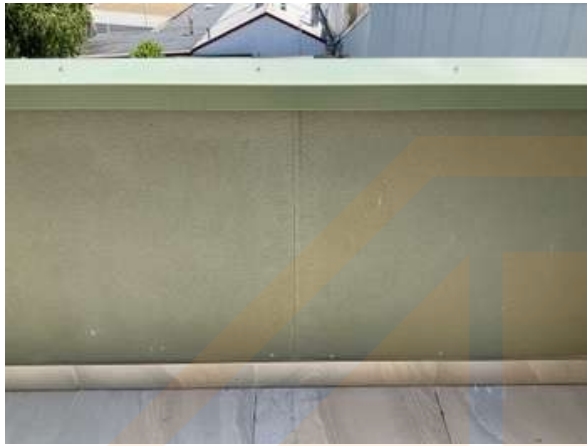
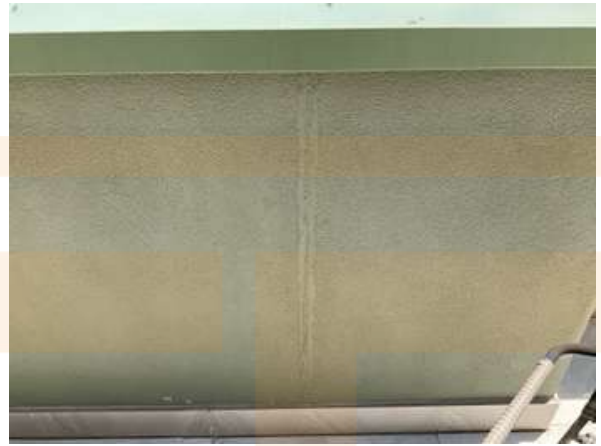
Minor Defect 3.04

External Areas Cracks to external cladding area's. During the inspection of the perimeter of the

building's exterior, it was observed that there are visible cracks in the applied finish covering the lightweight substrate construction material. These cracks, if left unattended, have the potential to allow water ingress, posing a risk to the structural integrity of the property.

Given the complexity of addressing these cracks, it is strongly recommended that a professional in this area be engaged to prepare and repair them. Their expertise and specialized knowledge will ensure that the cracks are adequately addressed, minimizing the risk of further damage and potential water ingress.

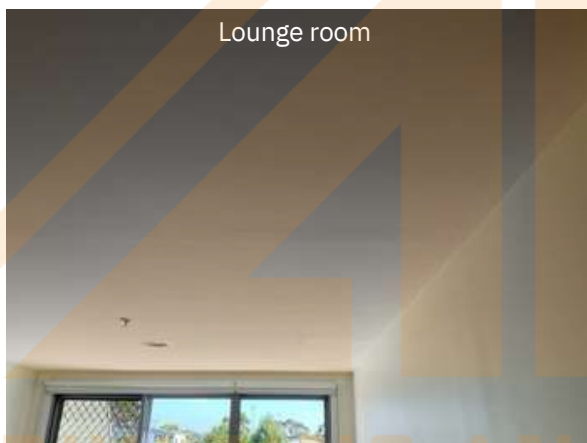
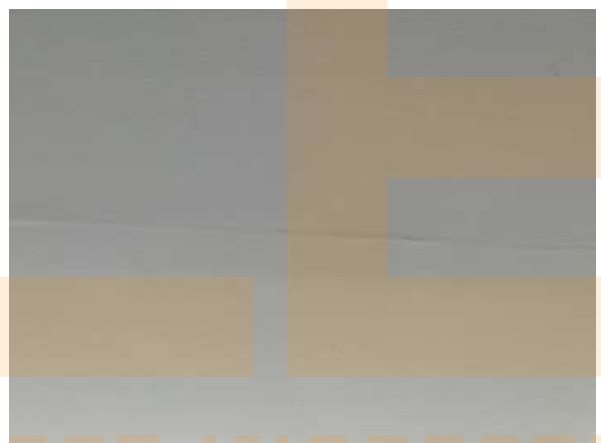
Minor Defect 3.05

Plaster & Timber Cracking - Damage Category 2 - Noticeable (up to 5mm)

Noticeable cracks are a common occurrence as a result of many primary defects. Such causes may include age, general wear and tear, expected building movement, general expansion/contraction of building materials in different weather conditions, and/or minor failings in the installation or application of building materials.

Noticeable cracks may result in minor sticking or jamming of associated doors and windows, which require easement. However, noticeable cracks are easily filled and repaired. A plasterer can be consulted to install an expansion joint at this point to allow for this movement during different weather conditions.

Relevant tradespeople, such as carpenters, painters and plasterers, should be appointed to perform remedial works, as deemed necessary.

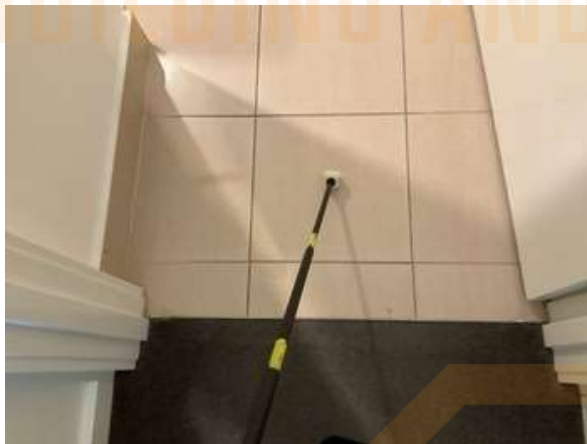
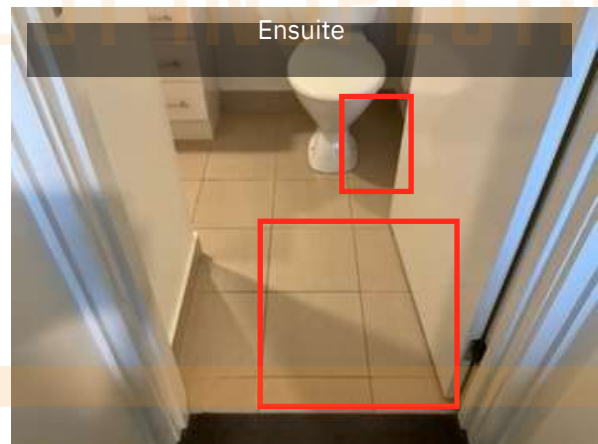
Minor Defect 3.06

Tiles - Drummy (Loose or Compromised)

Drummy tiled areas can be a result of poor workmanship, damaged tile grout or sealant, cracked tiles allowing water/moisture to penetrate and/or building movement.

Otherwise, it is advised that a tiling contractor be appointed to perform works as necessary, related to new tile grout and sealant to the junctions, Including any cracked tiles if applicable.

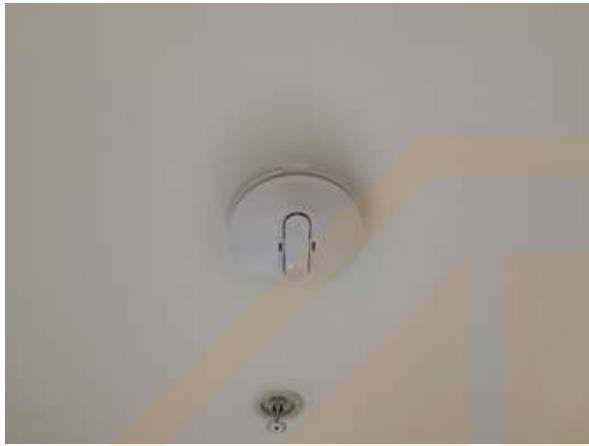
For your information 4.05

2 x Smokes Detectors - Recommend Battery Replacement.

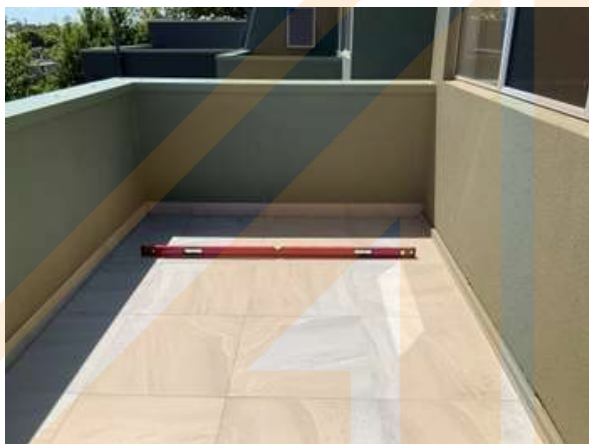
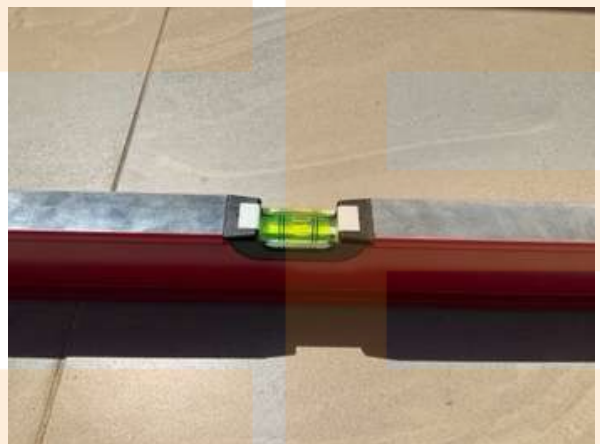
For your information 4.06

Inadequate Fall to Tiles in balcony

It is important to note that this is not a simple fix and would likely require an expensive repair process. This may include tile removal, substrate repair, re-waterproofing, and possibly addressing any further hidden damages that may be hidden until invasive works, begin.
