Building & Termite / Pest Report

Inspection Date: 16 Feb 2025

Property Address: Sample Street Bundoora 0101

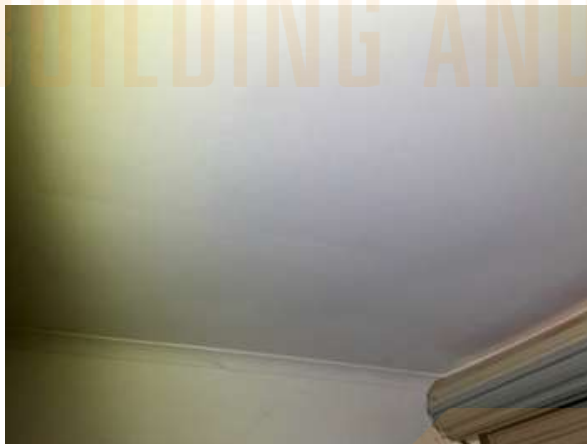
Serious Safety Hazard 1.01

When the plaster is severely compromised and bowed, we make this statement a safety hazard as the risk is much higher. However, at this stage the plaster does not appear to be too compromised, but please do not underestimate how quickly this situation can worsen.

In this particular case, there is no insulation in the garage roof space protecting moisture attacking the plaster, so this certainly contributes to the problem.

Moisture exposure without insulation protection can damage the plaster. However, this may only be a contributing factor alongside other defects in the home, such as leaking roofs or defective workmanship, insufficient glue, and insufficient fixings.

Drummy plaster generally requires chemical re-adhesion or screwing back to the frame, followed by patching and painting. However, in some cases, the plaster may be permanently deformed and need to be replaced entirely.

To prevent drummy plaster and plaster damage, it is essential to maintain a moisture-free and humidity-controlled environment. We recommend engaging a qualified plasterer and/or builder to carry out any necessary remedial works.

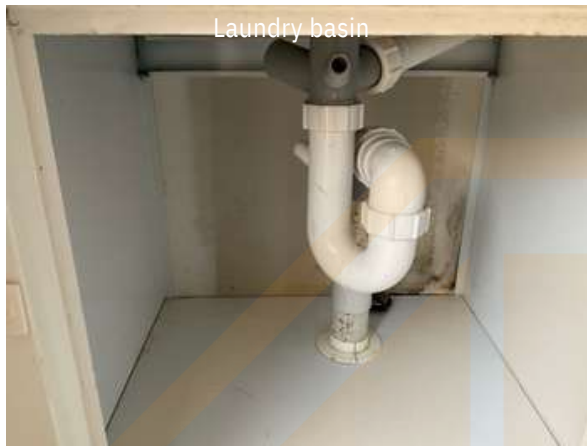
Serious Safety Hazard 1.02

Evidence of mould growth was observed. It is important to note that the presence of mould may indicate potential environmental, biological, or health issues.

To address any concerns regarding air quality spores or related issues, it is advisable to seek a specialist inspection from a suitably qualified environmental health inspector or a mould remediation company, especially if the mould is extensive.

In order to prevent further mould formation and development, it is recommended that the client ensures the general environment is free from moisture and humidity. However, in cases where the mould infestation is particularly severe, it is advised to engage the services of a professional cleaning contractor for thorough cleaning or remediation works. It is crucial to not only eliminate the visible mould but also determine the underlying cause of its growth. Simply getting rid of the mould without addressing the source may lead to its recurrence.

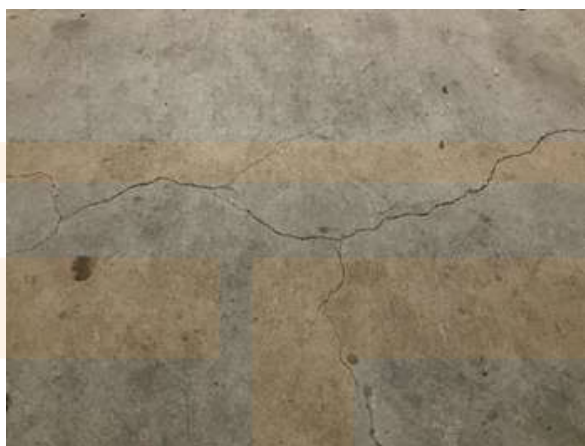
Minor Defect 2.01

Concrete - Cracking (under 5mm)

During the inspection of the property, it was observed that the concrete to area's has minor cracking. It is important to note that minor cracking, typically under 5 mm, is considered normal for concrete surfaces, such as paving, garage surfaces, driveways, or similar. However, if the cracks open and exceed 5 mm and/or if the concrete show signs of lifting or sinking, it may indicate more significant issues such as poor installation related to insufficient steel mesh or other factors.

To ensure the long-term stability of the concrete, I highly recommend having a professional assessment conducted in approximately 12 to 18 months. This assessment should be carried out by a skilled individual building Consultant, Engineer in severe cases, Concretor, Builder or similar skilled person with the understanding of concrete, who can determine if any further opening, movement or lifting of the concrete occurs.

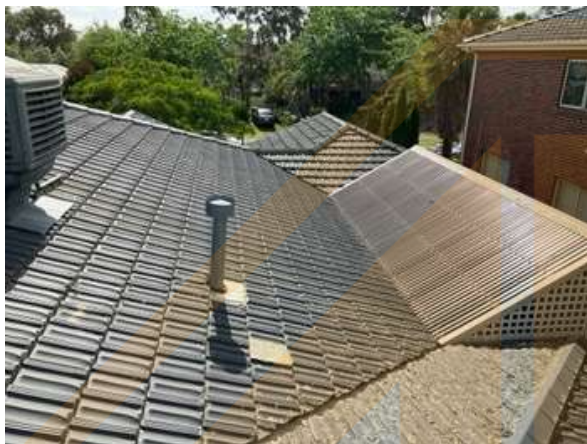
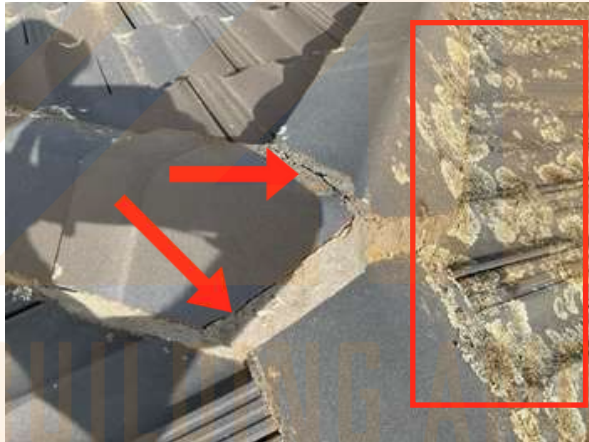
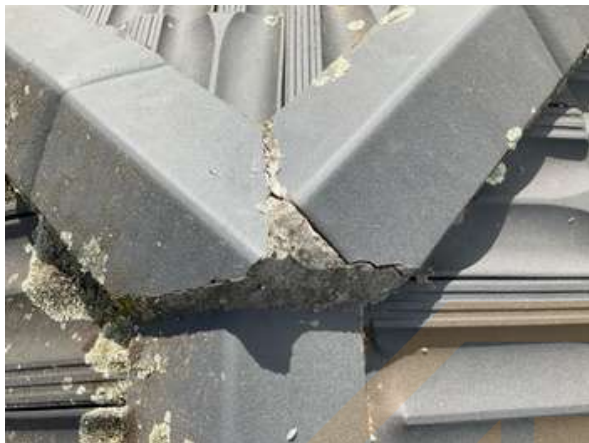
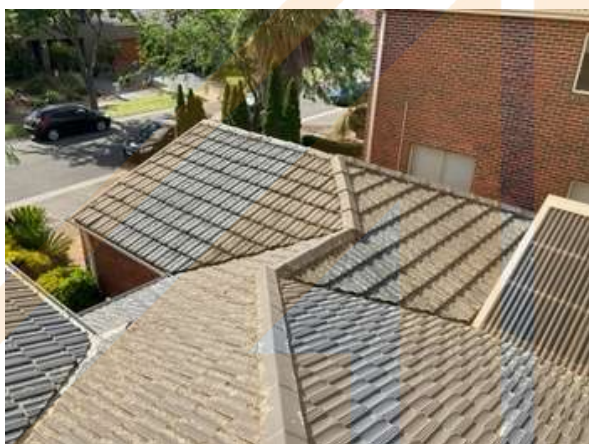
Minor Defect 2.03

Roofing - Exterior Roof Capping - Mortar Deteriorated The exterior roofing is showing signs of moss

Patch repairs noted to cracked tiles, these are considered a band aid repair. Ideally, you should look to replace these tiles.

Consultation with a roofing contractor should be considered :- OF IMPORTANCE

Attached are minimal PHOTO EXAMPLES as a guide of the exterior roof, but it is imperative when engaging a roofing specialist to inspect, identify and repair the entire roof areas.

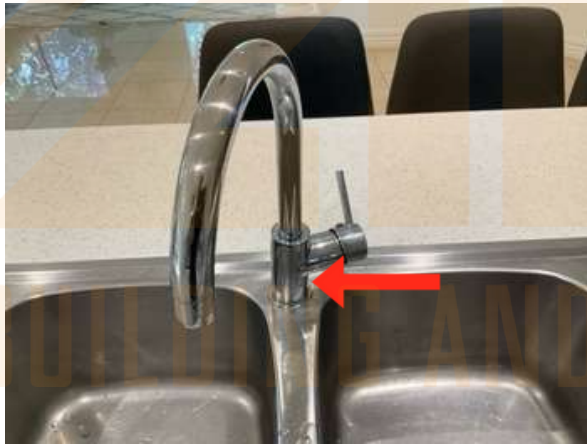
Location: Kitchen

The tap in this area has not been installed correctly, or has deteriorated with age, and is consequently loose. This tap being loose creates potential for water leaks and subsequent water damage to the surrounding area.

Where taps are loose, a qualified plumber should be appointed to re-fix the plumbing fitting to prevent further secondary damages that may not be seen, creating water damage unseen.

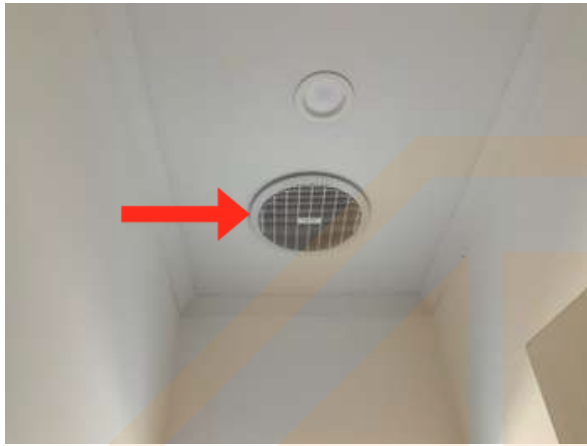
Minor Defect 2.11

The poor functionality of the fan decreases air flow and ventilation in the area; repair and/or replacement of the broken fan is therefore advised so as to ensure that the fan is fully operational.

A Licensed electrician should be appointed to repair/replace the fan at the client's discretion.

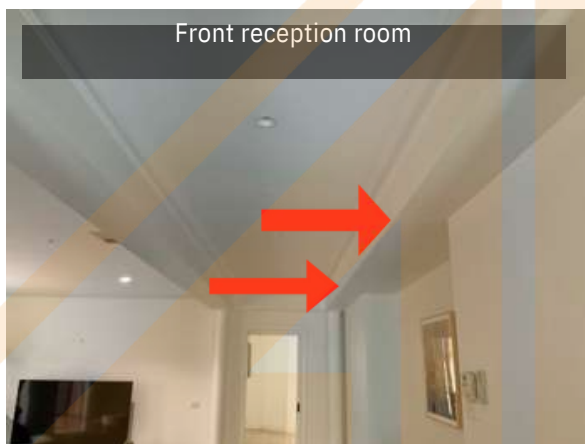
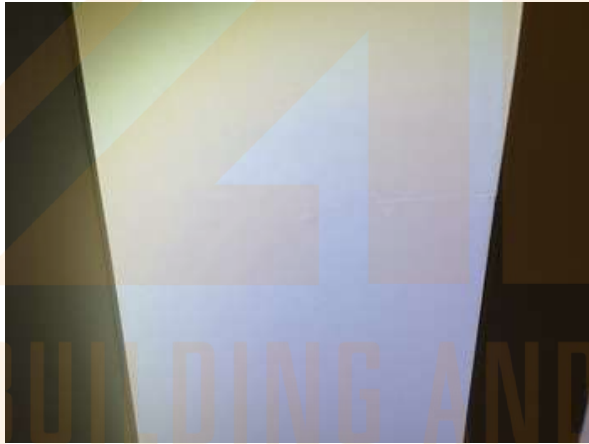
Minor Defect 2.14

Plaster & Timber Cracking - Damage Category 2 - Noticeable (up to 5mm)

Relevant tradespeople, such as carpenters, painters and plasterers, should be appointed to perform remedial works, as deemed necessary.

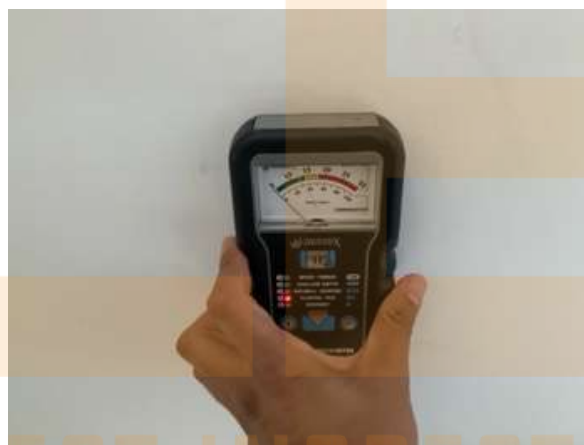
Minor Defect 2.15

Site Reference Plaster Ceiling - Water Damage / Water Staining During the inspection of the

property, it was observed that there is water damage to the ceiling lining in study room. This is usually an indication of excessive moisture present in the roof void, or coming from a leak in the roof covering, however at the time of the inspection there were no high moisture readings noted.

You will need to monitor this when there is heavy rainfall. If the problem still persists then It is recommended to appoint a roofing plumber or if the water problem is internally the appropriate trades person as soon as possible to identify the leak and carry out necessary rectification works to restrict further water damage. Once the leak is repaired, it is advisable to consult with relevant tradespeople such as plasterers and painters. Depending on the extent of the damage, rectification works may involve replacing the ceiling lining or minor repainting. In cases where water staining is old and inactive, affected building materials may be repaired or replaced at the discretion of the client.

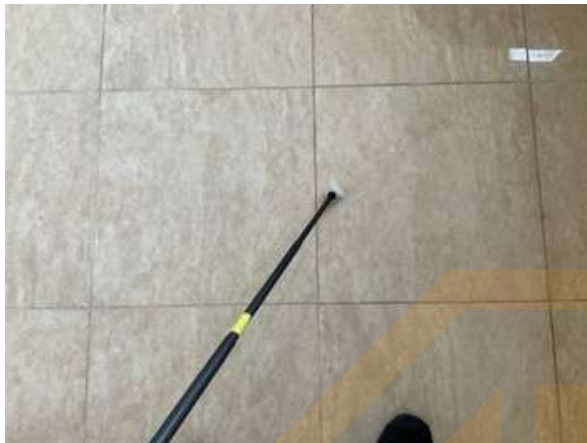
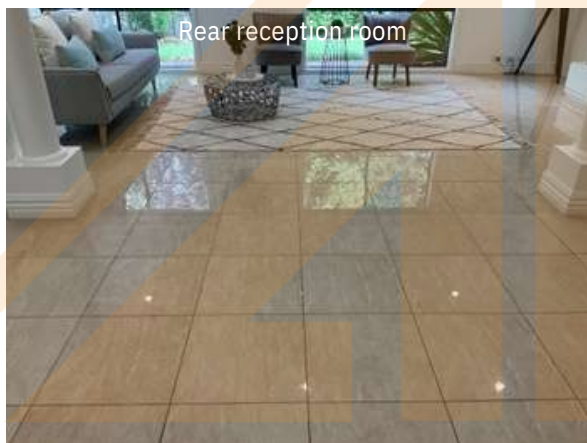
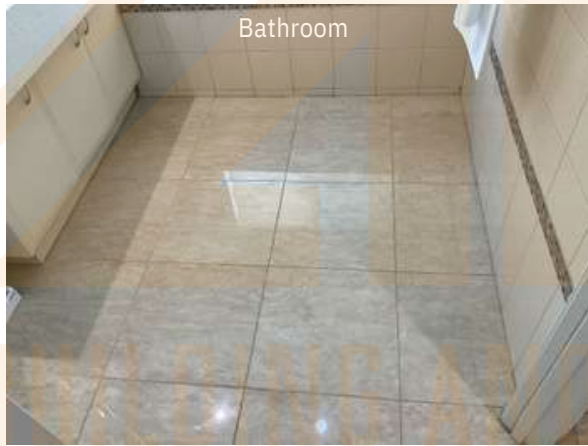
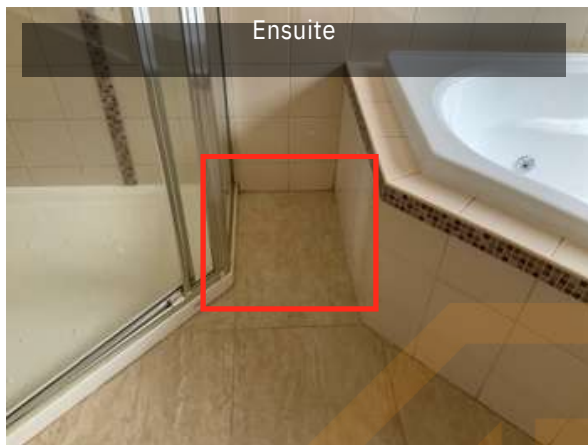
Minor Defect 2.16

Tiles - Drummy (Loose or Compromised)

During the inspection of the property, it was observed that there are drummy tiled areas present.

Drummy tiled areas can be a result of poor workmanship, damaged tile grout or sealant, cracked tiles allowing water/moisture to penetrate and/or building movement.

Specialist trades are available for these types of services. A registered builder may be required to undertake works if damage is extensive or if secondary building defects have resulted. Otherwise, it is advised that a tiling contractor be appointed to perform works as necessary, related to new tile grout and sealant to the junctions, Including any cracked tiles if applicable. However, prior to fixing drummy tiles, the cause or source of the problem in some cases needs to be resolved first and this simply needs to be determined.

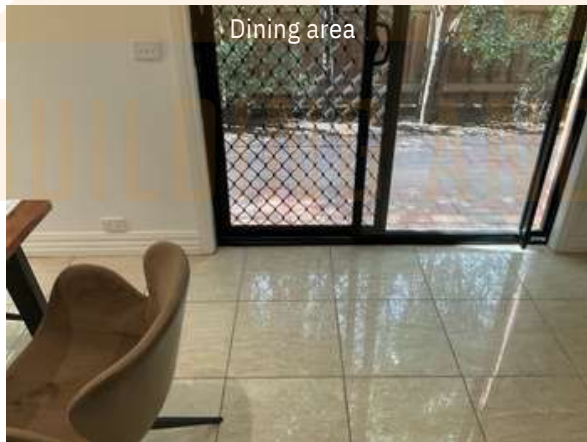
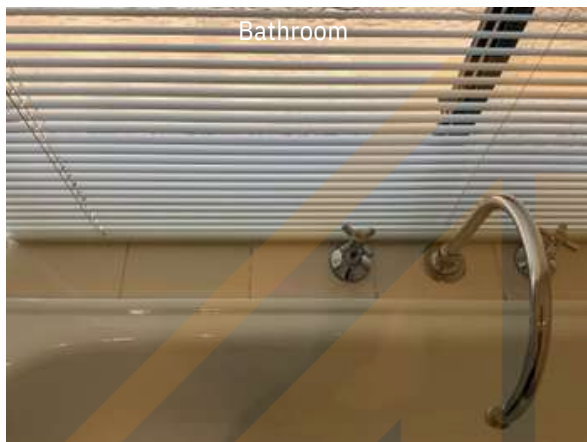
Minor Defect 2.17

Tiles - Cracked or damaged

Cracking was evident to the tiling at the time of inspection. While the cracking appears to be minor, these areas are frequently exposed to water, allowing potential for water penetration into adjoining sections of walls or flooring.

A registered builder, bathroom specialist and/or tiling contractor should be appointed to ensure that no further water damage occurs.

The re-application of silicone and grouting throughout the tile work is advised only at a time when the substructure and tiles are repaired and in sound structure

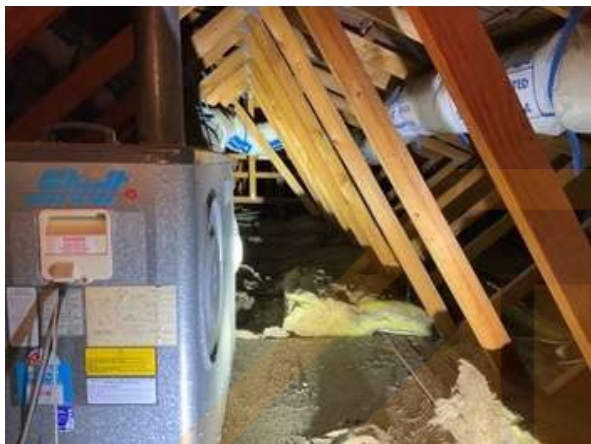
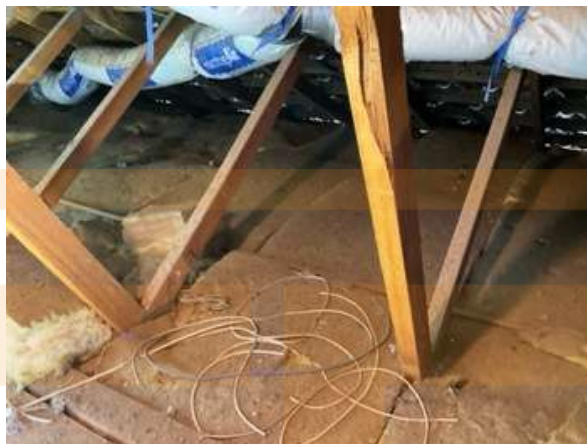
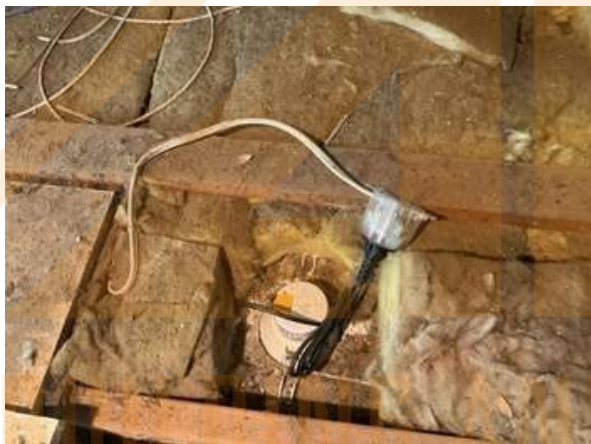
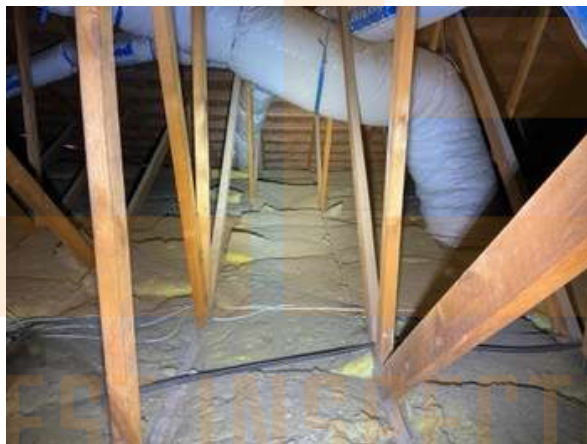
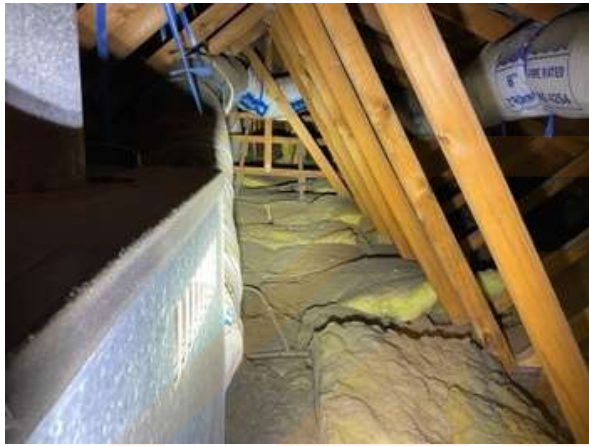
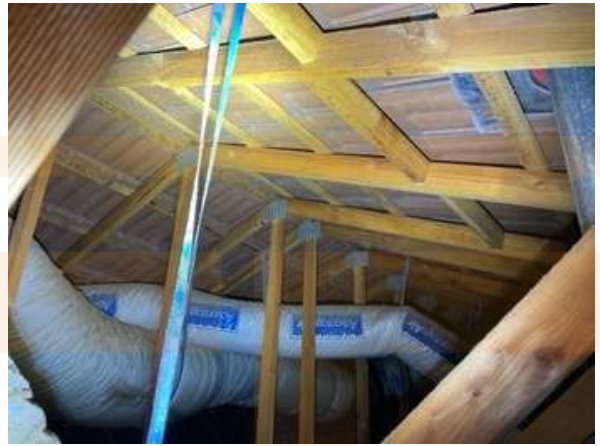
For your information 3.02

At the time of the inspection, the visible roof space area's appeared to be in good condition for its type and age with no evidence of immediate structural types concerns.

These photographs are an indication of the obstructions and limitations, such as timber rafters and associated timbers in a roof space also limiting accessibility.

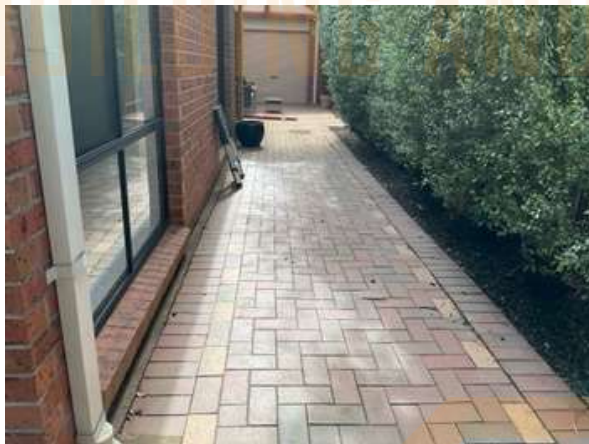
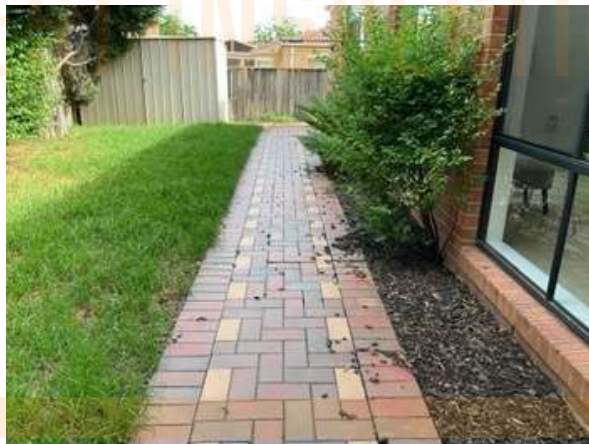
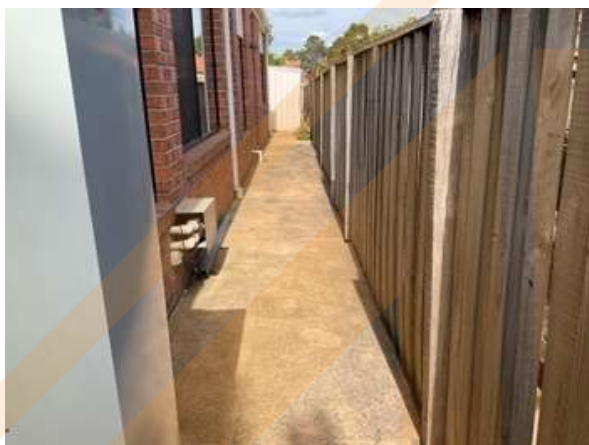
For your information 3.03

Perimeter Drainage Drainage - Perimeter Building Ground Fall Defective. Inappropriate drainage to

the perimeter can lead to water accumulation to the building foundations. This excessive water pooling around the foundations can result in various damages, including foundation movement, rising dampness on the walls, and potential dampness to the subfloor area or concrete slab.

It is recommended that remedial action be taken to address this issue. The appropriate course of action would be to ensure that the perimeter of the building is properly graded to allow water to flow away from the structure and/or also implementing suitable drainage systems near the foundations to prevent water accumulation.

I highly recommend you engage a registered plumber, specific landscaper who has the knowledge of drainage and/or a registered builder to install appropriate drainage solutions.

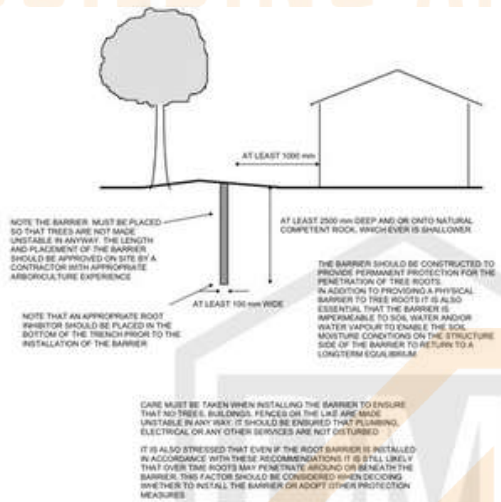
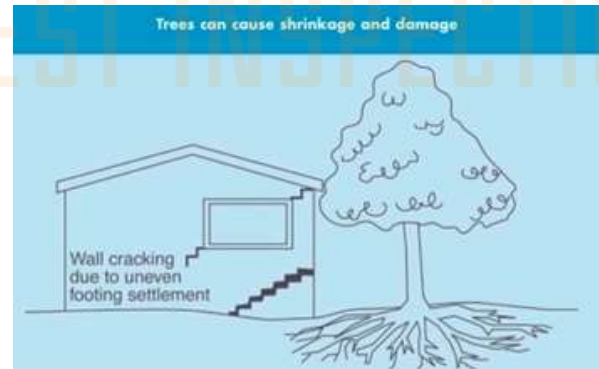
For your information 3.04

It is very important to note that although these trees in this report do not appear to be causing any major structural movement to the property that we can detect at the moment, there is a high potential risk that major structural movement may appear to the buildings foundations in the future.

I highly recommend that you engage a geotechnical engineer who will then guide you to an arborist and possibly a registered builder for further information on this matter.

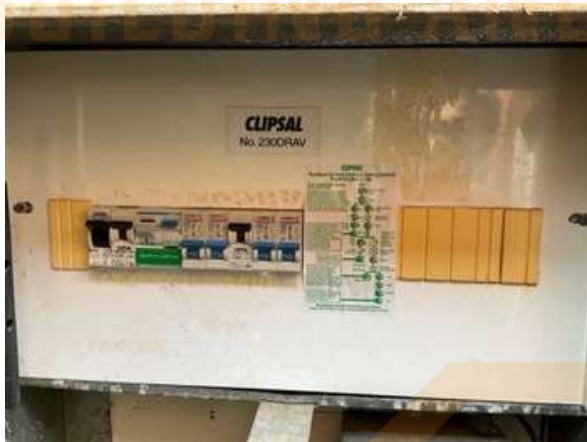
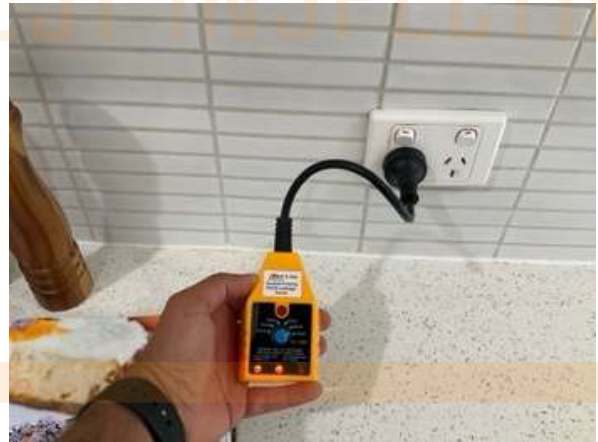
For your information 3.05

Note – Whilst I performed safety switch testing with my tester and manually tested the trip safety switch button, further electrical testing to the entire installation is recommended at the owners discretion.

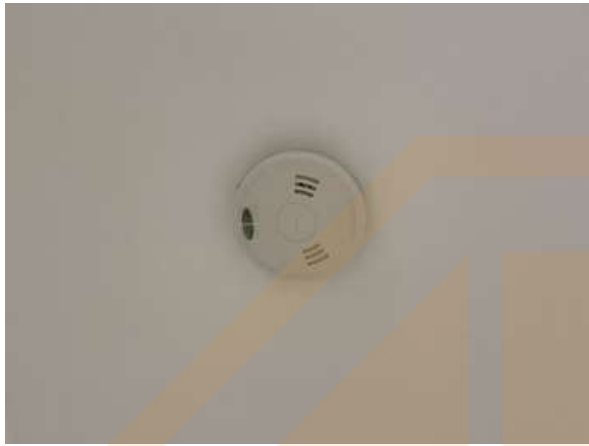
For your information 3.10

2 x Smokes Detectors - Recommend Battery Replacement.

Upon moving into a property, it is highly recommended that the battery of a smoke detector be replaced. By replacing the battery of a smoke detector you will now have a reference point as to when the new battery was installed.

A Smoke detector battery should be replaced within 12 month intervals.

There are other forms of testing in order for a complete assessment of a smoke detector, and it is highly recommended to engage a qualified electrician to test the complete operation of a smoke detector.

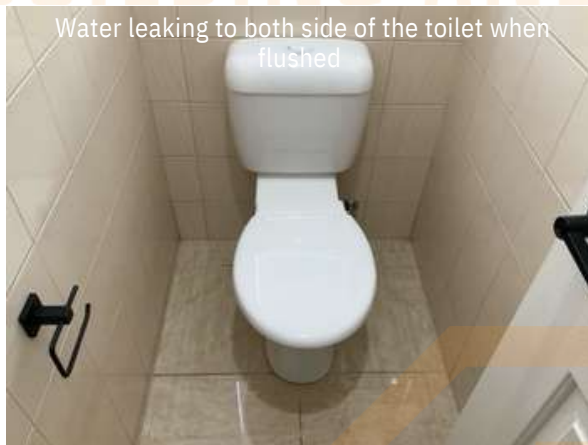
For your information 3.11

Location: Seperate Toilet

Finding: Toilet leak

In the separate toilet, there is a noticeable leak originating from the pipe connection when the toilet is flushed. This leak may lead to water pooling on the floor, posing a risk of water damage to the flooring and potential mold growth if left unaddressed. To rectify this issue, it is recommended to have a licensed plumber inspect the toilet's plumbing connections and replace or repair any faulty seals or components. Ensuring a tight seal and proper functionality will help prevent future leaks and maintain the integrity of the flooring.

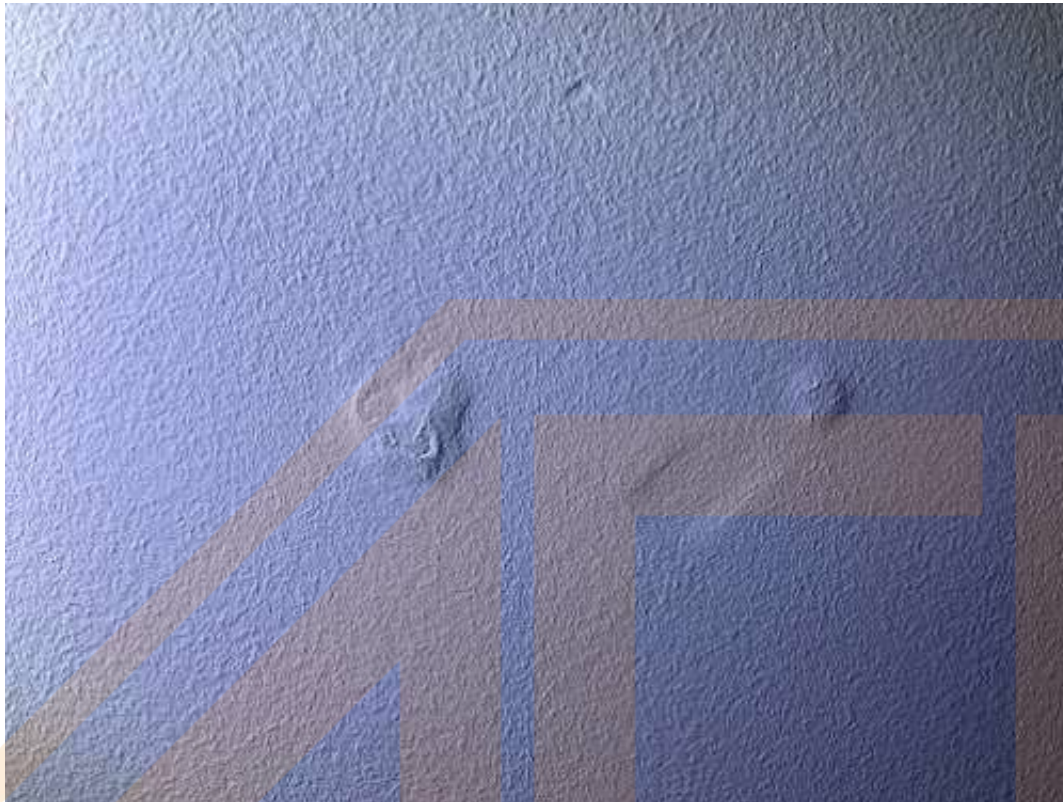
Paint & Plaster Condition - Overall

There are typical type damages to the plaster work and timber work. The various damages are generally cosmetic.

The paint and plaster surface damages remain consistent and typical with general wear and tear.

It was observed that the property has undergone recent painting and paint repairs to most or all areas.

It is unknown how severe hidden plaster and/or timber cracks may have been before the plaster & paint work was performed. Generally time brings out cracking with ongoing movement to the property.

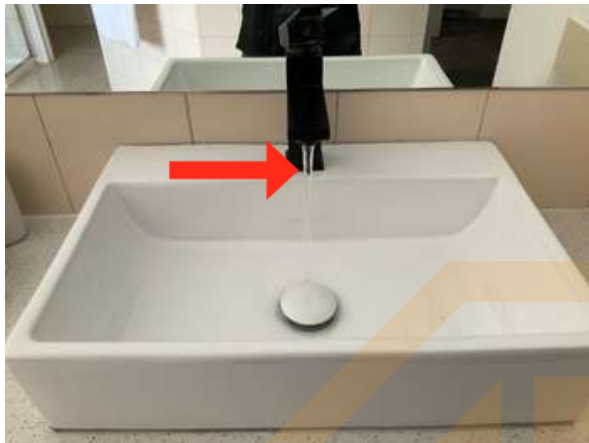
For your information 3.12

Ensuite Water pressure During the inspection, it was noted that the wash hand basin in the ensuite exhibits low water pressure. This issue can cause inconvenience to users and might suggest a problem with the plumbing system, such as a partially closed valve, sediment buildup in the pipes, or an issue with the faucet itself. To address this, it is recommended that a qualified plumber be engaged to investigate the cause of the low pressure. Potential remedial actions could include cleaning or replacing the aerator, checking the water pressure regulator, or ensuring there are no obstructions or leaks in the supply lines. Regular maintenance will help ensure optimal water flow and prevent any further complications.

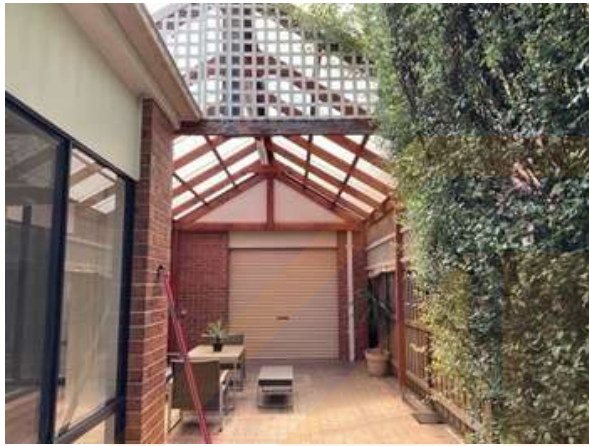
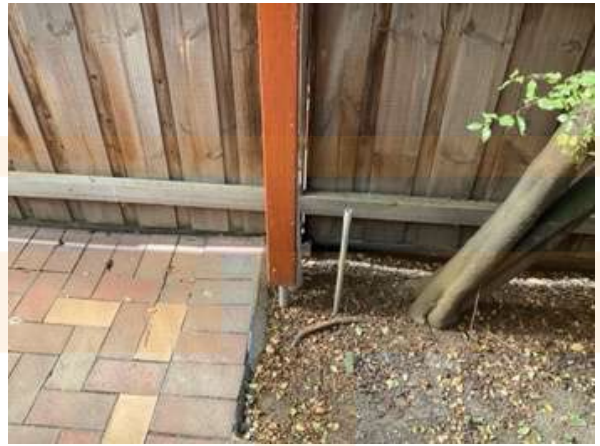
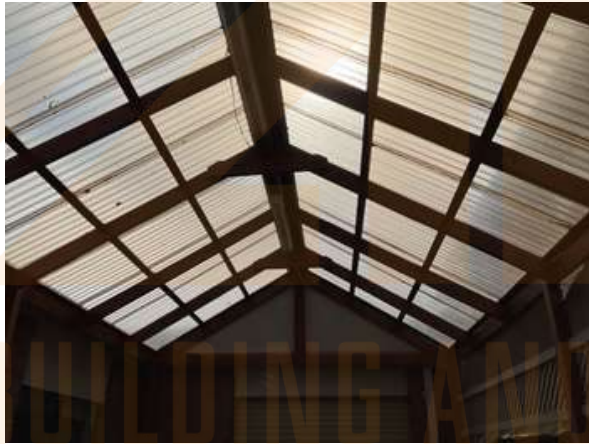
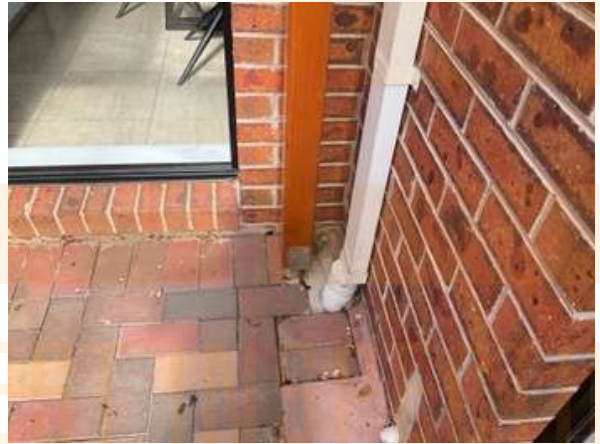
For your information 3.13

I highly recommend that you further investigate this home as the Verandah may or may not have the correct permits / paperwork through the council, architects, engineers, etc regardless if the works have been done to a quality tradesmens like manner or not.

This information is outside the scope of my works to give advice and/or comment, however I would like to recommend that you contact your legal representative, whether it is a lawyer or conveyancer as they will be able to advise you further on this matter as they are the experts to assist and give you further information on this topic.

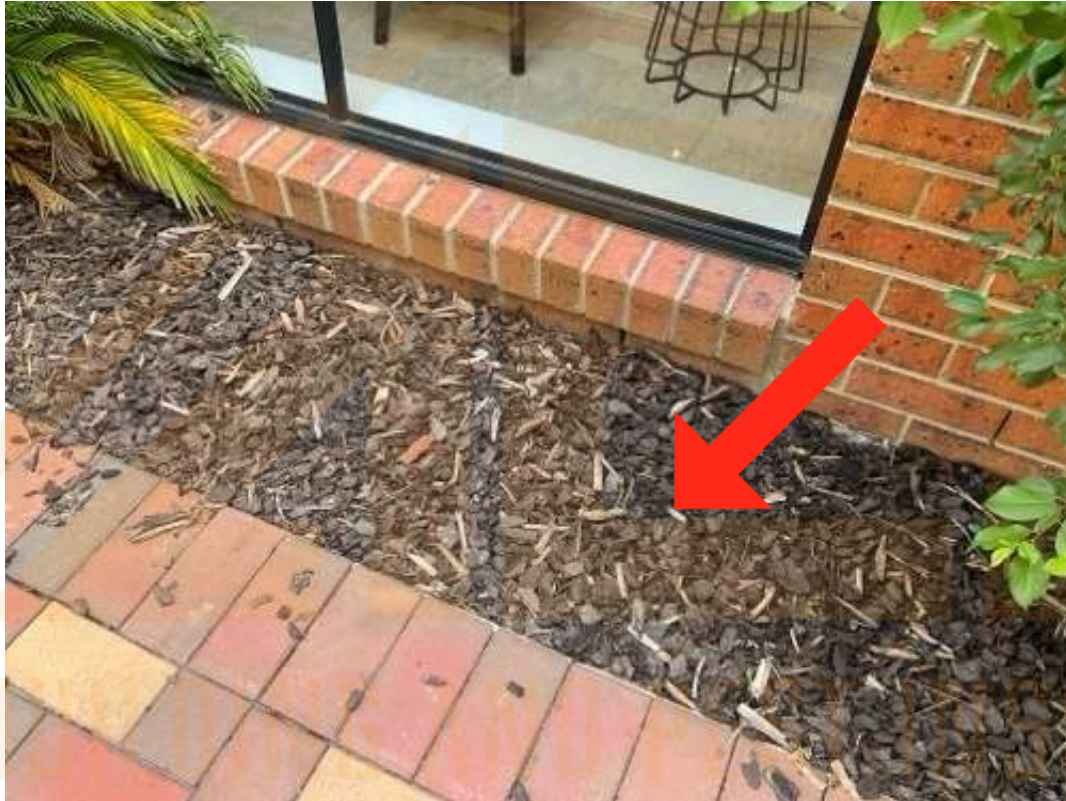
It is always important to keep the garden beds as clean as possible and take out excess old bark from the trees, leaves and keep bark mulch to a minimum or better introduce rocks or some item that does not create an conducive environment for termites and hold excess moisture.

Photos added are only samples of the garden.

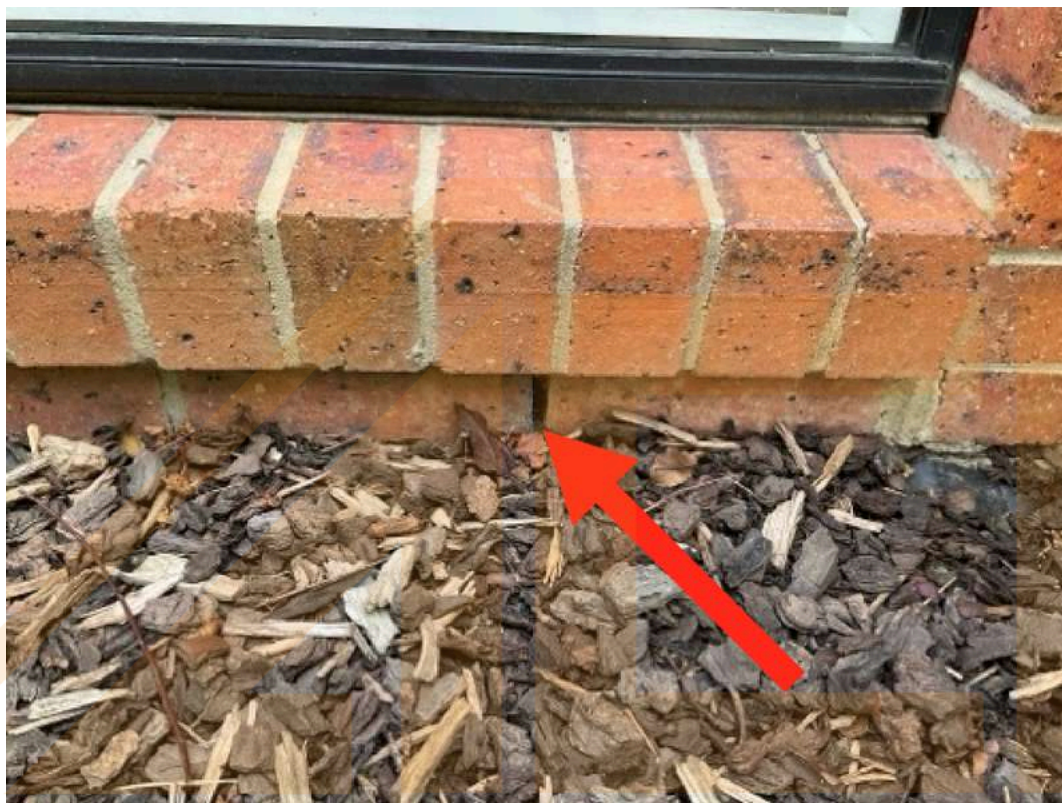
Finding: Weep Holes or Ventilation Areas - Bridging Or Breaching Of Termite Barriers Defective.

Additionally build-up of moisture is likely to occur if Weep Holes or Ventilation Areas are covered further attracting termite activity to these areas.

I have only taken example photos of the weep holes or ventilation holes to the perimeter of the building and the entire building must be inspected and remediated.

Therefore any termite activity leading into Weep Holes or Ventilation Areas will become easily detectable during frequent pest inspections.

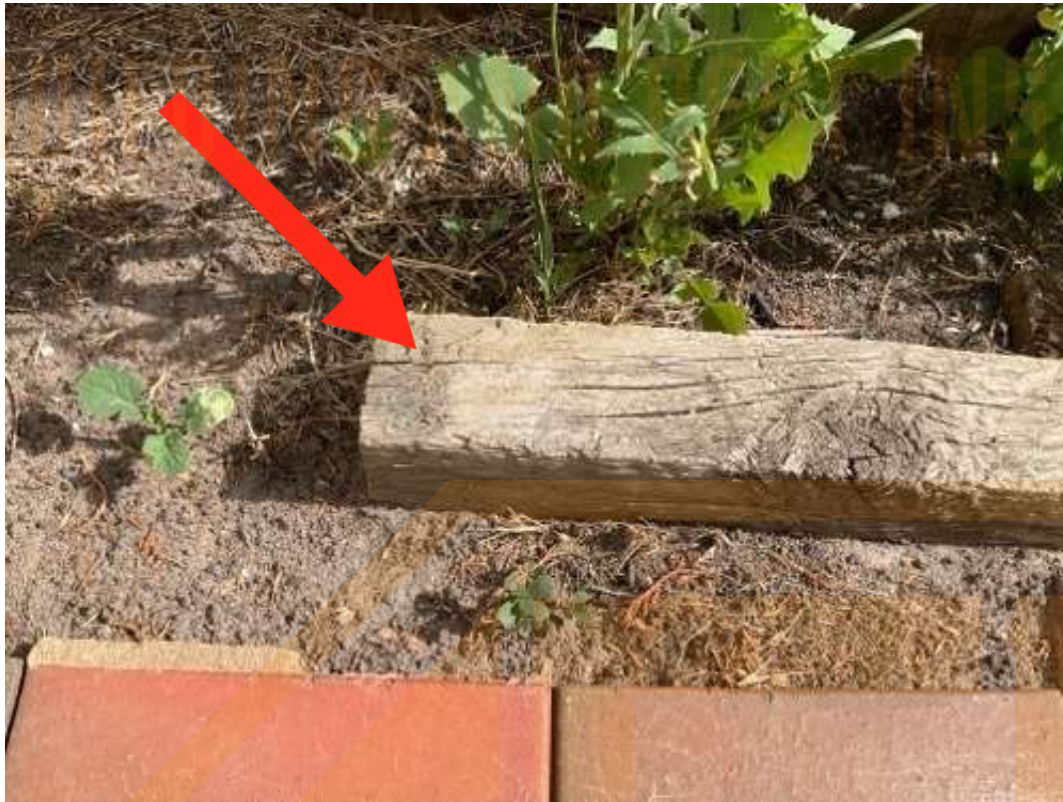
Conditions conducive to timber pest attack 4.05

UNTREATED OR NON-DURABLE TIMBER USED IN A HAZARDOUS ENVIRONMENT

Any timbers in direct ground contact provide opportunity for concealed termite entry and are likely to be subject to premature rot and decay as the soil retains moisture or damp conditions against the timbers.

When met with excessive moisture timber begins to decay and develop wood rot. Any timbers that are in direct contact with external grounds, sub-floor area's, sheds or similar especially if left untreated or non-durable also provide ingress for subterranean termites into that particular element.

Photos added are only samples of the garden.

Remove untreated timber that is in direct contact with grounds. Consider replacement with more durable materials i.e. treated timber or non timber elements.

Frequent pest inspections are advised to readily identify any termite activity in these areas.

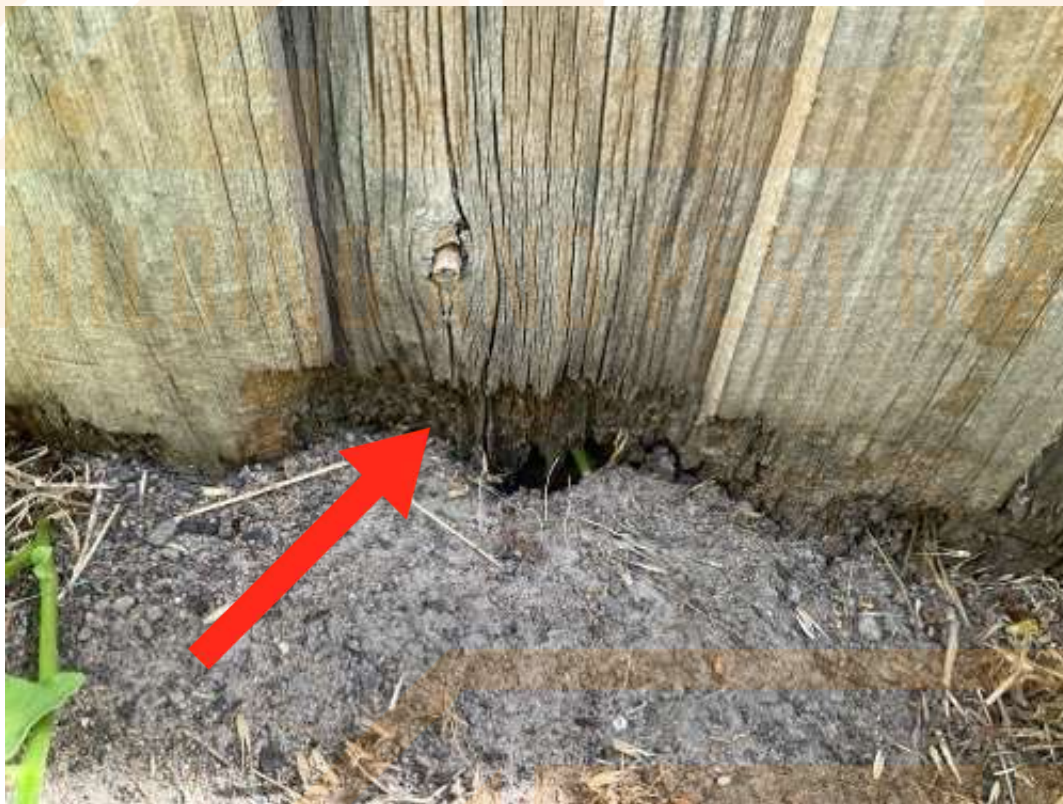
Conditions conducive to timber pest attack 4.06

Timber Pest - Damage Identified.

It is suspected that timber pest activity is occurring or has occurred as there is evidence of timber damage to the fencing in the exterior garden, but the timber pest may not be limited to these areas.

The client IS HIGHLY RECOMMEND gaining further advice from a licensed pest controller as to the costs and procedures involved with application of a management system and/or eradication.

◆ It is recommended that obtaining such advice be of HIGH PRIORITY.

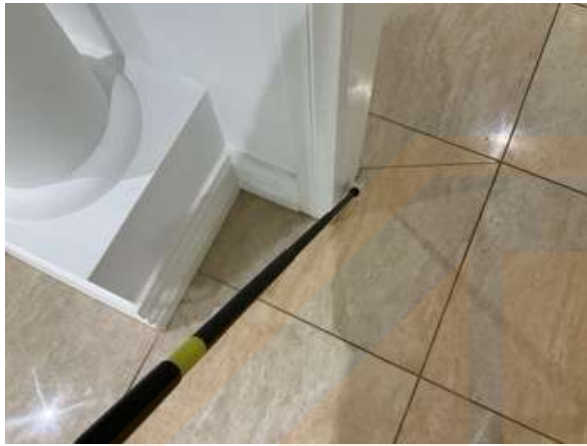
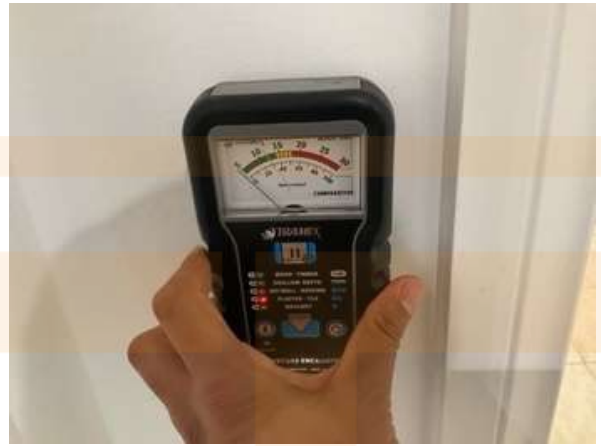
there are various timber's with high moisture readings and/or decay, know as wood rot.

Wood rot, also known as Fungal Decay, which occurs when timbers and other cellulose building materials are exposed to damp conditions on an ongoing basis.

drainage concerns, which hold above average moisture and water pooling to the surrounding property.
