# Building & Termite / Pest Report

**Inspection Date: 16 Feb 2025**

**Property Address: Sample Street Craigiburn**

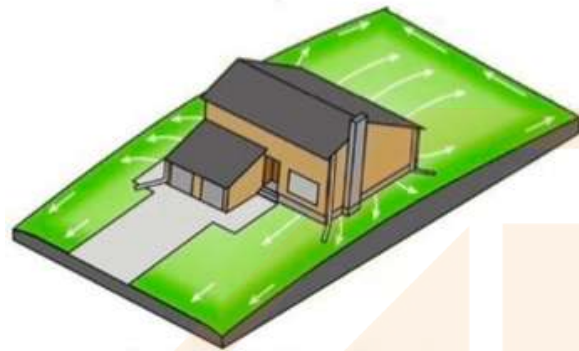
Ideal Water Runoff

It is recommended that immediate remedial action be taken to address this issue.

I highly recommend you engage a builder, specific landscaper who has the knowledge of drainage.

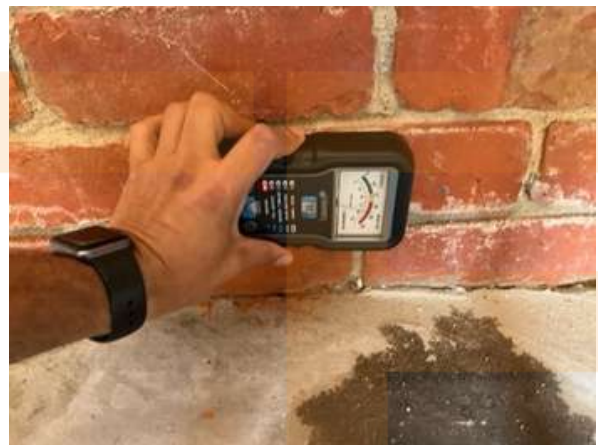
In summary, the rising damp issue in the garage of the Australian residential property requires immediate attention. By addressing the underlying cause and implementing the recommended remedial actions, the potential health risks and further damage to the building can be mitigated.

To rectify this major defect, it is recommended to engage the services of a qualified plumber, builder, and/or structural engineer, and possibly a geotechnical engineer, to conduct further investigations. These professionals will be able to provide a comprehensive analysis and suggest appropriate remedial actions, such as installing a new damp proof course, improving drainage systems, and repairing any damaged building elements. It is important to note that without these invasive investigations, a complete analysis of the defect cannot be determined.

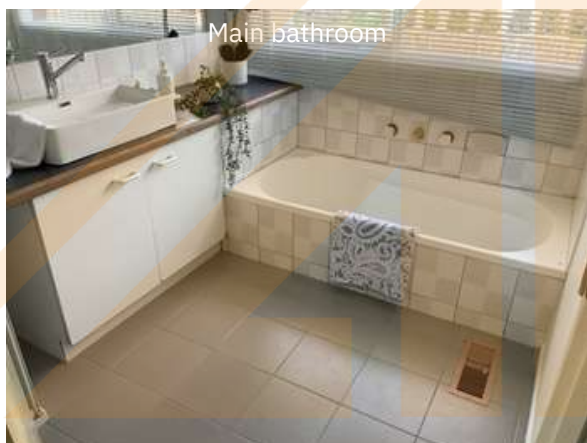
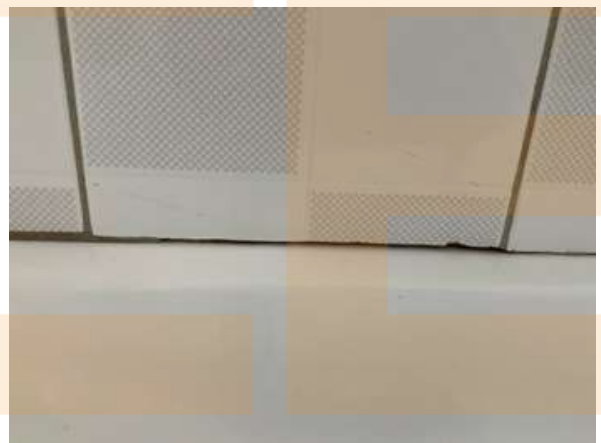
In conclusion, addressing the compromised silicone / sealant and tile grout in the wet areas is crucial to prevent water ingress and potential building damages. Engaging a sealant specialist or utilizing a specialist trade with products like Kerapoxy flexible 2 part resin grout can provide effective and long-lasting repairs.

It is vital to address any loose or cracked tiles, damaged waterproofing or any other building damages before proceeding with the repairs.

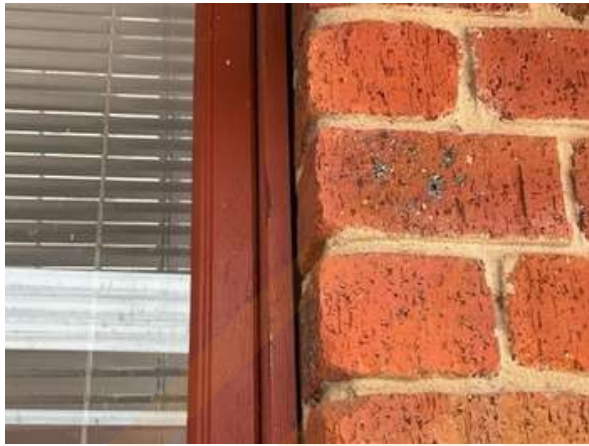
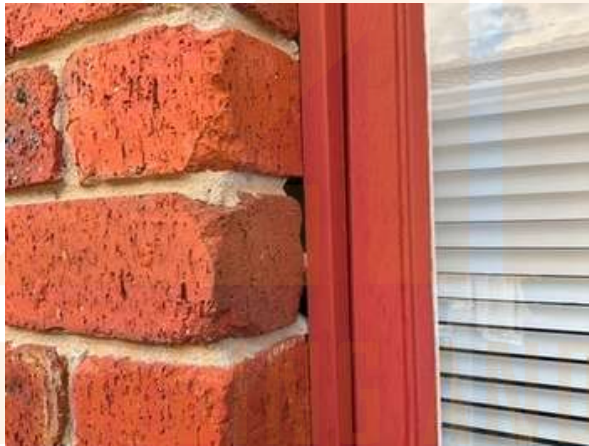
If there are signs of water damage inside the property, such as water stains, wood rot, or other damages, it is advised to conduct further investigations by the appropriate trade professionals. However, it is crucial that the exterior openings are sealed first before any internal repairs are made to prevent recurring damage.

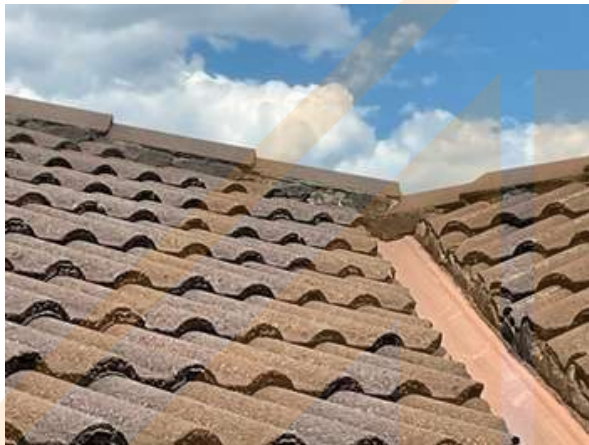
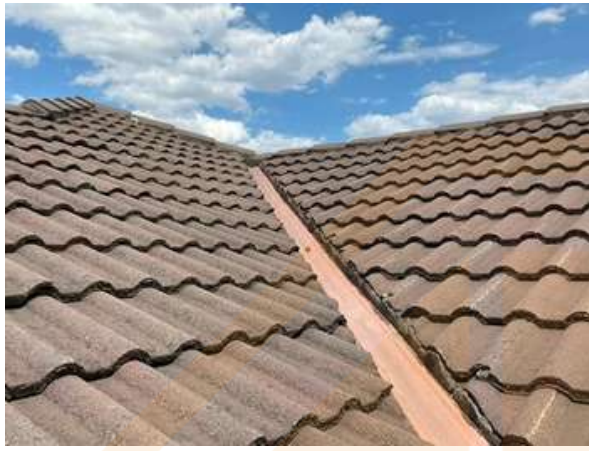
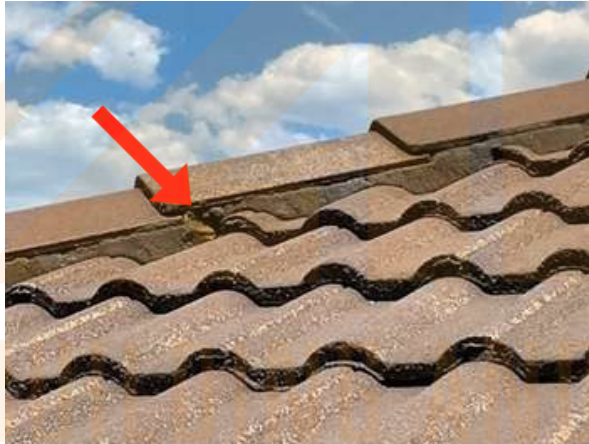
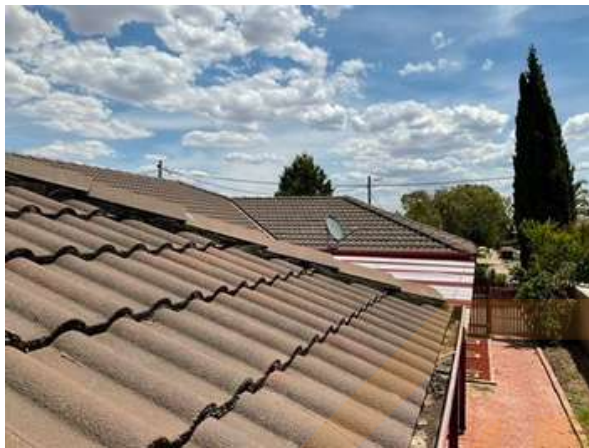
## Minor Defect 3.04

Roof Capping - Mortar Deteriorated.

Upon inspection of the exterior roof, it was noted that sections of the CEMENT TILE MORTAR has weathered and aged, showing varying levels of deterioration as the CEMENT TILE MORTAR has become loose, cracked and/or missing in the Valleys, Hips and/or Ridges.

Where left unmanaged, deteriorating roof tiles and cement tile mortar is likely to lead to water ingress through the roofing which creates a number of secondary defects, including minor and/or major water leaks and weather exposure to internal roofing structures.

WEATHERED, BUT REASONABLY GOOD CONDITION

We highly recommend consultation with a roofing contractor to repair the roof.

The roofing contractor can advise if the roofing requires partial repair or significant repair.

Taking action to repair the roof will eliminate water ingress through the damaged areas and will increase the longevity of the exterior roofing structure.

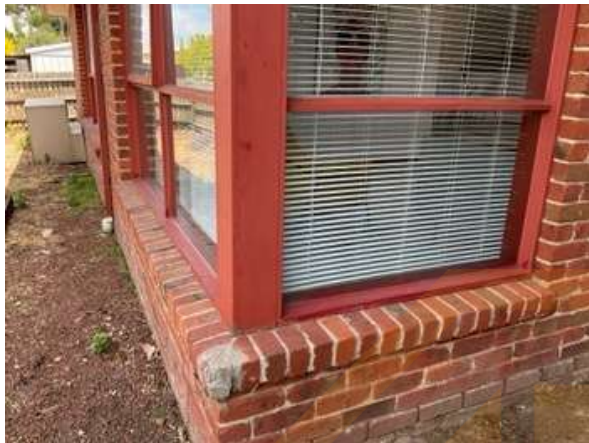
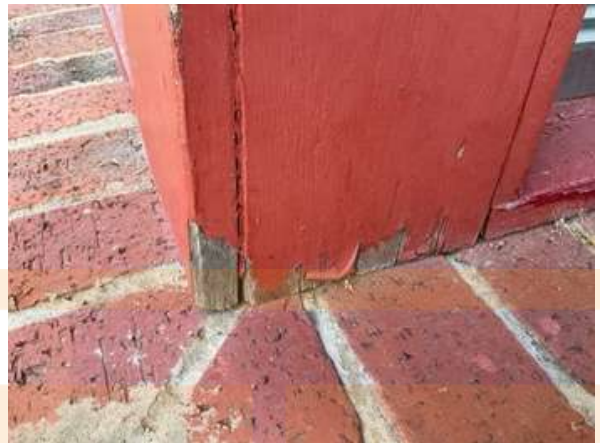
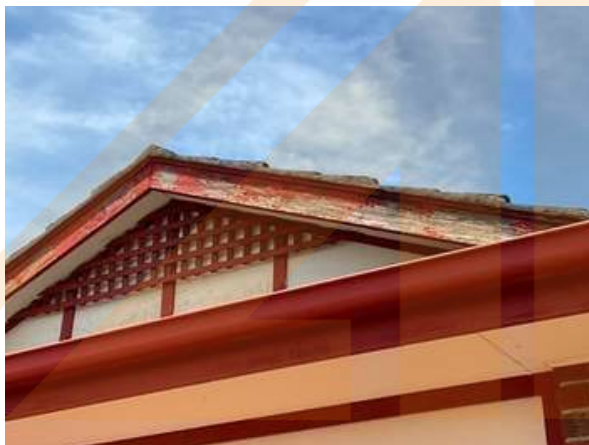
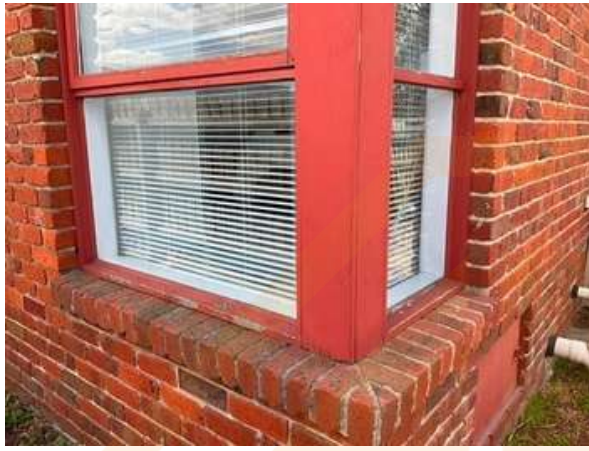
## Minor Defect 3.05

Exterior Timbers - Weathering & Paint/Repairs Required

Weathering, incomplete, or sub-standard painting to the exterior timbers should not be dismissed as solely an appearance defect. Over time, it can lead to secondary damages, exposing the timbers to direct sunlight, rain, and ongoing moisture. It is imperative to sand back, fill, level, and paint degraded paint finishes as necessary.

Failure to provide sufficient paint or treatment will result in accelerated deterioration. Early protection is necessary to prevent the timber from advancing to fungal decay, also known as wood rot.

Immediate action is recommended to adequately treat these timbers. Engaging a professional painting contractor as soon as possible is advisable to perform the necessary works and protect the affected areas from further deterioration. Alternatively, if the homeowner possesses the experience and knowledge, they may choose to undertake the timber repairs and painting themselves.

Regardless of who performs the task, it is crucial to thoroughly paint all timbers, paying special attention to the timber ends, such as window frames, timber posts, and timber facias. Deterioration tends to be more accelerated at the end of the timbers due to timber grain exposure.

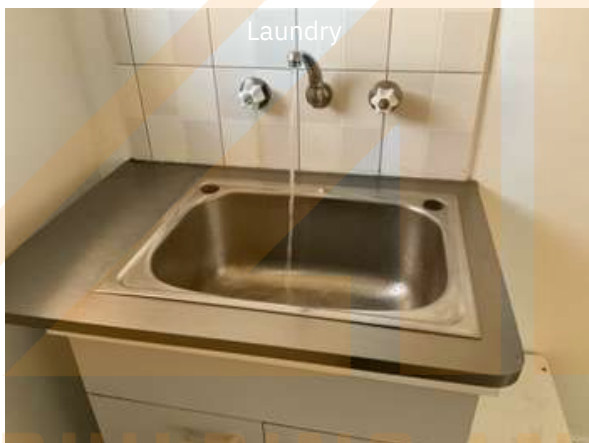
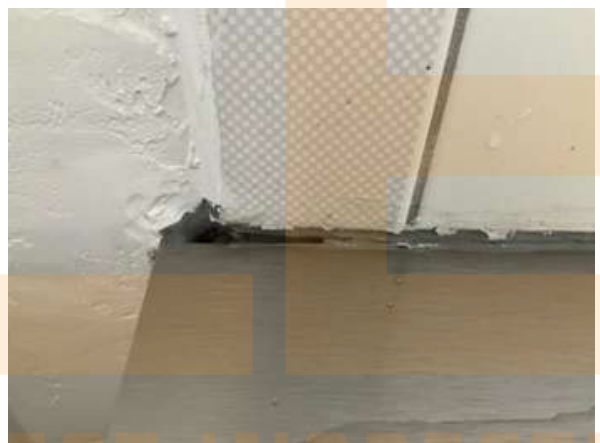
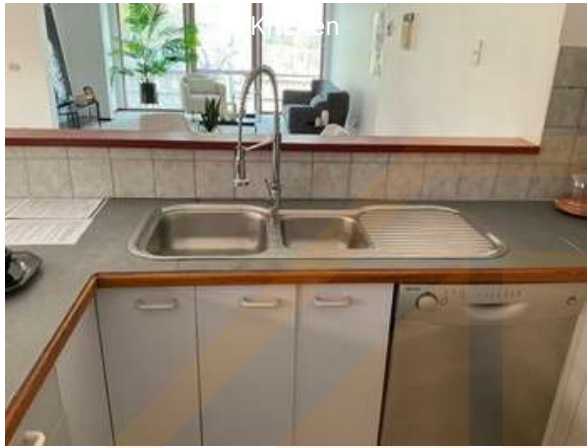
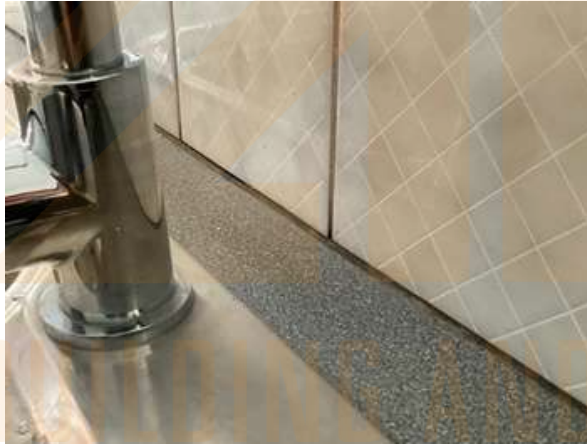
### Minor Defect 3.06

**Location:** Sealant & Other Damages  
**Finding:** Sealant – Worn / Damages

The silicon/sealant is damaged and worn in area's, which poses a potential risk of water ingress and potential building damages. It is crucial that repairs are performed promptly. You certainly do not want to wait for water damages to show and identify secondary building damages as by this time, the cost of repairs are significant.

To address this, it is necessary to take out the old sealant in its entirety and replace flexible sealant that can accommodate expected expansion and contraction while maintaining a watertight seal to protect all associated building materials. This will ensure the joints remain watertight and protective of all associated building materials.

It is highly recommended to engage a professional silicon/sealant specialist that utilizes silicon/sealant like a Polyurethane seal to the tile junctions, corners, and edges can further enhance the repair's durability.

It is imperative that the necessary repairs and maintenance are carried out as soon as possible to prevent any potential building damages and to ensure the long-term durability and safety of the property.

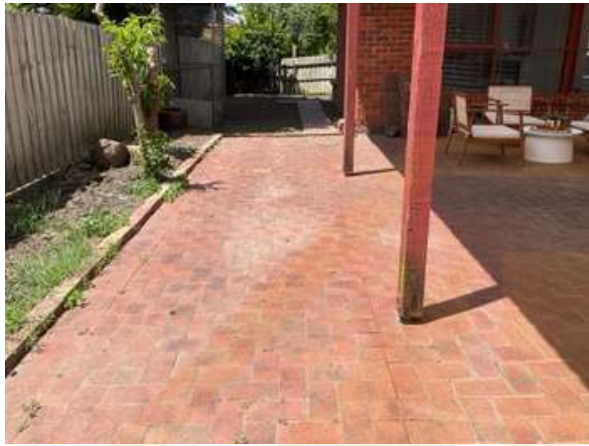
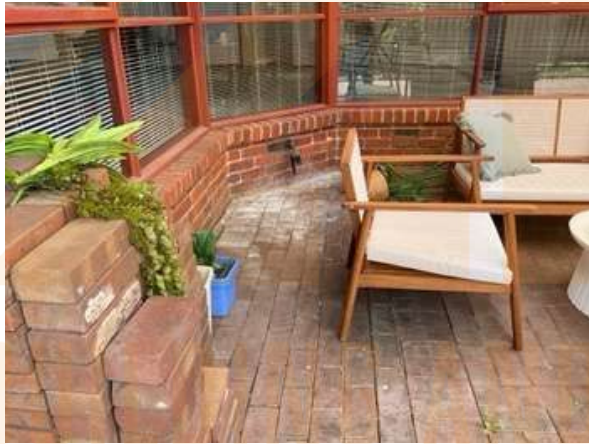
### Minor Defect 3.07

During the inspection of the external paved area, it was observed that sections of the paving are uneven, posing a potential trip hazard. This unevenness is primarily caused by a substandard base under the paving, excessive water accumulation in the area, and/or the presence of tree roots.

The recommended remedial action is to re-pave the affected area; however, it is crucial to first identify and repair the underlying cause of the problem. In cases where excessive water is the issue, a performance solution should be implemented. Moreover, it is essential to allow the soil to dry out before proceeding with the repaving process.

If significant tree roots are present, it is advisable to seek the assistance of an arborist, suitable tradesperson, or landscaper. It is worth noting that once a tree is removed or treated with poison, the large underground roots will decay and collapse, potentially destabilizing the soil and causing uneven paving once again. Therefore, it is vital to address any necessary rectification works before installing new paving, regardless of whether it will be continuous concrete or an exterior paving tile.

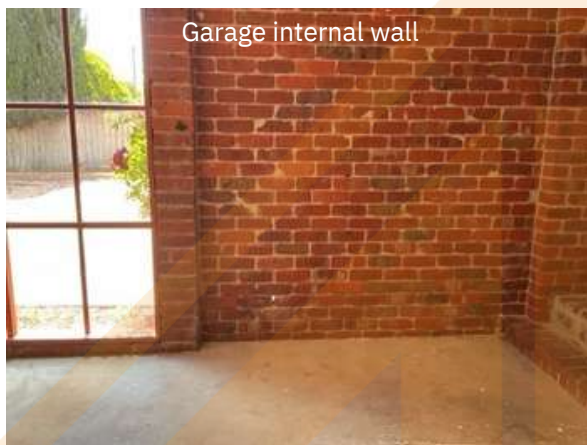
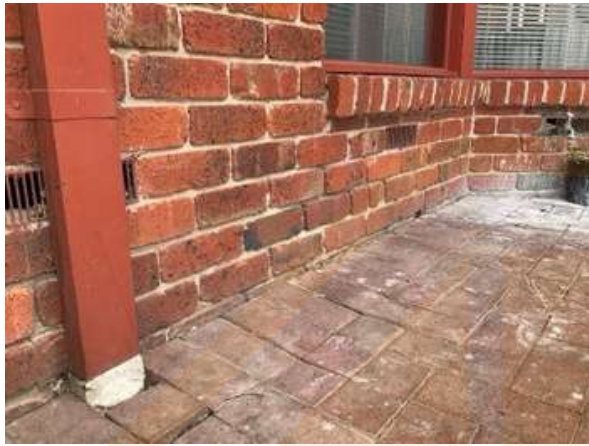
## Minor Defect 3.08

Brickwork - Deteriorated mortar - Minor

The mortar is deteriorating, into the brick mortar joints to numerous areas of the building.

The result of the deteriorating mortar may have contributing factors, such as higher than normal moisture readings, or back many years ago the bricklayers applied a special chemical adhesive into the brick mortar mix as a waterproof, however it has now become apparent over time on some buildings the chemicals are eating into the brick mortar, or in some cases the sand cement mix ratio was not mixed appropriately, as there was not enough cement in the mix.

Mortar, or 'bedding', is the material which fills joins and intersections between bricks in masonry walls and structures. Sections of mortar in this brickwork were identified as having deteriorated, which is generally expected for a property of this age and condition.

Mortar may deteriorate as a result of age of building materials, minor movement of bricks, or frequent exposure to weathering. Mortar should be replaced to ensure that bricks remain in their intended location and to prevent gaps, which would allow water or moisture ingress and secondary damage as a result.

Generally the deterioration of the mortar will continue, so I highly recommend that this item be monitored over time by an appropriate and competent person and/or an expert in the field of brick mortar is engaged for further assessment.

Mortar deterioration can be addressed by a bricklayer where areas of deterioration are localised and easily accessible. Alternatively, appointment of a registered builder is advised, to repoint large areas of decaying mortar.

Where secondary structural defects have become evident, consultation with a structural engineer may be required.

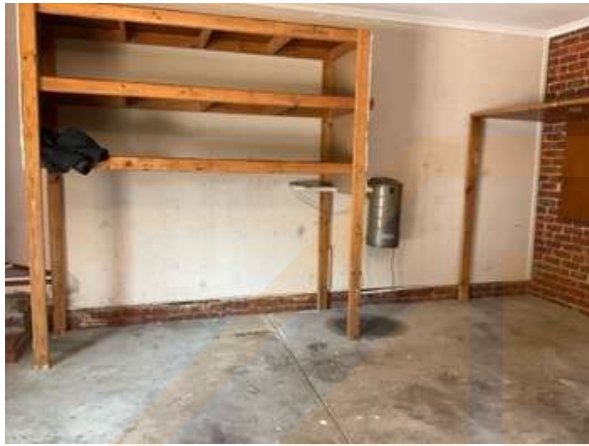
### Minor Defect 3.09

During our inspection of the property, we observed that efflorescence appears to be affecting the brickwork in the garage area.

While efflorescence itself may not necessarily lead to secondary damage if left unmanaged, it is crucial to consider other defects in the area, particularly drainage concerns, as they can exacerbate the presence of efflorescence. It is important to note that the cause or source of efflorescence can be a significant concern, as it may potentially lead to further damage to the building materials.

Depending on the location of the efflorescence, such as subfloors, brick walls, or inside garages in the concrete or brick walls, there may be other damages present, such as damp rising, dampness, concrete cancer, or other serious defects. It is not uncommon for people to underestimate the impact of efflorescence, which is why we highly recommend further investigation by a registered builder, plumber, and/or sometimes a structural engineer as the first point of contact. They will be able to determine the cause or source of the efflorescence and perform any necessary remedial works at the discretion of the client.

On another matter, it is common for efflorescence to occur to the concrete and brick walls, adjacent to the neighbouring property, which generally states that the neighbouring properties water run-off is falling directly towards the garage, which can create other concerns with water into the foundations

In order to address the issue of efflorescence in the garage area, we suggest engaging the services of a qualified professional to conduct a thorough investigation and provide appropriate remedial action. This will ensure that any potential secondary damages to the building materials are identified and addressed promptly, preserving the integrity of the property.

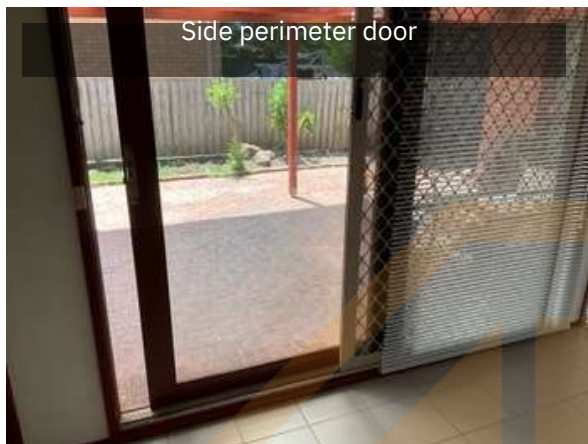
### Minor Defect 3.10

Restricted function of the affected doors may pose as a potential safety hazard if required for emergency egress from the building.

Generally, factors such as general age of the building element and a lack of maintenance are the usual causes for this type of defect.

Replacement of door hardware or tracks may be required, as well as minor repairs and cleaning. A registered builder or general handy person will be required to repair the affected doors.

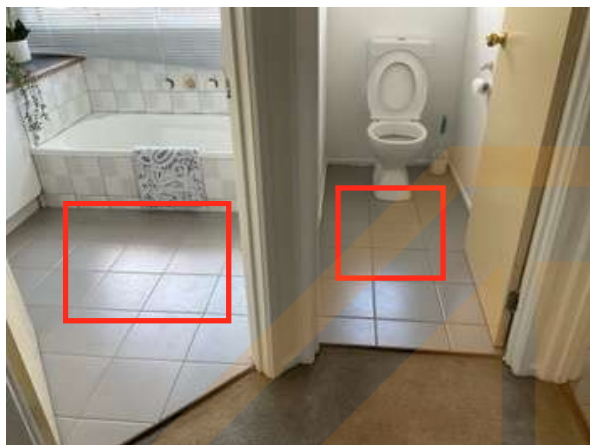
## Minor Defect 3.11

Tiles - Drummy ( Loose or Compromised )

During the inspection of the property, it was observed that there are drummy tiled areas present.

The term "drummy" refers to tiles that have become detached from their fixing or have hollow areas underneath the tile indicating a lack of consistent cement or glue beneath the entire tile and/or water/moisture under the tile.

Drummy tiled areas can be a result of poor workmanship during construction or damaged tile grout or sealant, also cracked tiles allowing water/moisture to penetrate.

It is important to note that any exposure to moisture/water can cause tiles to become drummy and cracked over time, especially in shower areas where the problem is more pronounced.

If left unmanaged, ongoing water penetration to these areas generally continues to create further subsequent water damages, which is likely to necessitate bigger repair works in the future to affected building elements, such as timber framing to the walls and subfloor where applicable, plaster damages, tile damages, timber door frames and skirting damages, also help necessitate conducive environments for termites due to the ongoing moisture and many other damages, that can be minor or major.

Specialist trades are available for these types of services. A registered builder may be required to undertake works if damage is extensive or if secondary building defects have resulted.

Otherwise, it is advised that a tiling contractor be appointed to perform works as necessary, related to new tile grout and sealant to the junctions, Including any cracked tiles if applicable.

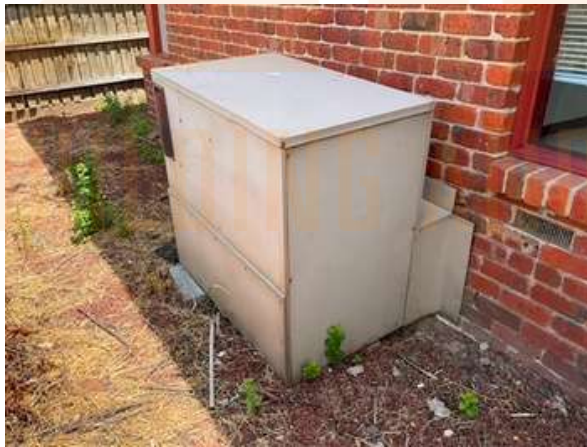
## Minor Defect 3.12

**Location:** Perimeter Of Building - Exterior

During the inspection of the property, it was observed that the Boiler service is positioned directly on the ground without any concrete base or support. This lack of proper support can lead to potential issues with the plumbing connections, including water and gas. The movement of the Boiler service due to its unstable positioning can compromise these connections, posing a risk to the overall functionality of the unit. Furthermore, the absence of a concrete base exposes the hot water service to accelerated deterioration, which can further impact its performance and lifespan.

To address this defect, it is recommended that a qualified professional be engaged to install a concrete base or suitable support for the Boiler service. This will ensure stability and prevent any movement that may jeopardize the plumbing connections. Additionally, the installation of a concrete base will help protect the unit from premature deterioration, allowing for its optimal functioning and longevity.

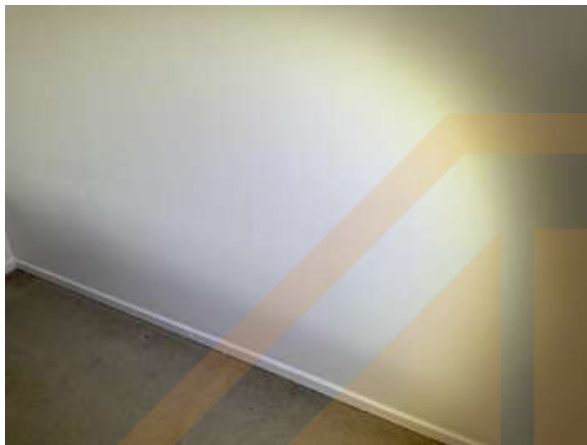
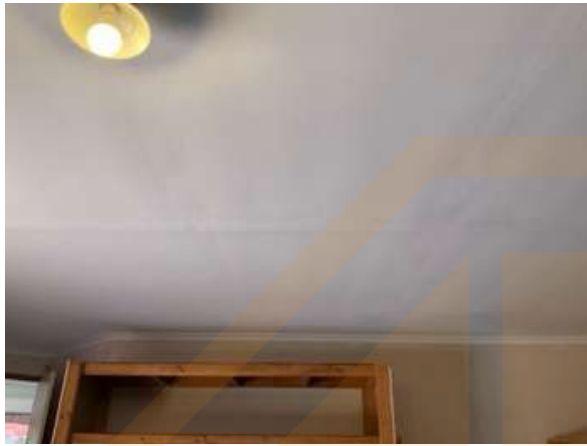
## Minor Defect 3.13

Plaster & Timber Cracking - Damage Category 2 - Noticeable (up to 5mm)

Please note that some cracks in the plaster work and/or solid plaster work have been repaired, so it is unknown how severe the cracks in the plaster work and/or solid plaster work really were, before they were repaired.

Whilst we may have a photo of damaged paint, or a minor plaster cracking, etc, there may be many more paint/plaster defects and plaster cracking in other areas throughout the property.

Noticeable cracks are a common occurrence as a result of many primary defects. Such causes may include age, general wear and tear, expected building movement, general expansion/contraction of building materials in different weather conditions, and/or minor failings in the installation or application of building materials.

Relevant tradespeople, such as carpenters, painters and plasterers, should be appointed to perform remedial works, as deemed necessary.

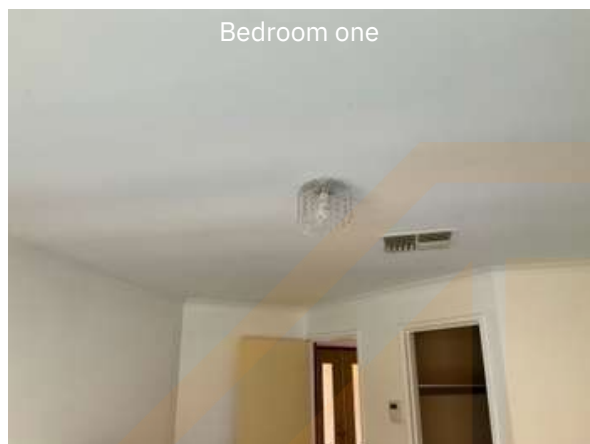
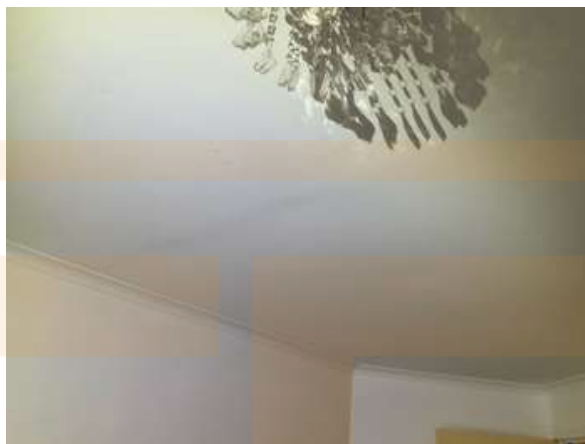
Bedroom one

In conclusion, the plaster defects in various areas of this property require immediate attention.

We suggest the client takes prompt action to address the issue, engaging qualified professionals to assess and rectify the plaster as necessary.

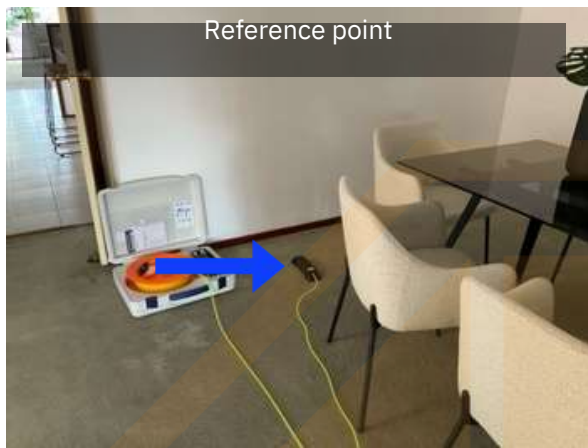
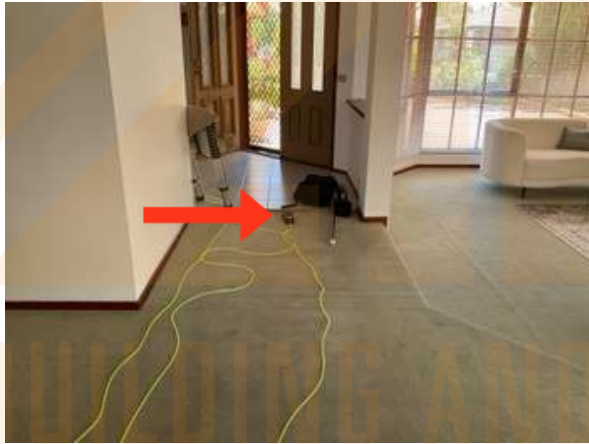
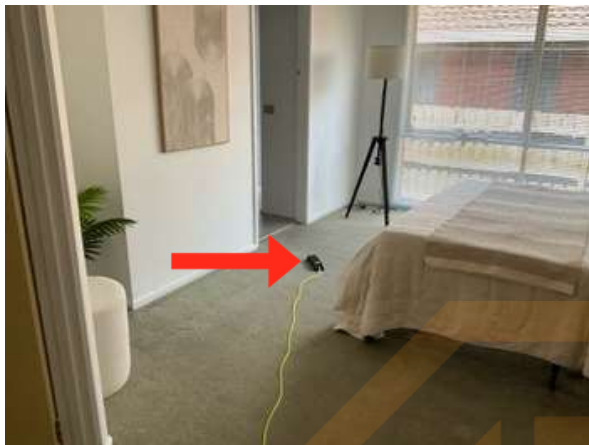
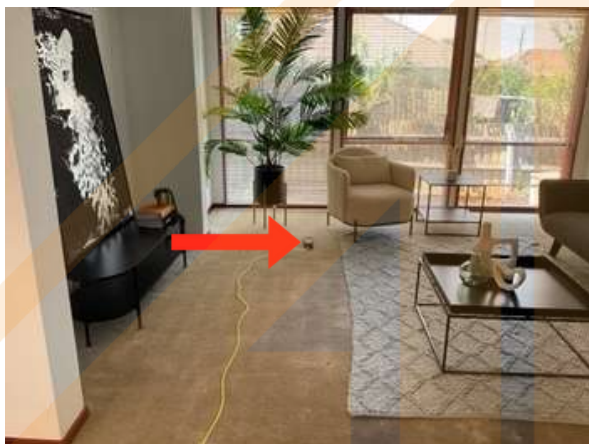
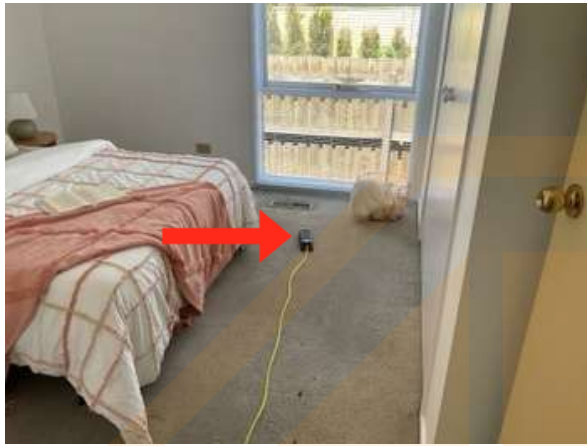
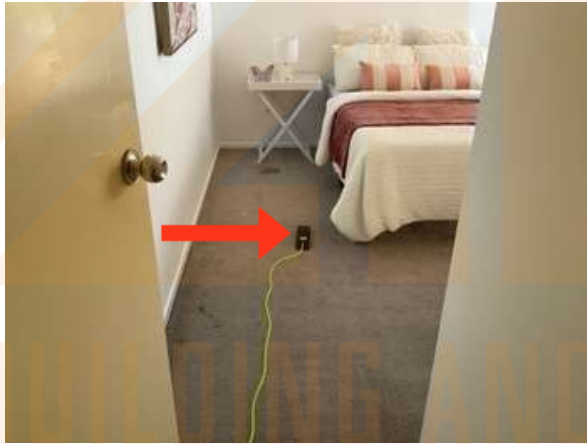
### Minor Defect 3.16

◆ RESULT - Taking into consideration, the properties type and age, it appears that the FLOOR LEVELS HAVE ACCEPTABLE VARIATIONS IN HEIGHT.

Where flooring remains relatively unchanged for an extended period of time (i.e. several months or seasons ) it is likely that the flooring is relatively stable, however unexpected movement to the foundations of a property can occur at any time, for reasons such as extensive tree roots, water pooling to the foundations, general age and/or other type conditions.

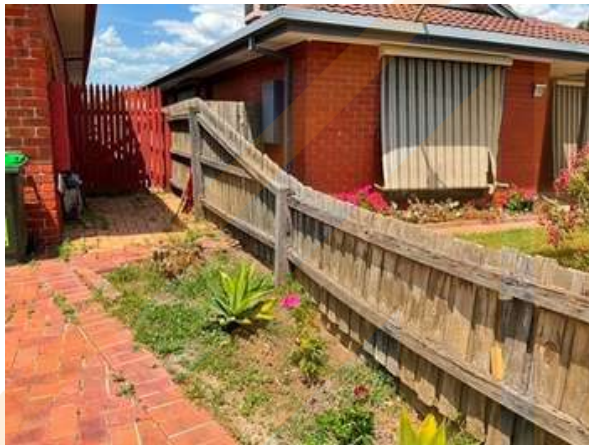
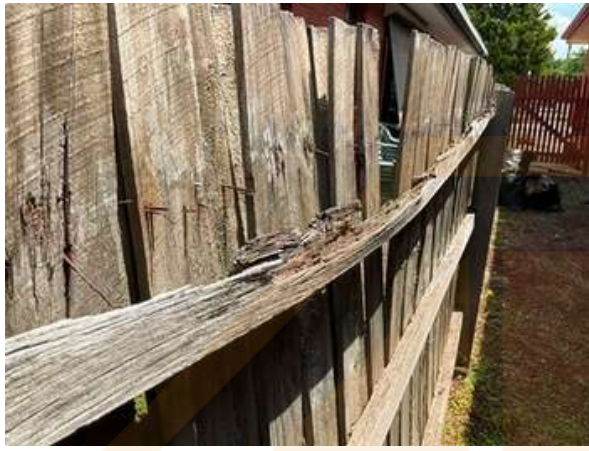
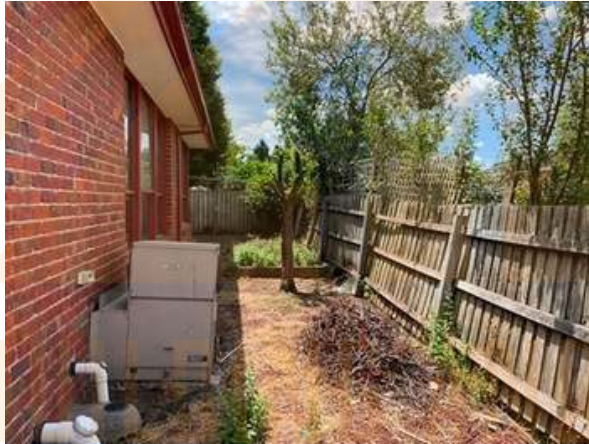
### Minor Defect 3.18

Note - under normal circumstances, the cost to replace a fence is shared with the neighbouring property, however the challenges associated with a new fence is getting the neighbour to agree to the type of fence, sometimes the design of the fence and finally if the neighbour is happy to pay for half the cost of a new fence.

When a neighbour disputes to pay for a fence, please contact your local council as there are complex laws in relation to this type of dispute.

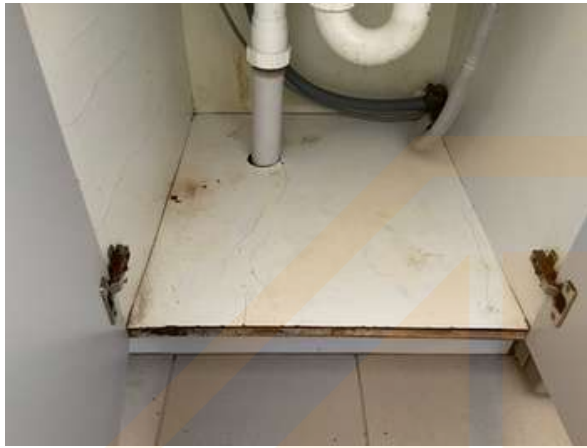
### Minor Defect 3.19

Water Staining / Damages

Cabinetry - Water Rott / Water Staining

NO MOISTURE DETECTED - During the inspection of the wet area, water staining was observed on the surfaces surrounding the cabinetry. This indicates that these surfaces have been exposed to moisture or water over time. While no excessive moisture was detected with our moisture meter at the time of the inspection, this does not mean that the concern is not ongoing. The problem may be intermittent and may not have been present during the inspection.

Upon closer examination, it appears that the water has primarily originated from methods like carelessness with water spillage and things of this type of nature. Of course there can be other reasons for the cabinetry minor water damages such as leaking plumbing, water connections to the dishwasher or fridge and other type situations.

If the water staining is old and no longer active, the affected building materials can be repaired or replaced, at the client's discretion, as long as the damage is purely cosmetic.

It is advisable to have an appropriate handyman, carpenter, or similar professional assess the area to determine if there is any ongoing moisture issue over a period of time.

However, if there are any signs of the ongoing water leaking then immediate attention is required by a plumber.

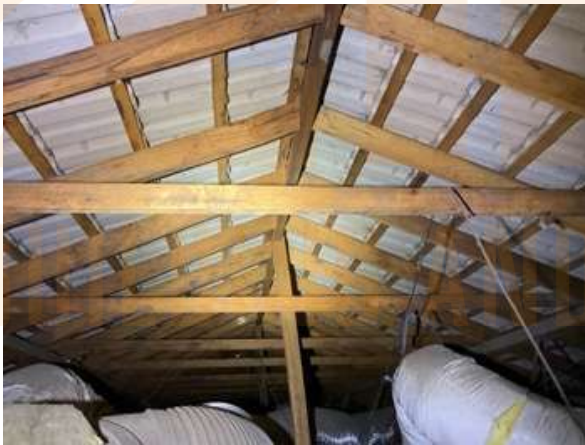
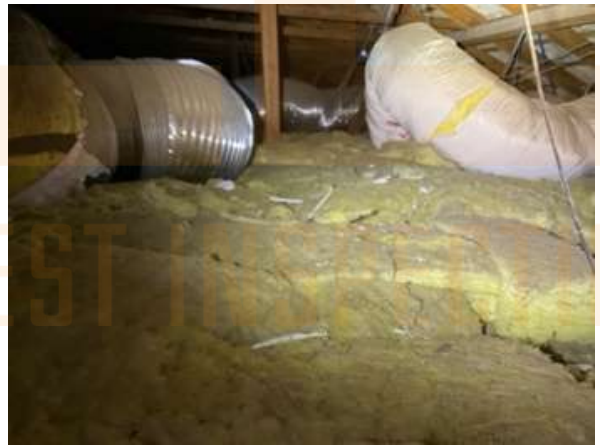
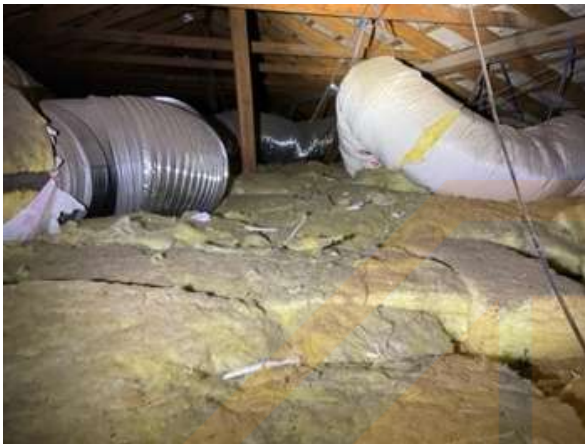
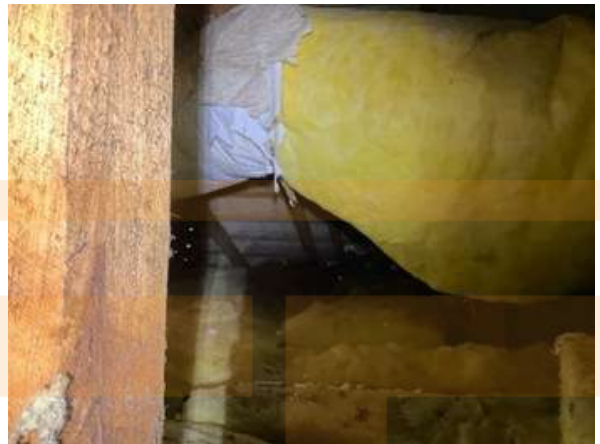
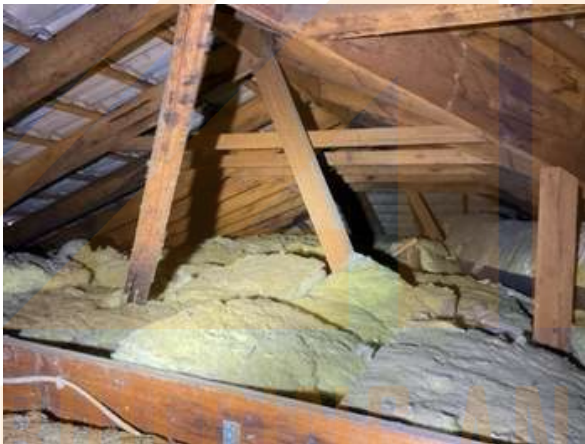
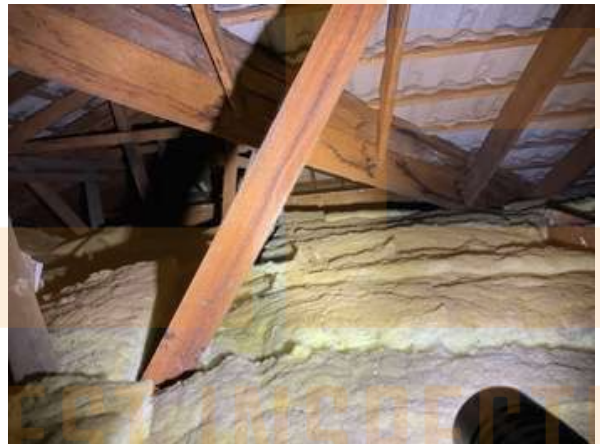
## For your information 4.02

At the time of the inspection, the visible roof space area's appeared to be in good condition for its type and age with no evidence of immediate structural types concerns.

These photographs are an indication of the obstructions and limitations, such as timber rafters and associated timbers in a roof space also limiting accessibility.

These obstructions can hide an array of defects and it is impossible to rule undetectable issues or damages.

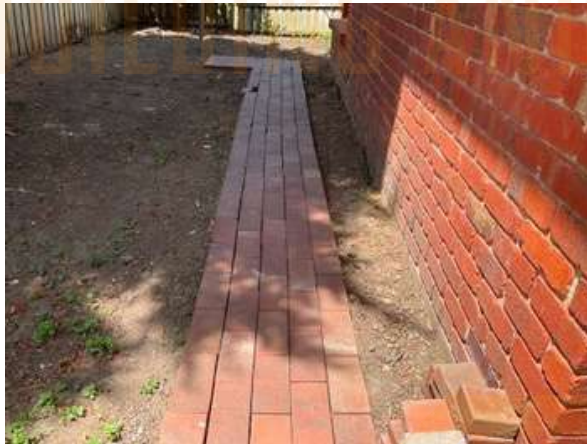
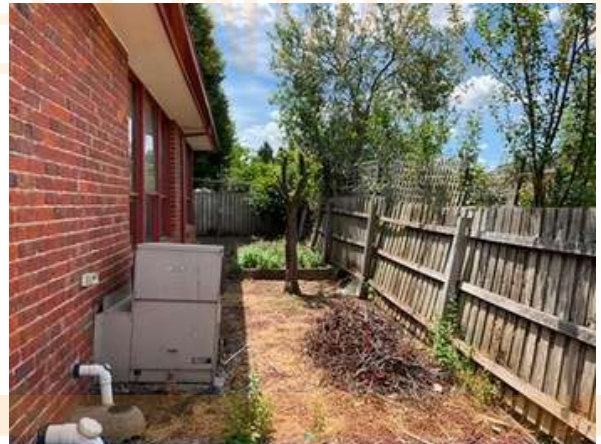
### For your information 4.03

Perimeter Drainage Drainage - Perimeter Building Ground Fall Defective. The perimeter of the

building requires to either have appropriate fall away from the building, particularly noting NOT to shift the water into neighbouring properties or allowing the water to fall back towards the foundations.

Inappropriate drainage to the perimeter can lead to water accumulation to the building foundations. This excessive water pooling around the foundations can result in various damages, including foundation movement, rising dampness on the walls, and potential dampness to the subfloor area or concrete slab.

Furthermore, the pooling of water near the foundations can lead to internal damages such as wood rot and other secondary issues related to foundation movement. There can be various other concerning damages related to inappropriate drainage.

It is recommended that immediate remedial action be taken to address this issue. The appropriate course of action would be to ensure that the perimeter of the building is properly graded to allow water to flow away from the structure and/or also implementing suitable drainage systems near the foundations to prevent water accumulation. By addressing these drainage concerns, the risk of further damages and associated issues can be significantly reduced.

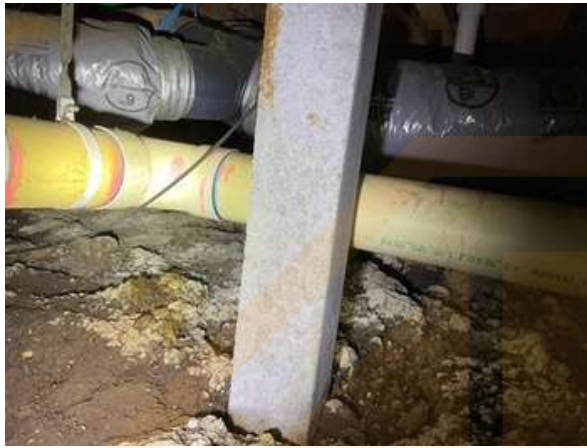
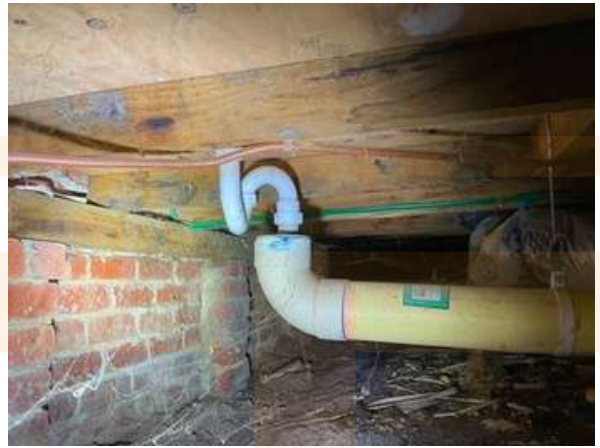
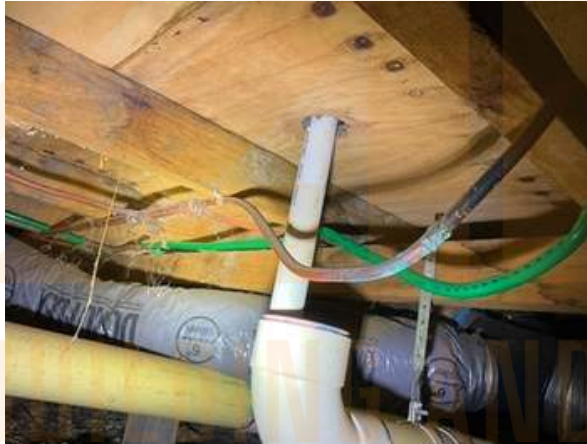
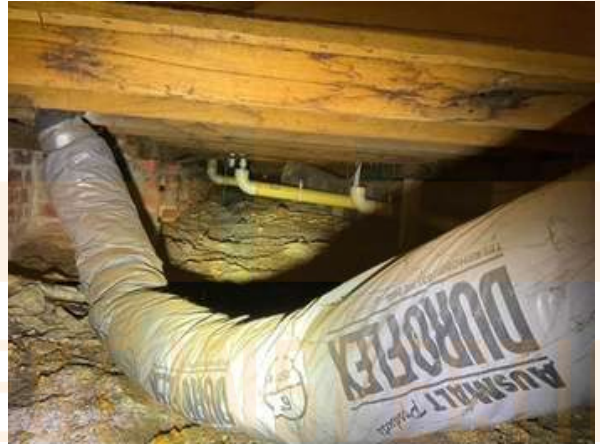
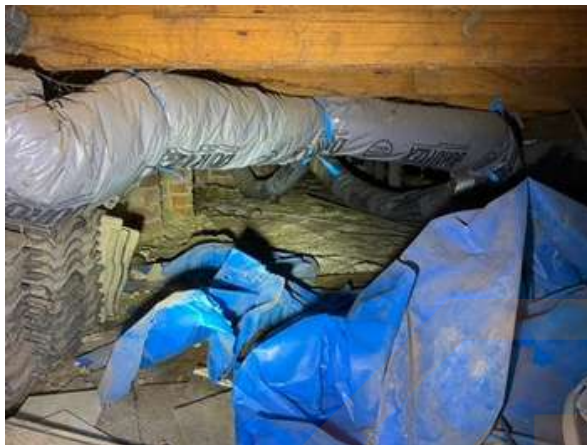
#### For your information 4.04

General Sub-Floor Photo's for your information.

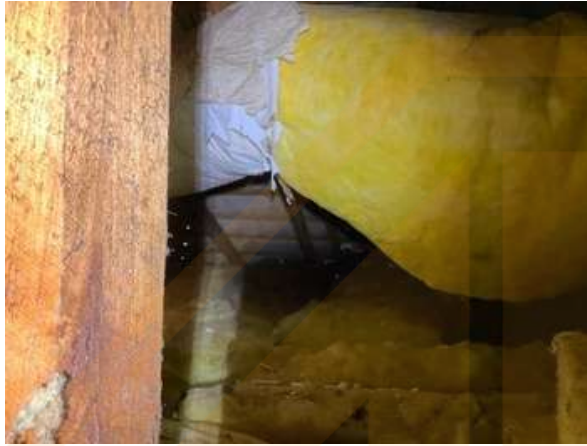
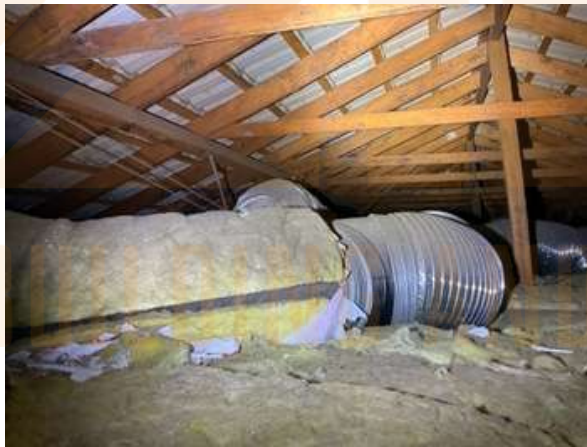
### For your information 4.05

Heating / Cooling Ducts - damaged

The heating/cooling ducts were found to be damaged and not at a fully operational level.

Generally, damage to ducts occurs as a result of ageing and material deterioration, but impact damage or pest damage may also be the underlying cause.

The damage sustained by the ducts detracts from the energy efficiency of the property. The airflow within the property is likely to be restricted, particularly in areas where ducting shows signs of major damage.

A heating/cooling specialist should be appointed to provide further advice on remedial work options and to perform any works deemed necessary.

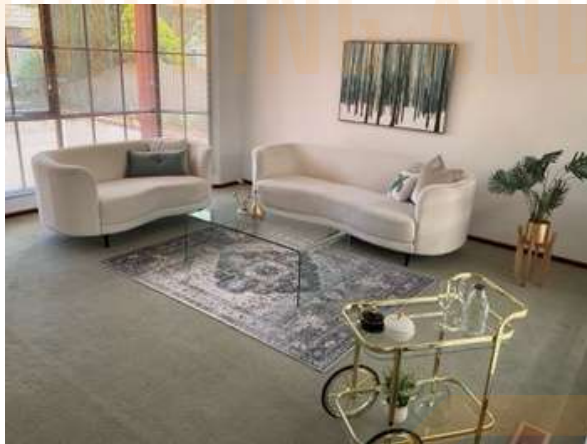
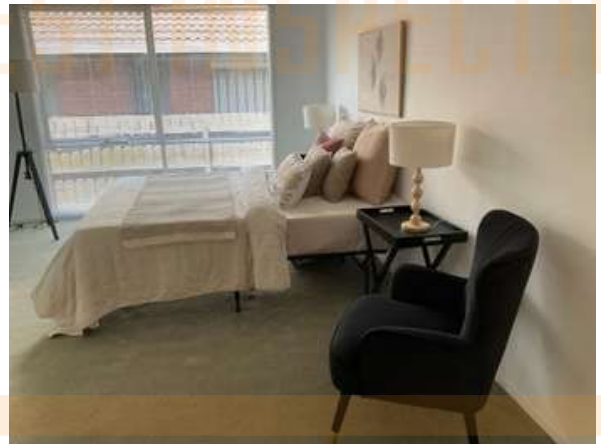
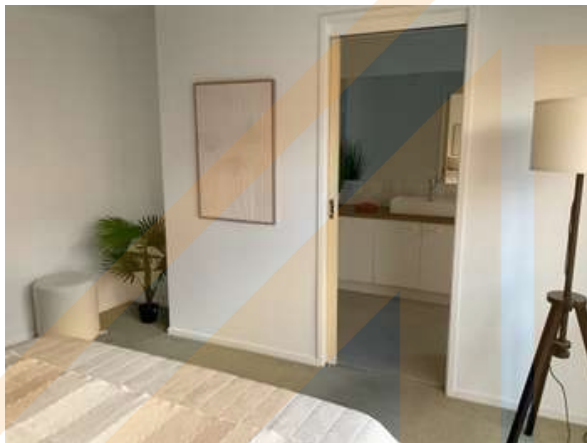
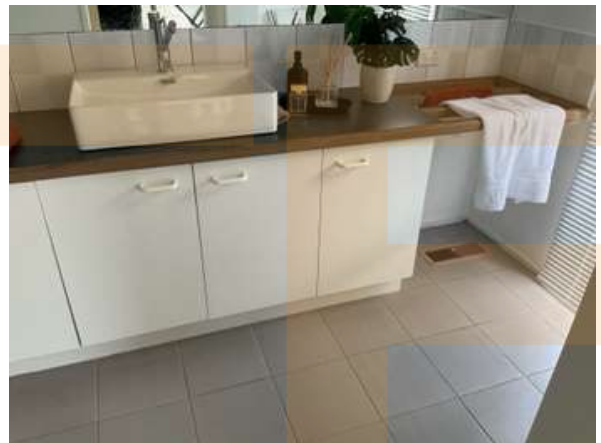
## For your information 4.08

These photographs provide a glimpse of the obstacles we faced, but it is important to note that there may be areas not captured due to their difficulty or inaccessibility. These obstructions can potentially conceal a range of defects, including minor and major issues, safety hazards, termite activity, and environments conducive to termite infestation, among others.

At your discretion, when a property has residents, furniture, stored items and various other items on-site we recommend a re-inspection once the property is vacant and/or emptied, allowing for a more comprehensive assessment without furniture, belongings, or storage obstructing our view. This will enable us to possibly provide you with a more accurate and detailed report.

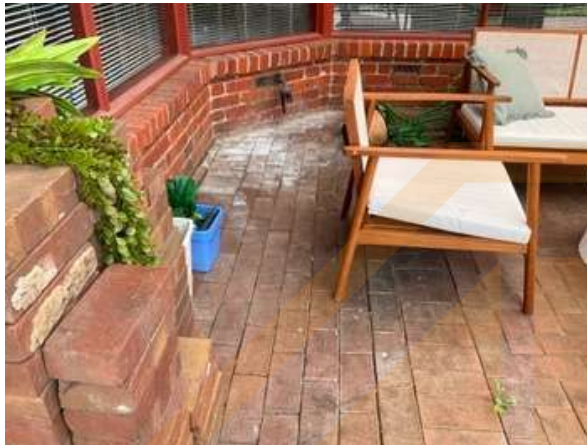
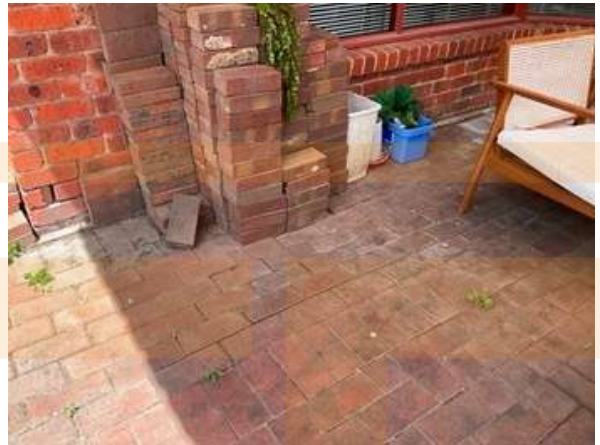
## For your information 4.10

**Location:** Perimeter Of Building - Exterior

Sinkholes are formed when the land surface above collapses or sinks into the cavities or when surface material is carried downward into the voids. Drought, along with resulting high groundwater withdrawals, can make conditions favorable for sinkholes to form.

Step #5: Consult with a Soil Testing Firm ( geotechnical engineer ) or Engineering Company.

Step #6: Monitor the Sinkhole for Signs of Growth.
