# Building & Termite / Pest Report

**Inspection Date: 16 Feb 2025**

**Property Address: Sample Street Craigiburn**

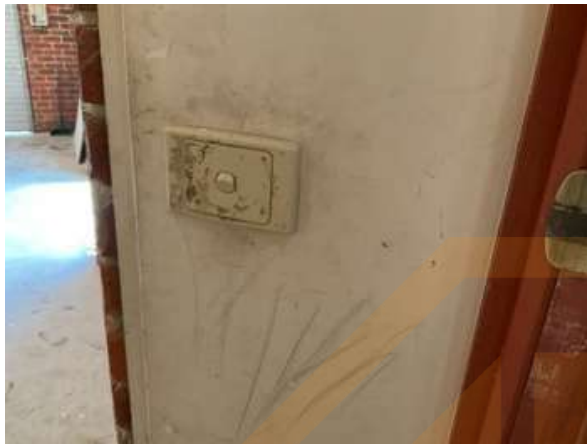
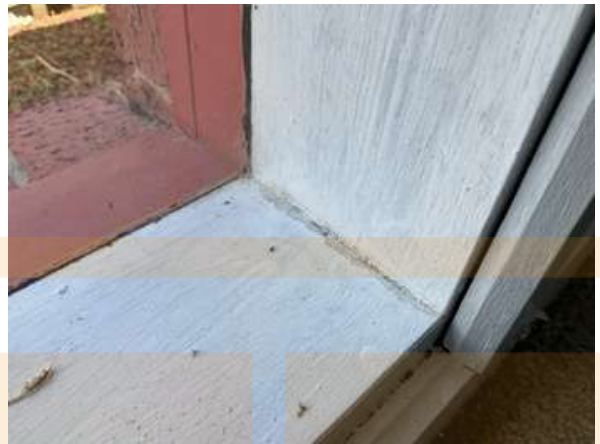
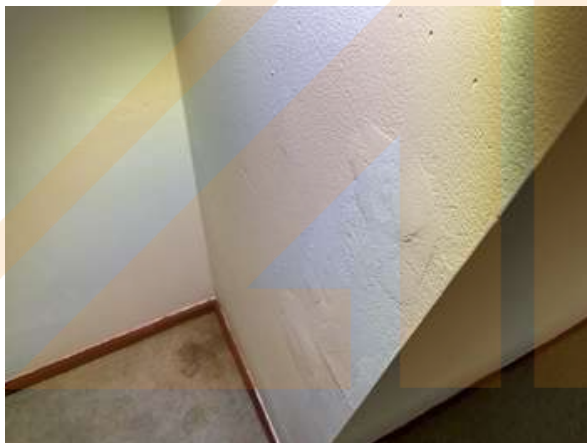
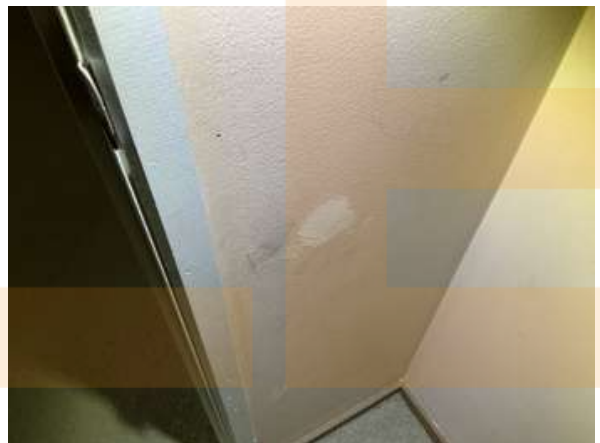
## For your information 4.11

Paint & Plaster Condition - Overall

There are many type damages to the plaster work and timber work. The various damages are generally cosmetic.

Whilst numerous, the paint and plaster surface damages remain generally consistent and typical with general wear and tear.

It was observed that the property has undergone painting and paint repairs to areas.

It is unknown how severe hidden plaster and/or timber cracks may have been before the plaster & paint work was performed. Generally time brings out cracking with ongoing movement to the property.

We do recommend a further inspection in approximately 12 months for further assessment by a building consultant or a registered builder to determine if there are significant signs of movement/cracking reappearing.

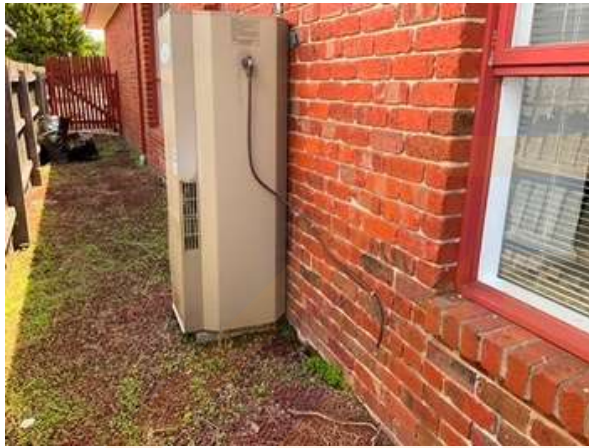
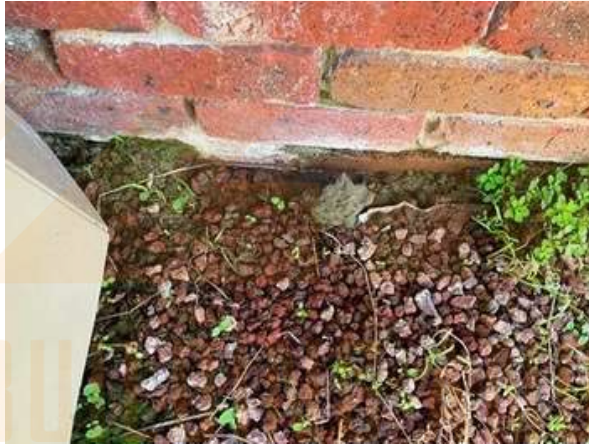
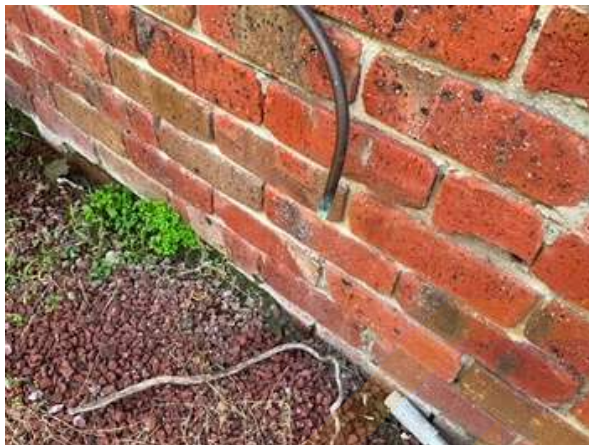
### For your information 4.13

**Location:** Perimeter Of Building - Exterior

**Finding:** Water storage heater

During the inspection, I observed an active leak in the water storage tank, which appears to have been an ongoing issue as the surrounding wall area was noticeably saturated. Additionally, there was evidence of ponding near these regions, and the brickwork exhibited high moisture readings. This leak poses an immediate concern and should be addressed urgently to prevent further damage to the walls. I recommend engaging a licensed plumber to assess the situation and carry out the necessary repairs to the water storage tank and any affected areas. Prompt action is essential to mitigate the risk of structural damage to the property.

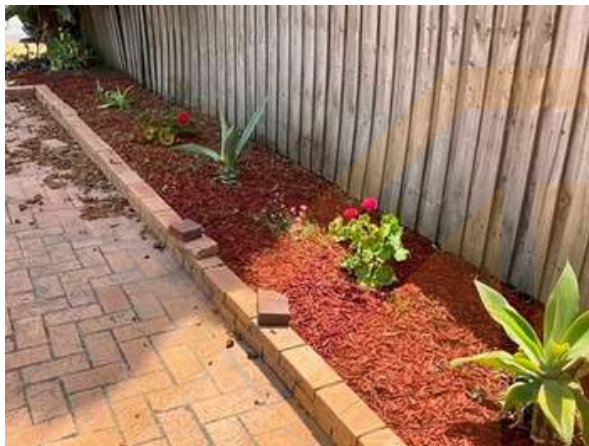
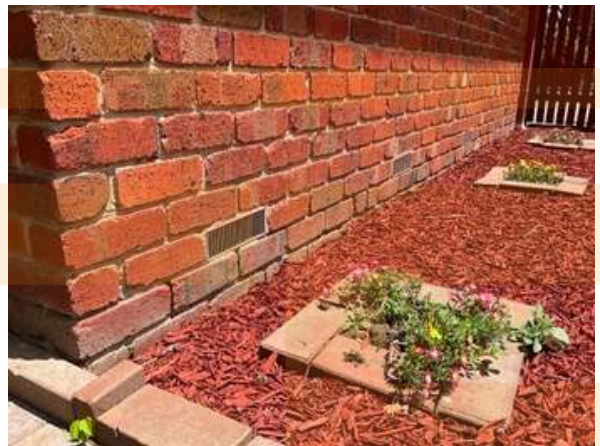
### Conditions conducive to timber pest attack 5.03

Photos added are only samples of the garden.

It is always important to keep the garden beds as clean as possible and take out excess old bark from the trees, leaves and keep bark mulch to a minimum or better introduce rocks or some item that does not create an conducive environment for termites and hold excess moisture.

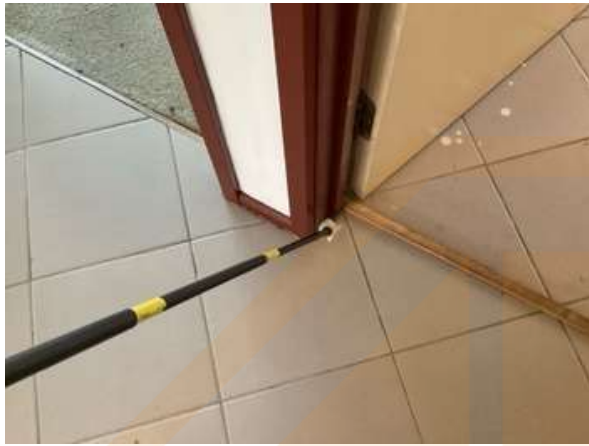
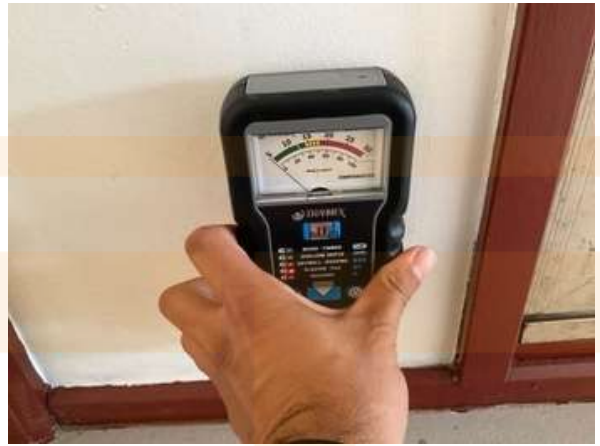
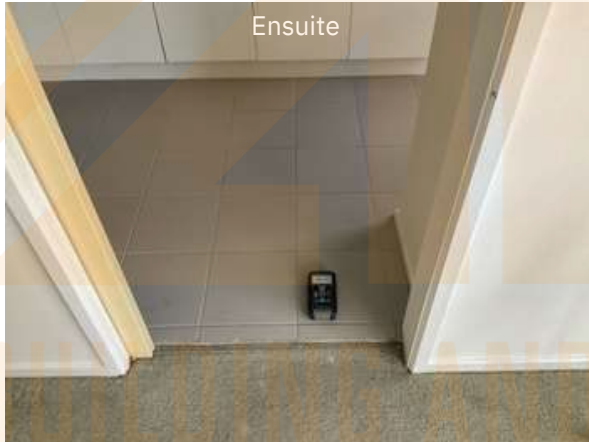
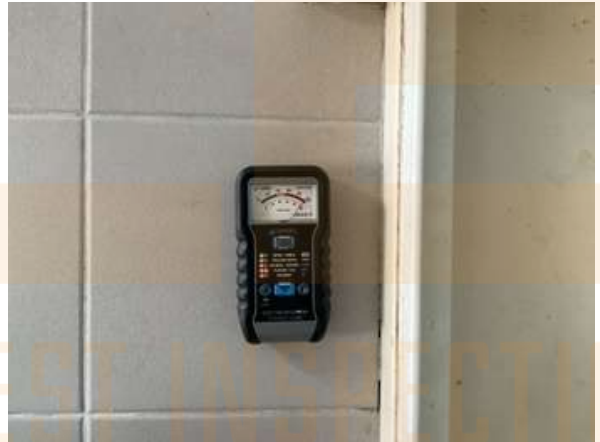
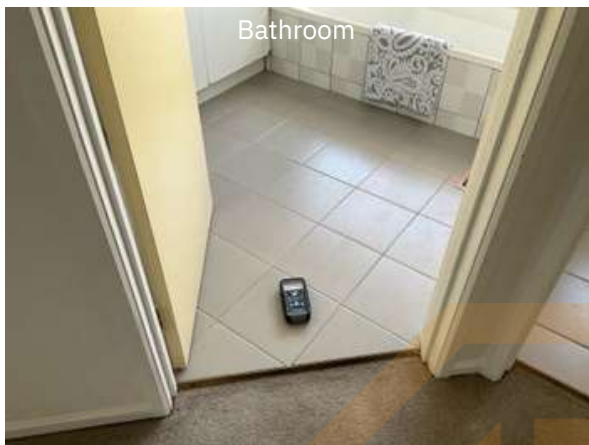
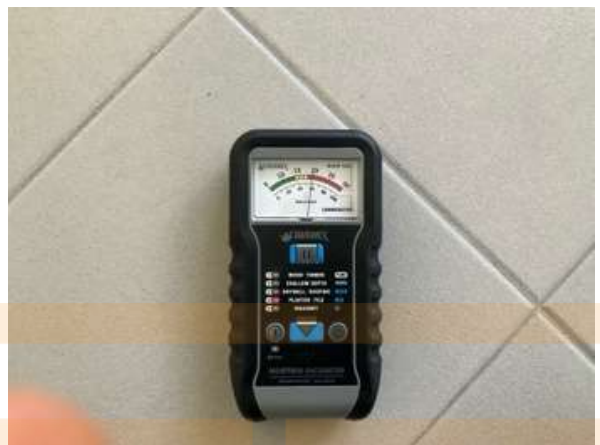
◆ TERMITE/ TIMBER PEST DETECTED - At the time of the inspection there was evidence of ( timber pest ) damage and/or activity to the visually accessible timber, that we believe has been caused by termites and/or timber pest.
