Building & Termite / Pest Report

Inspection Date: 3 Feb 2025

Property Address: Sample Street Altona 1234

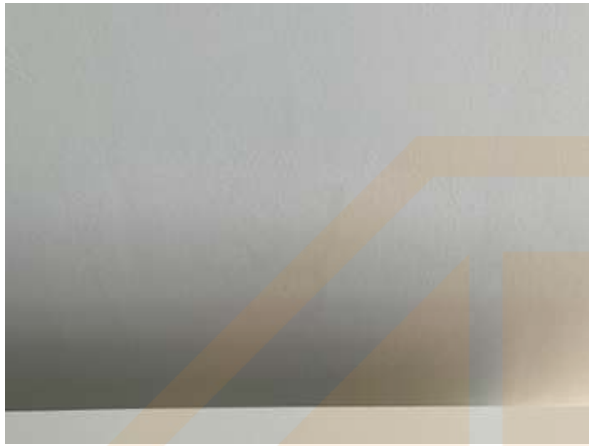
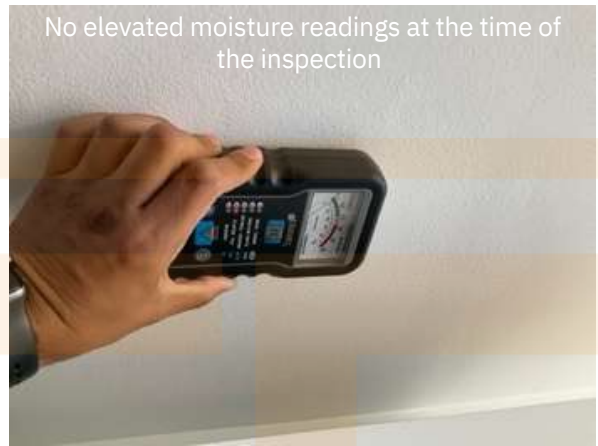
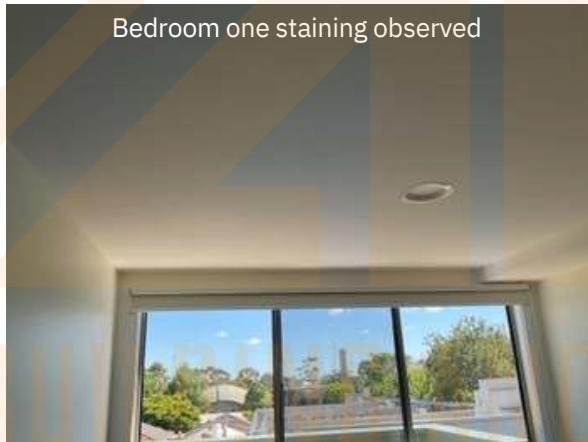
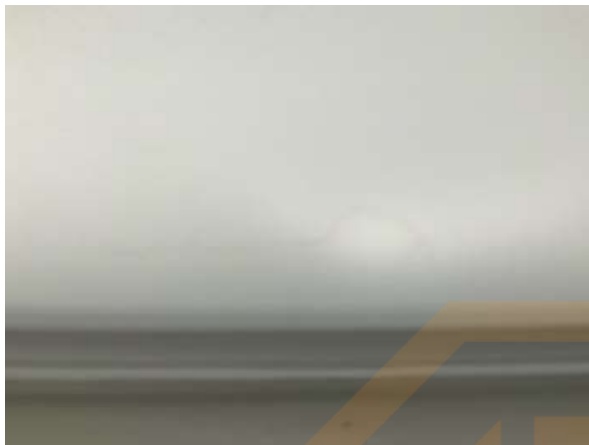
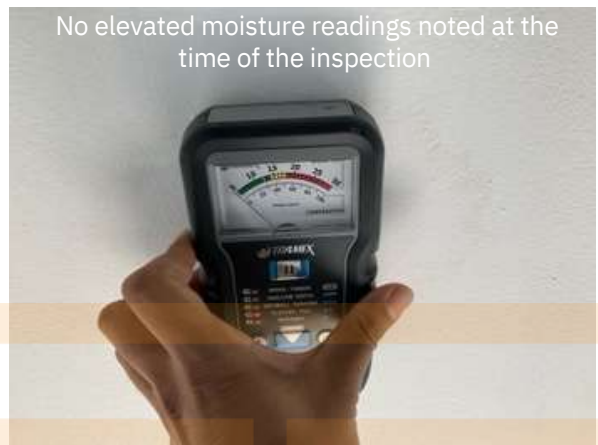
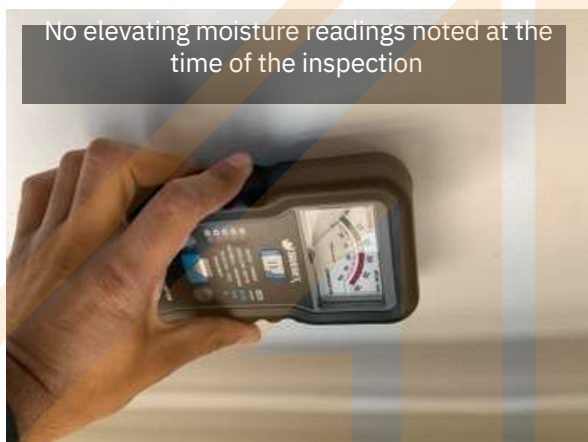
Staining observed in the lounge room

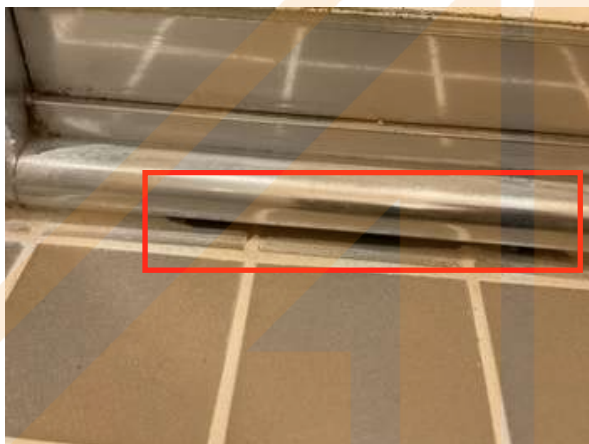
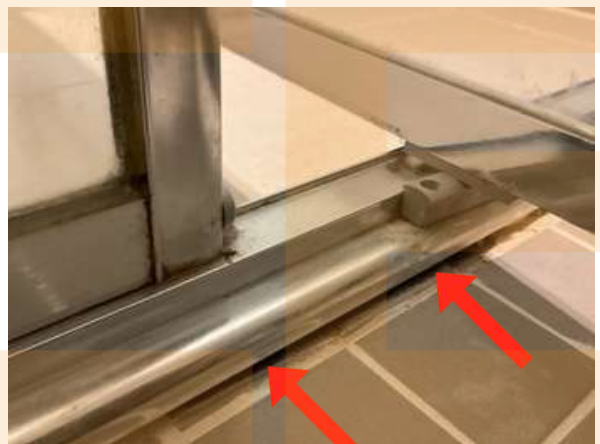
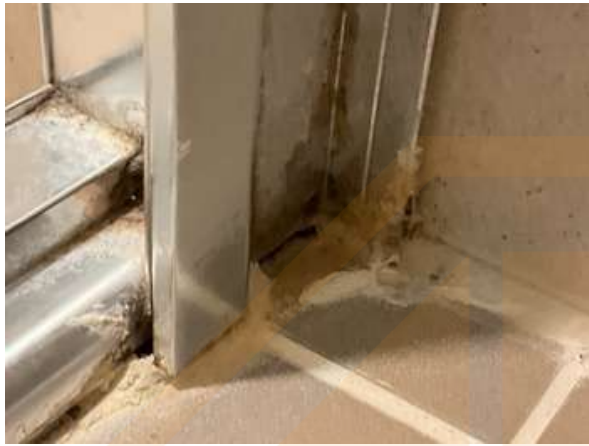
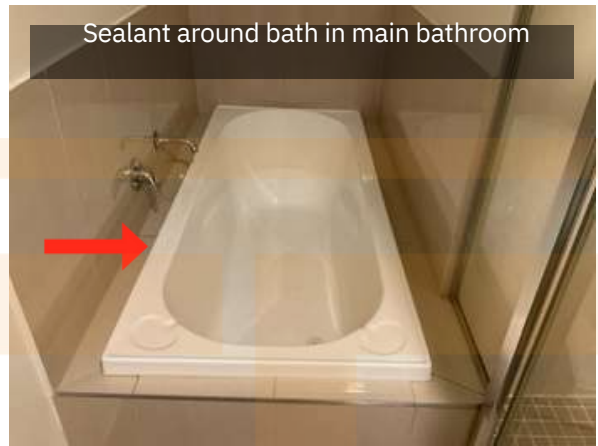
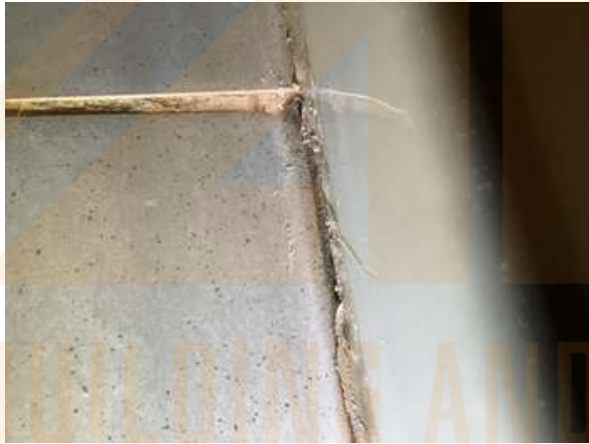
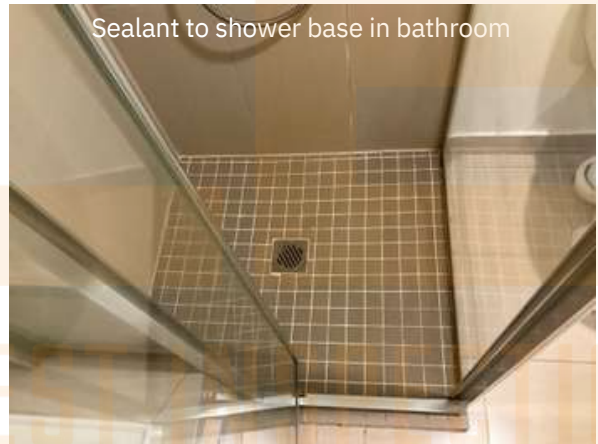
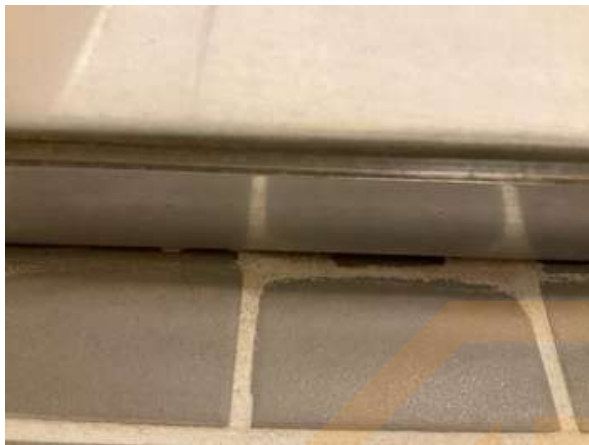
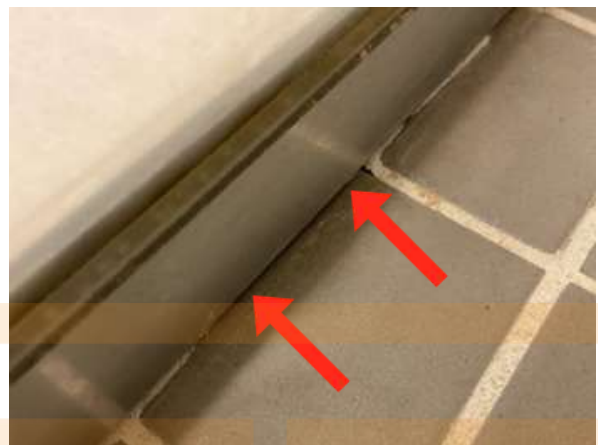
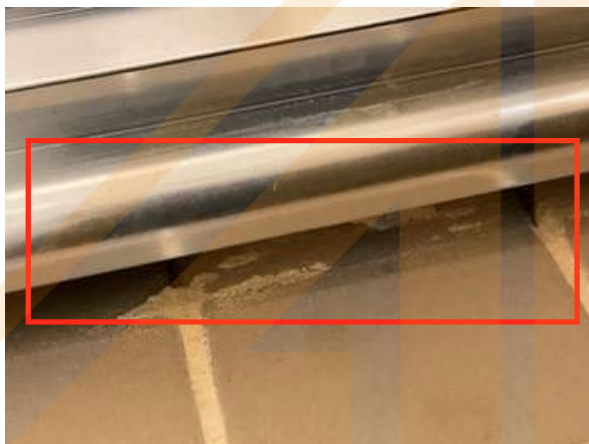
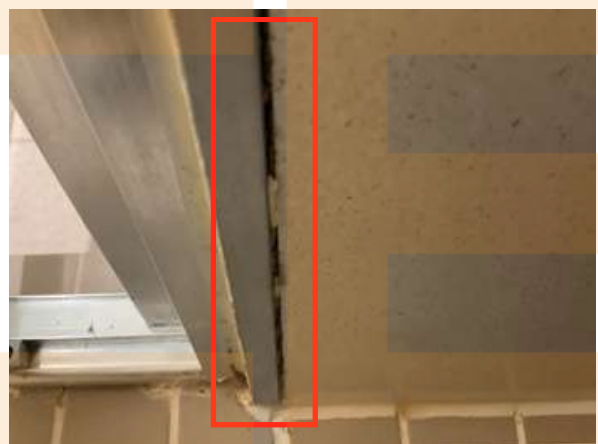
In conclusion, addressing the compromised silicone / sealant and tile grout in the wet areas is crucial to prevent water ingress and potential building damages. Engaging a sealant specialist or utilizing a specialist trade with products like Kerapoxy flexible 2 part resin grout can provide effective and long-lasting repairs.

It is vital to address any loose or cracked tiles, damaged waterproofing or any other building damages before proceeding with the repairs.

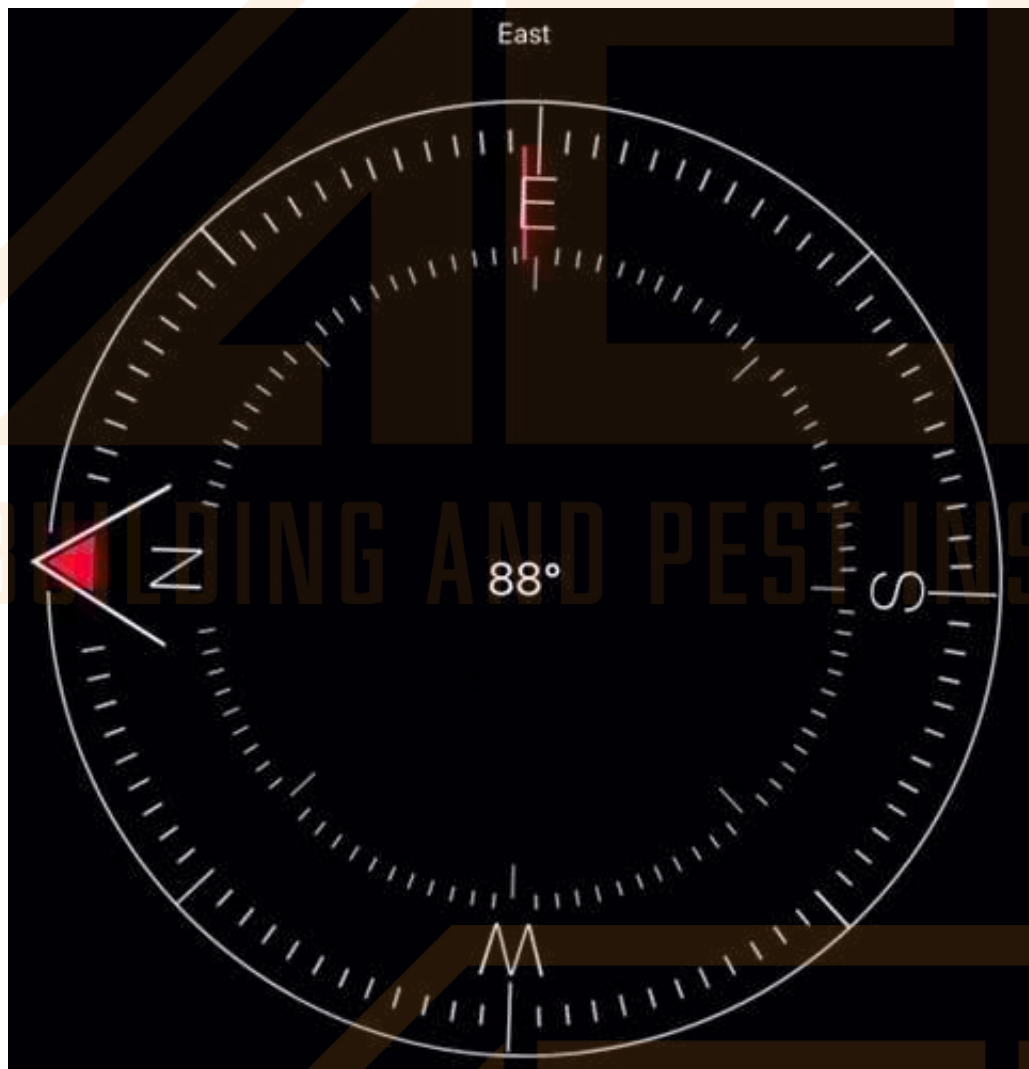
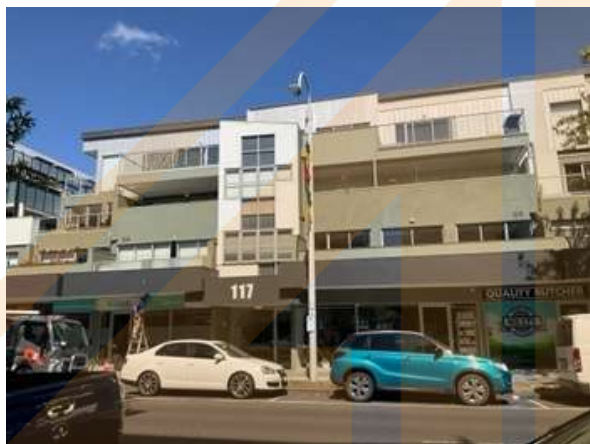
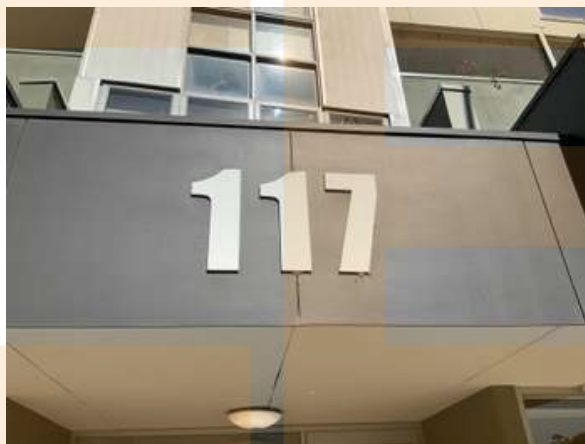
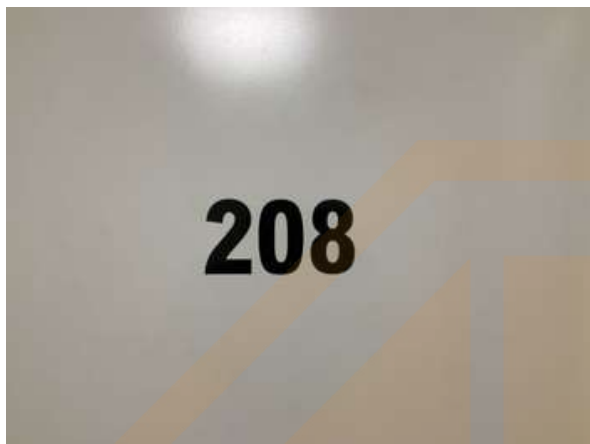
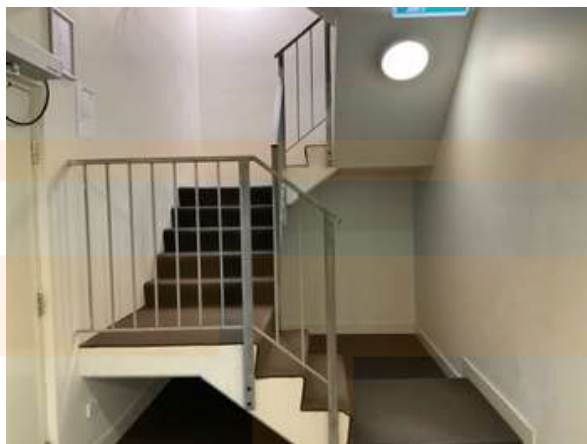
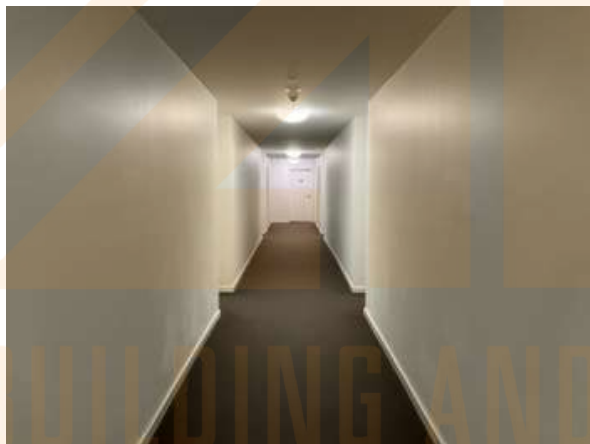
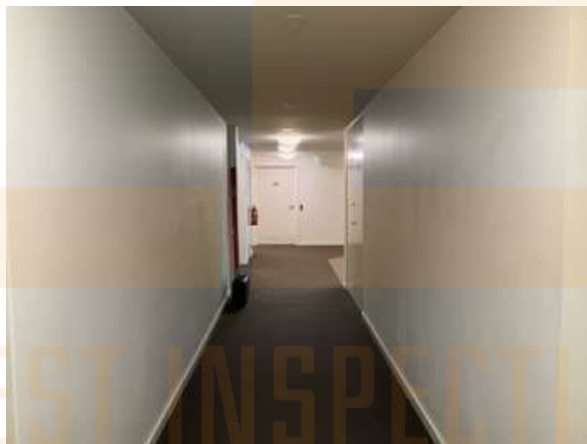
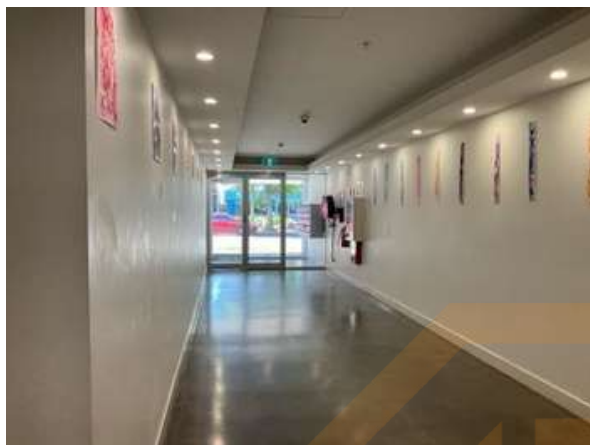
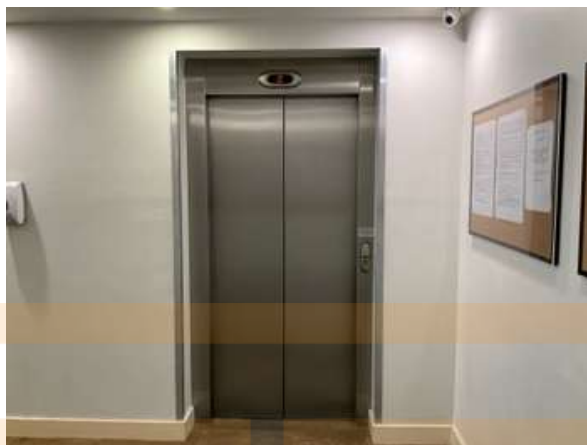
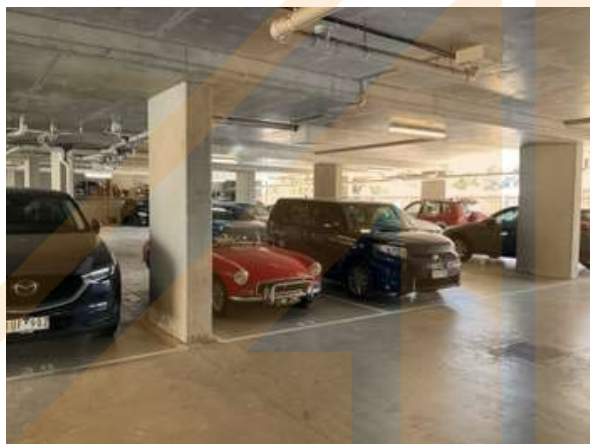
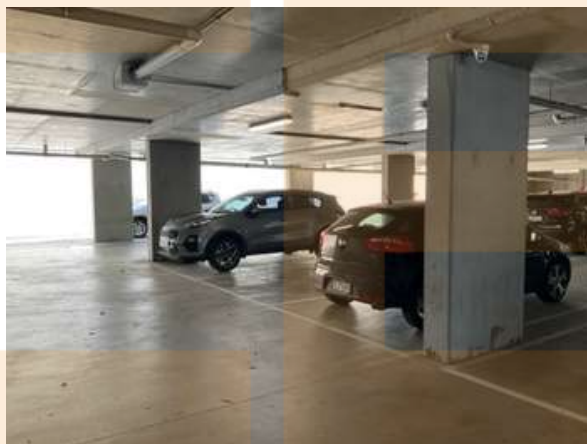
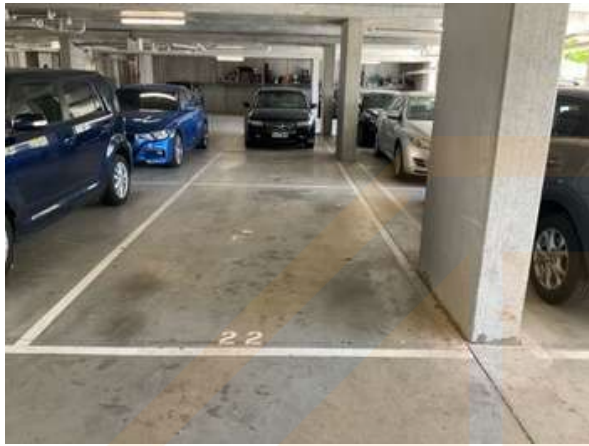
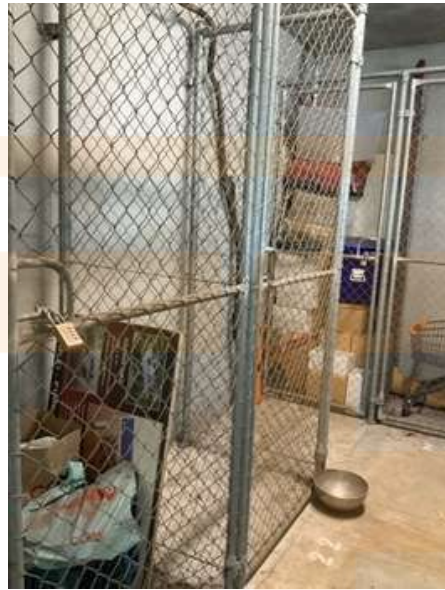
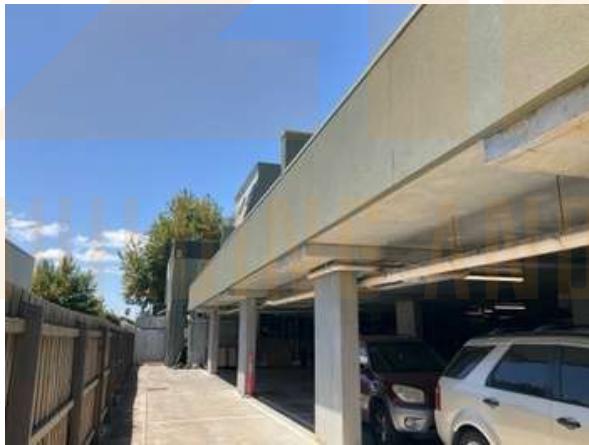
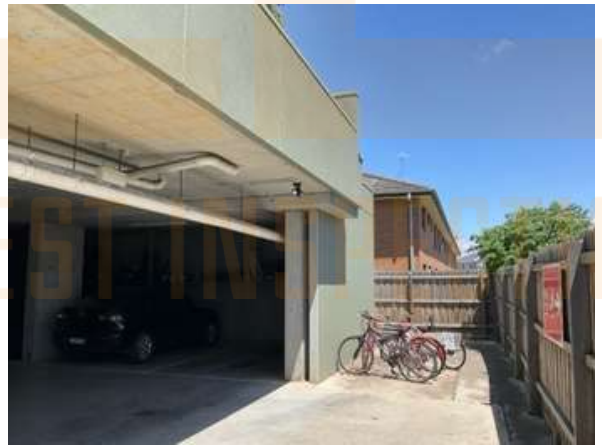
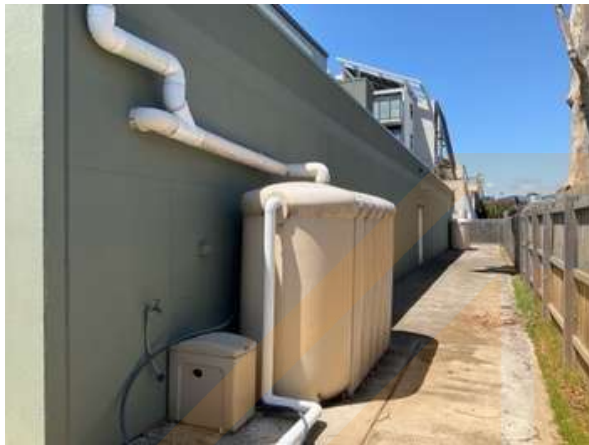
General Site & Communal Photos

Reference Photo's.

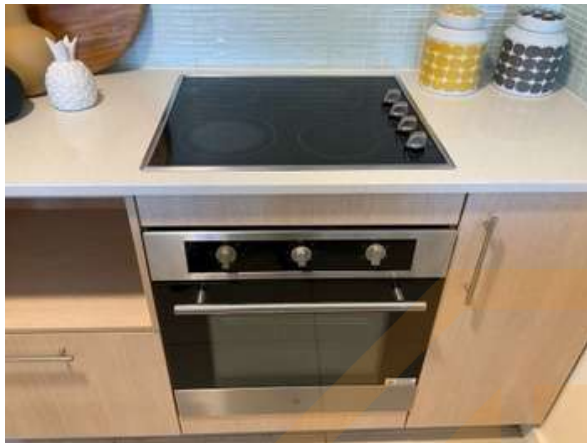
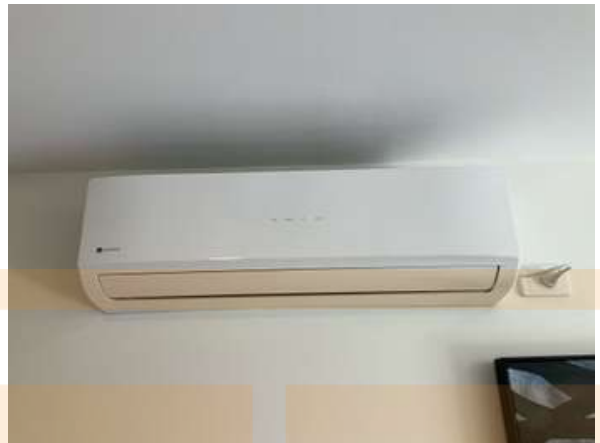
Similarly, any electrical appliances and services should be maintained and serviced by a qualified electrician or appropriate technician or manufacturer service agent.

It is important to note that some properties may have both gas and electrical appliances, while others may only have one or the other.
